Departmental investigation
into a fire in the
engine room aboard
the Australian Antarctic
Research and Supply Vessel
AURORA AUSTRALIS
off the coast of West Australia
on 14 January 1999

investigation into the engine room fire on board the

Australian Antarctic Research and Supply Vessel

AURORA AUSTRALIS

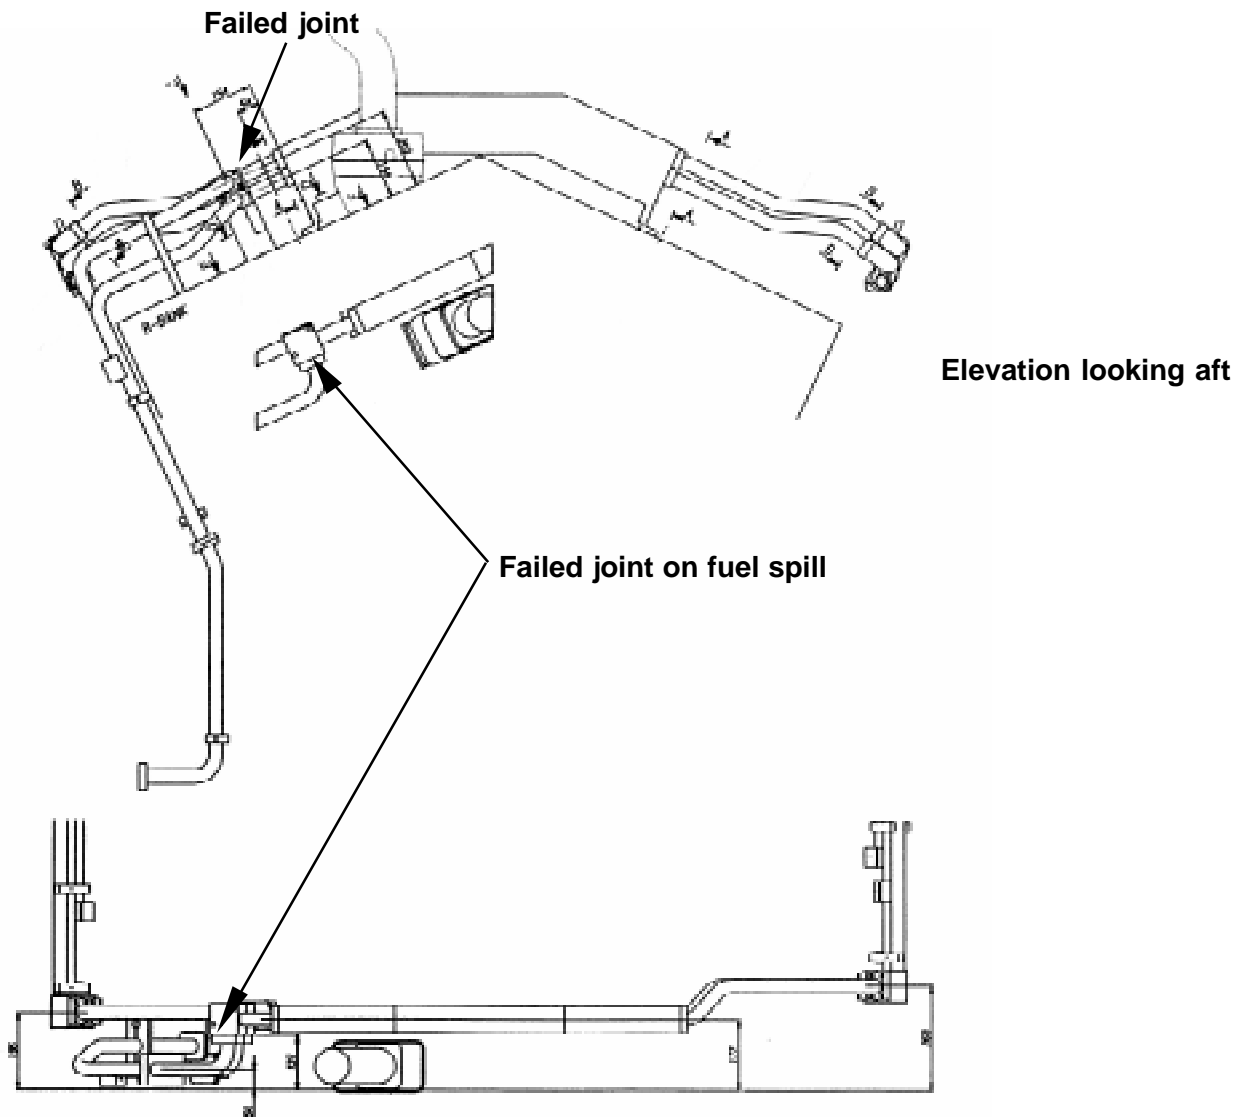
When the cover was removed, it revealed a failure of the flanged joint on the fuel return pipe, adjacent to the forward end of B bank, where it branches across the engine to the hot box of A bank. See diagram page 19. Of the four screws securing the flange, the upper two had broken, the left lower screw was quite loose and the fourth had lost its preload. The pipe had sprung and the joint had opened up about 3 mm. During the investigation the engine room staff reported that difficulty had been experienced fitting the LP fuel pipework and this is borne out by the fact that the pipe sprung when the screws failed.

Fuel supply and spill pipework at forward end of VASA 32 engine

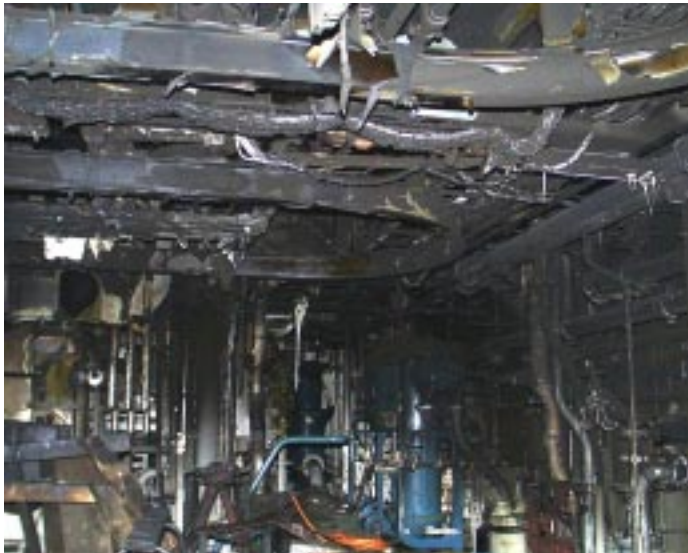
Damage to electrical cables under deckhead

It is usual, in incidents of this type, for even a relatively short-lived fire to produce enough hot gasses, which rise and become trapped against the deckhead, to rapidly cause severe heat damage to electrical cabling in cable trays. It was this effect that had caused the most serious and extensive damage. The fire damaged power cables, control and monitoring wiring and lighting throughout a large area of the engine room, both under the platform deck and the engine room deckhead. (See photos 20) It is also likely that charring of cable insulation caused most of the smoke which was generated during the incident.

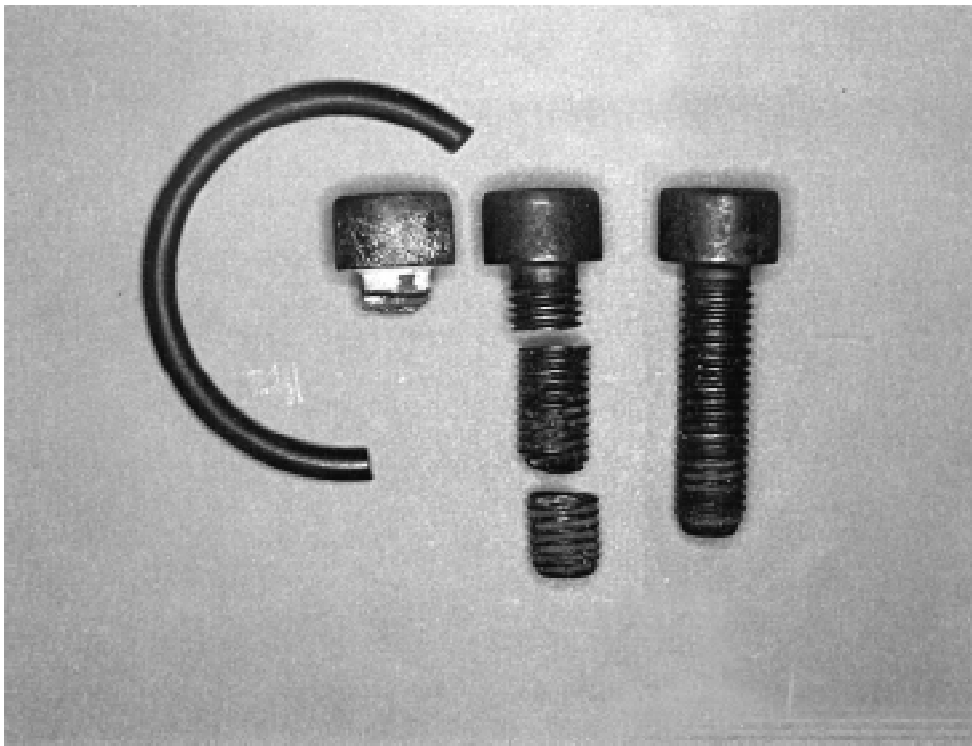
The shipowner supplied two complete screws and parts of two screws from the failed joint for metallurgical examination by ETRS. One screw head was missing. None of the three screw heads, with their small portion of attached thread, showed the reported distortion in the thread. See photos next page.

The report, commissioned by the shipowner, on the examination of the screws which were provided, contained no conclusions but in discussion stated that one screw, which had failed in high-cycle, low-stress, fatigue, had failed first. The other screw had started to fail in fatigue, but when the first had failed, this one had then suffered a fast fracture. The two intact screws from the flange showed no sign of over-tightening or fatigue.

The O-ring was also examined and it was found that, as the rubber was firm with no visible degradation or cracking, it had not contributed to the failure.

Screws and O-ring from failed flange joint, as supplied for examination
