**Departmental investigation
into the the fire
aboard the Australian flag
oil tanker
HELIX
at Brisbane, Queensland on
17 October 1998**

HELIX

at Brisbane, Queensland on 17 October 1998

Published: June 1999

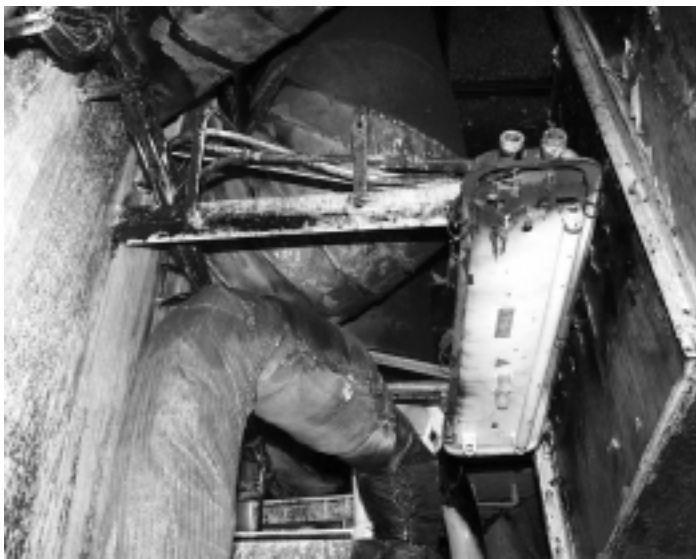
Fire damage immediately aft of hydraulic room bulkhead
Small lagging fire occurred on this pipework

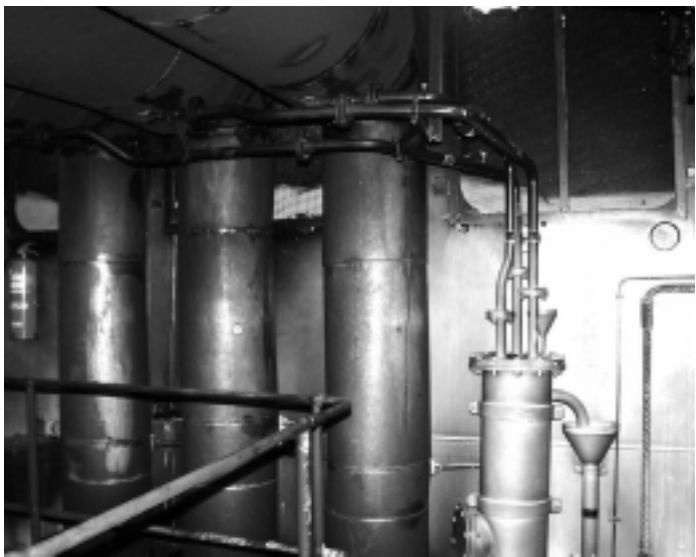
Smoke damage around diesel exhaust trunks above hydraulic room

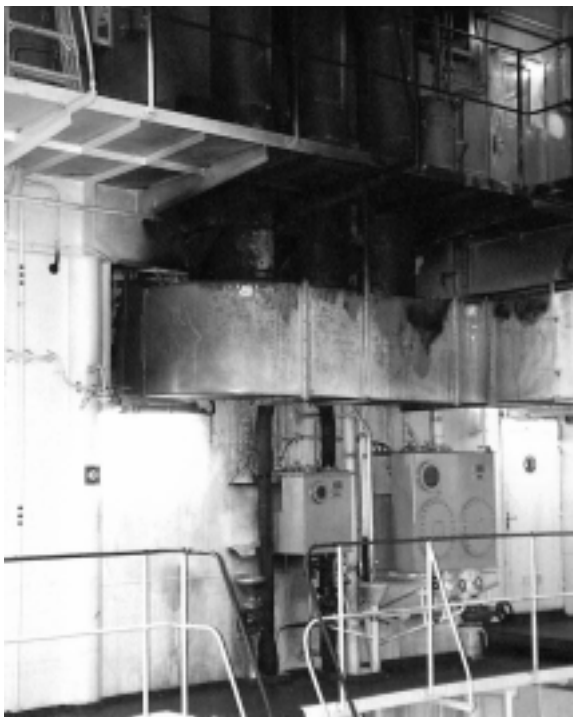
Smoke damage at top of engine room

Looking forward towards top of hydraulics room bulkhead

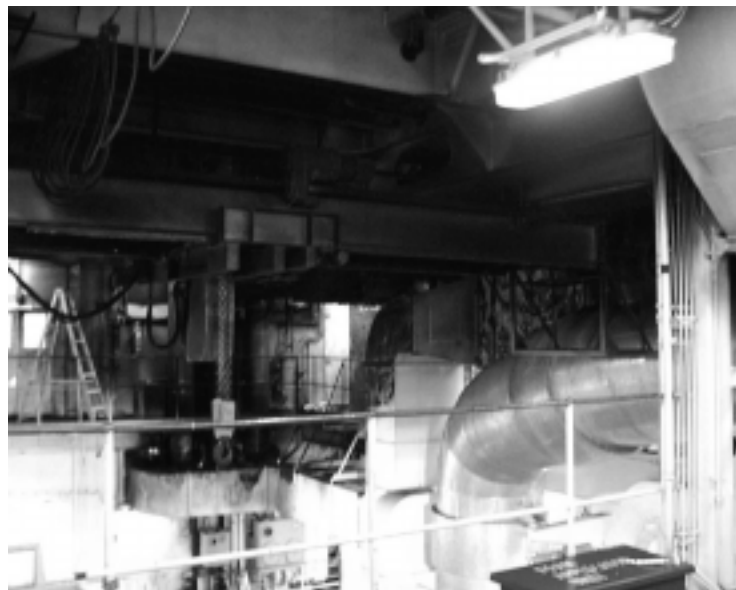
Smoke damage outside hydraulic room

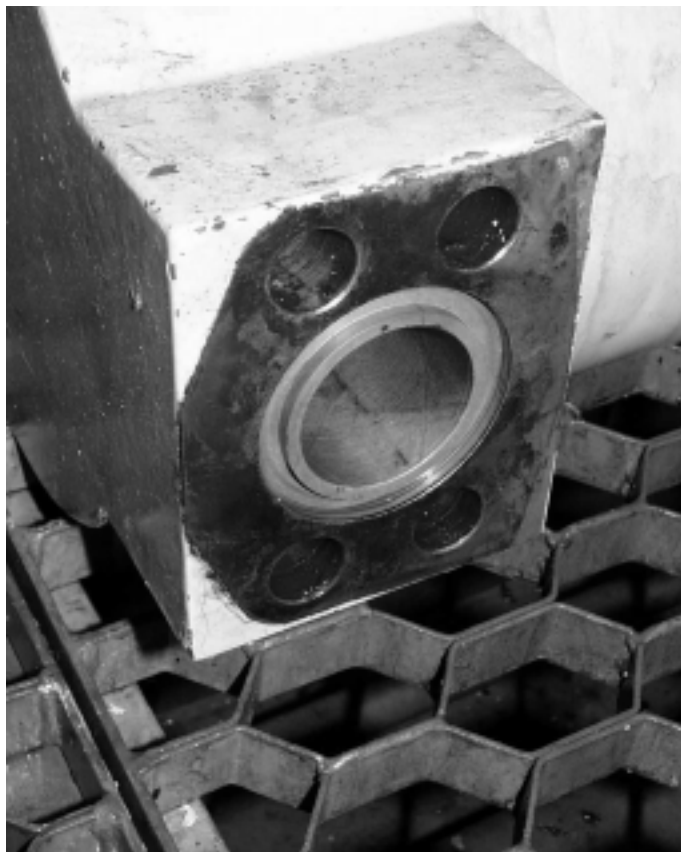
Damper body joint face

The bolt clearance holes in the attachment flange of the pulsation damper, where it joins the pump body, were found to be worn due to relative movement of the parts. Some fretting marks were evident on the two mating surfaces and the split O-ring was distorted. The thread in one of the holes in the pump body was damaged but the depth of the hole was 32 mm allowing sufficient clearance for the end of the bolt; the

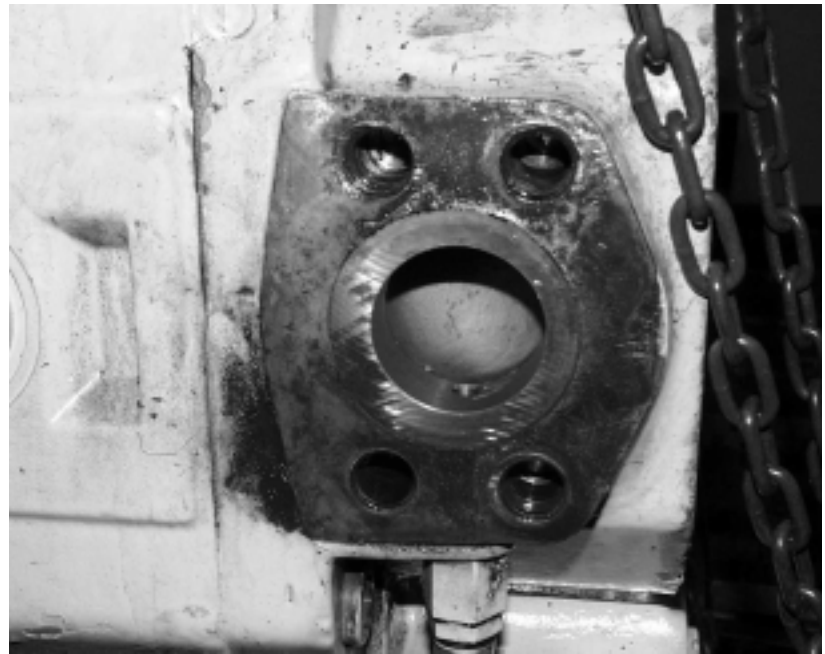
Pump body joint face

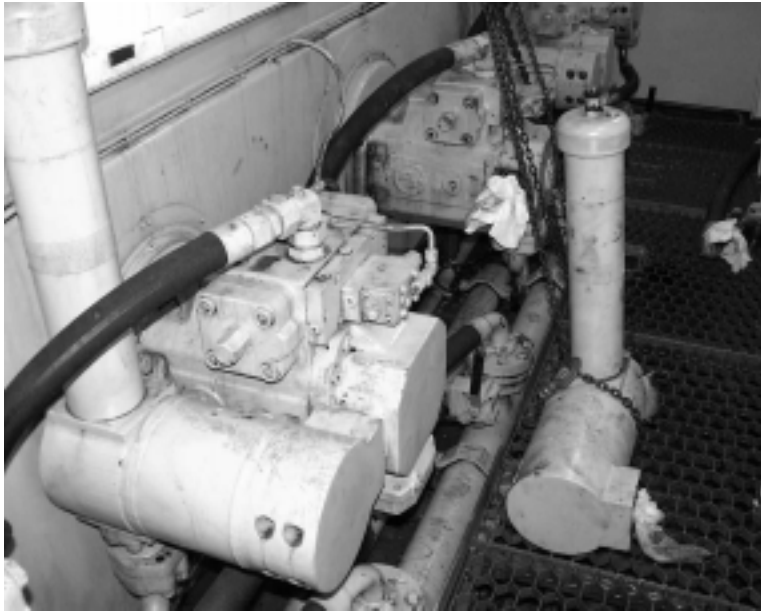
Hydraulic pumps (No.3 damper/filter unit removed)

At the time of the incident, No.3 hydraulic pump was in use for the cargo discharge. Following the fire, it was found that the two upper set bolts, securing the pulse damper unit to the HP outlet flange of the hydraulic pump, had failed approximately 180 mm below the heads of the bolts. The two lower bolts were found slack. The upper eye in the bracket securing the other end of the pulse damper to the pump body had failed (see photo bottom page 12). The effect of these failures was to allow the pulse damper to move relative to the body of the hydraulic pump and for the joint to open up to the point where the O-ring had failed, allowing the escape of hydraulic oil under high pressure.

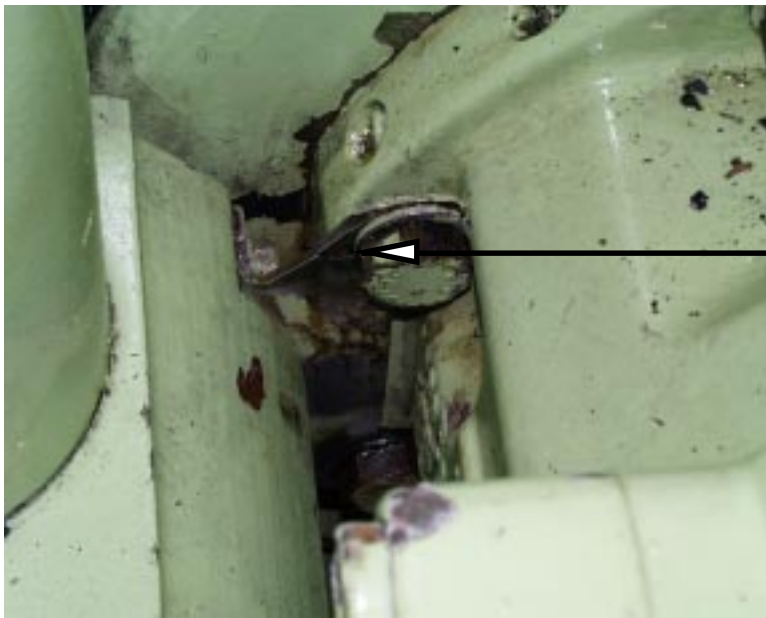
Failure

The supporting bracket, at the pump drive end, for the pulsation damper/filter unit was distorted and cracked across the bolt holes. Significant marking due to vibration was found on the pump flange where the bracket was secured.

**Broken
bracket on
No. 3 pump**

The fact that screws and brackets had failed at the opposite end of the damper unit (pump drive end) on all of the diesel driven pumps, indicates that vibration from the diesel engines was also a contributing factor in

the initiation of the failure. In addition, the original design of the pulsation damper did not incorporate the HP filter as fitted to the units on board *Helix*. The weight of this filter, attached to the end of the pulsation damper, would impose a considerable additional load on the pressed metal bracket supporting that end of the damper at the pump body flange. With the failure of the supporting bracket, the total load of the combined weight of the pulse damper and the HP filter would have been transferred to the four 20 mm set bolts securing the damper unit to the pump outlet face.

2. The failure of the bolts was initiated by fatigue crack growth due to insufficient preload (torque) upon assembly.
3. The failure of the supporting bracket was caused by vibration and inadequate design, once the weight of the HP filter unit had been added to the pulse damper.

In the report on the fire which was prepared by the suppliers of the hydraulic installation, it is recommended that the screen is rebuilt in such a way that the prime movers and the hydraulic pumps and their pipe connections are separated completely. It is also worth noting that, when the vessel was under construction, an owner’s remark was submitted to the shipyard about the lack of protection of the engines and exhausts from hydraulic oil. This resulted in the addition of 1.5 m to the then existing height of the partition, although this was considered unnecessary by the shipyard at the time.

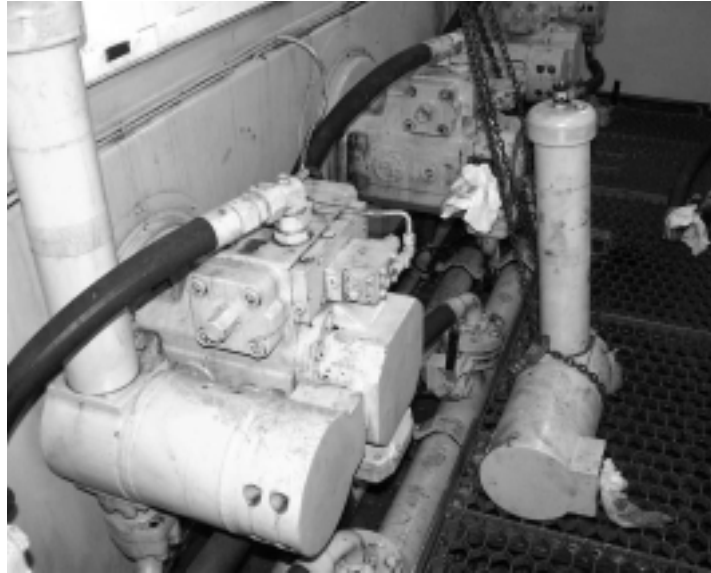
Figure 1. View of the cargo discharge hydraulic pumps showing the pulsation damper/filter bypass assembly removed from the pump with the failed joint. The locations of the cap screws used to secure the pulsation damper filter/bypass assemblies are indicated by arrows.

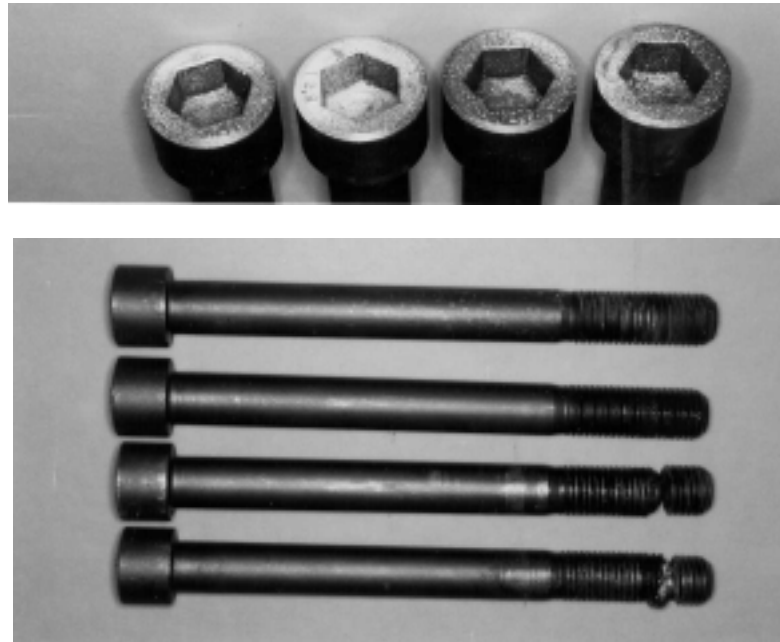
The damper and filter assembly is attached to the pump housing by four steel cap screws. The nominal diameter of the screws was 20mm. All four screws exhibited the grade marking 12,9. Two of the screws fractured as the result of fatigue crack growth. The remaining two screws were intact with no obvious indications of crack growth. The four cap screws from the hydraulic pump are shown in figure 2.

Figure 2. Cap screws from the failed pulsation damper filter/bypass hydraulic pump joint, as received.

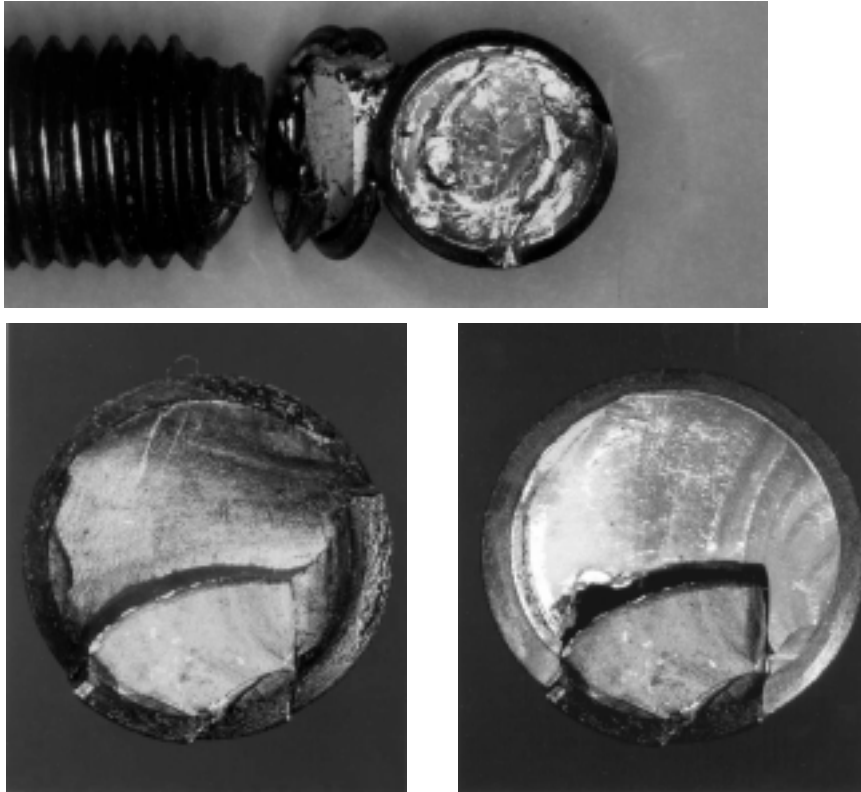
Fatigue crack growth in the first screw to fracture was caused by an alternating stress state aligned with the axis of the screw. The plane of crack growth was normal to the axis of the screw. Fatigue cracking initiated in the root of the thread engaged in the pump housing, two thread forms from the joint surface. Following the growth of this initial fatigue crack and the accompanying changes in load transfer further fatigue cracking initiated in the screw from the thread root closest to the joint surface. The growth of multiple cracks resulted in the liberation of the small section of the screw, see figure 3.

Figure 3. First screw to fracture, showing multiple crack growth. A detailed view of the primary fatigue fracture is shown, bottom right. A detailed view of the secondary crack (liberated section of the screw removed) is shown, bottom left.

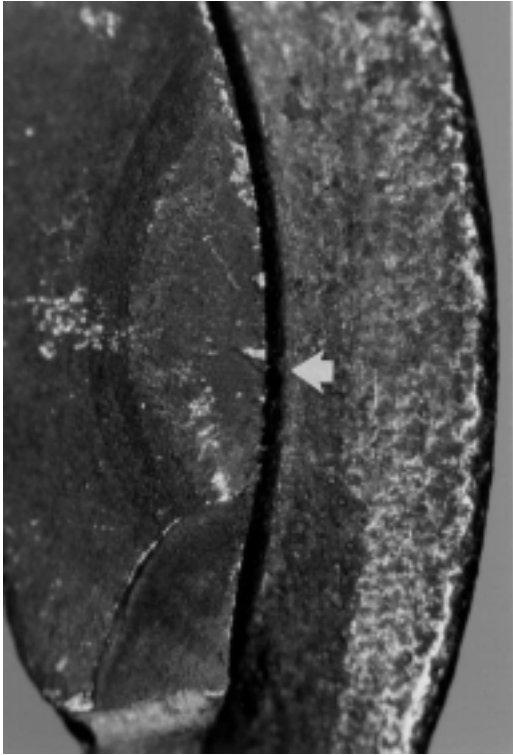
No gross material abnormalities or geometric discontinuities were observed to be associated with the initiation of fatigue cracking during a nondestructive inspection of this screw, see figure 4

Figure 4. Detailed view of the site of primary fatigue crack initiation.

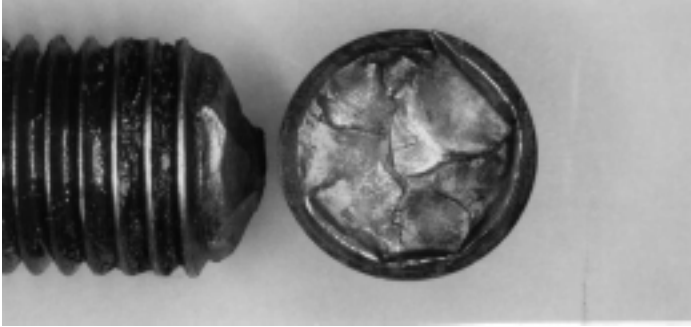
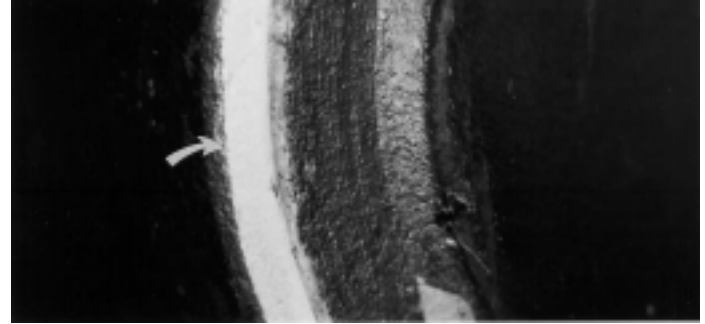
The features of fatigue crack growth in the second screw are consistent with the application of alternating, rotating, prying loads under the head of the screw. Fatigue cracking initiated at a number of sites in the root of the first engaged thread. Crack growth extended on planes inclined to the axis of the screw, see figure 5. This type of fatigue crack growth is consistent with a loosening of the bolted joint following the fracture of the first screw.

Wear on the edge of the bearing surface of the cap screw head is consistent with an alternating prying loading condition created after joint loosening.

Figure 5. Fatigue fracture, second cap screw. A detailed view of the wear on the edge of the cap screw head is shown at the bottom of the figure.

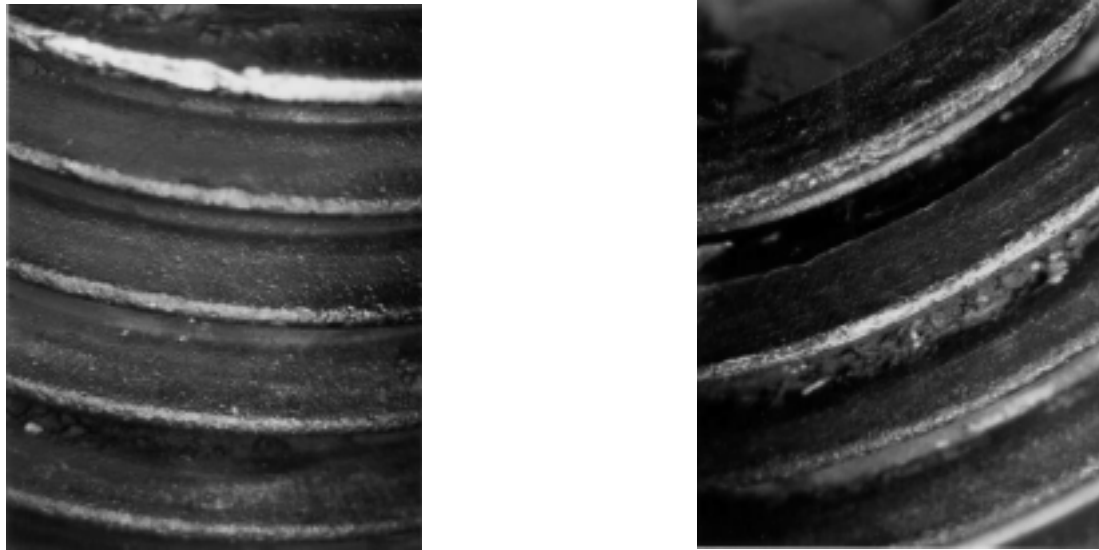
It was notable during the examination of the bearing surfaces of the threads and screw heads that there was little evidence of interaction with the mating surfaces in the pump housing and damper assembly, see figures 6 and 7. This lack of surface interaction (scoring, ploughing) may indicate a low assembly torque and, consequently, a low preload in the screw.

The breakaway torque of the cap screws installed in the remaining hydraulic pumps was reported to be 250Nm, considerably less than the specified 640Nm. This low value of breakaway torque supports the hypothesis that the preload in the cap screws created during assembly was inadequate

Figure 6. Detailed views of the loaded thread flanks of an intact cap screw from the failed joint (left) and the cap screw that fractured first (right).

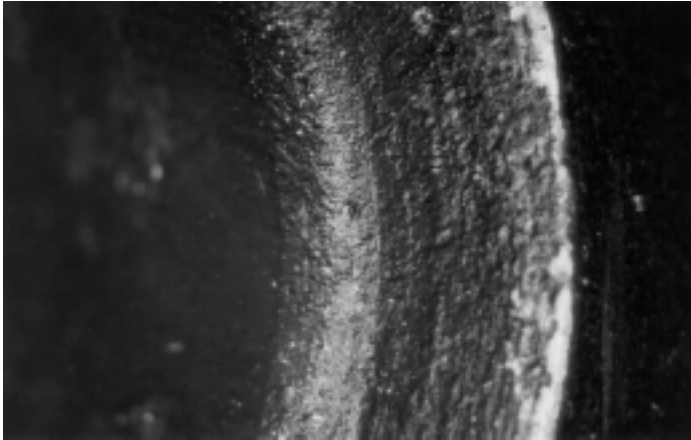
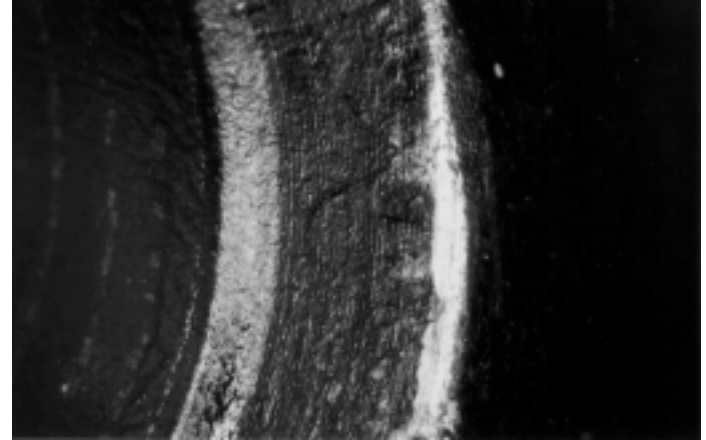
Figure 7. Detailed views showing the bearing surface under the heads of two cap screws from the failed joint.
