Departmental investigation
into the fire aboard the
Australian flag oil tanker
TASMAN
in the port of Melbourne,
Victoria on
19 December 1998

Navigation Act 1912 Navigation (Marine Casualty) Regulations investigation into the fire aboard the Australian flag oil tanker *TASMAN* in the port of Melbourne, Victoria on 19 December 1998

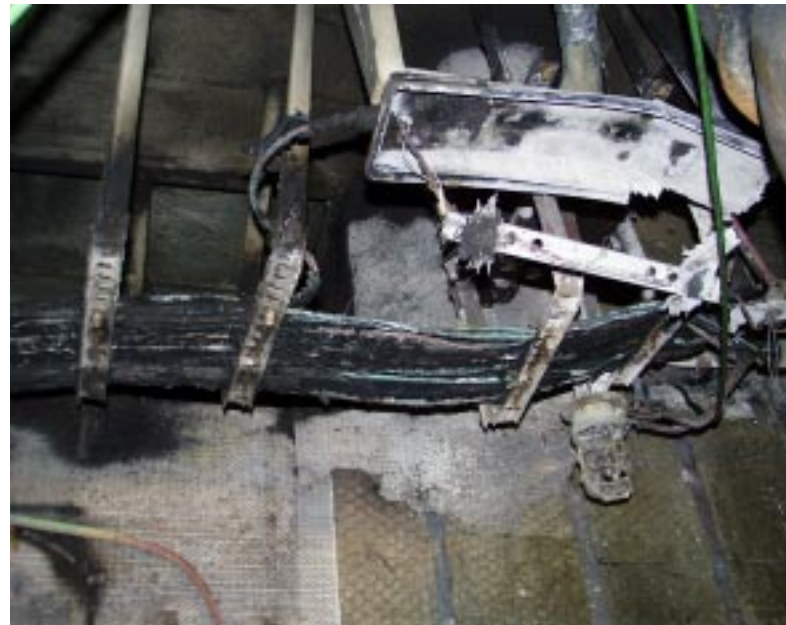
Following the extinction of the fire, an examination was made of the damage to no. 1/2 diesel generator room. It was evident that the most significant damage was to electrical cabling, as cable trays carrying the main power cables from the three generators to the main switchboard run along the deckhead above no. 1 generator. In addition to the power cables, a large number of control, monitoring, alarm and communications cables were also damaged by heat.

It is usual, in incidents of this type, for even a relatively short-lived fire to produce enough hot gasses, which become trapped against the deckhead, to rapidly cause severe heat damage to electrical cabling in cable trays. It was this effect that had caused the most serious damage, being to power cables, control and monitoring wiring

FIGURE 5
Fire damage to deckhead cables and fittings

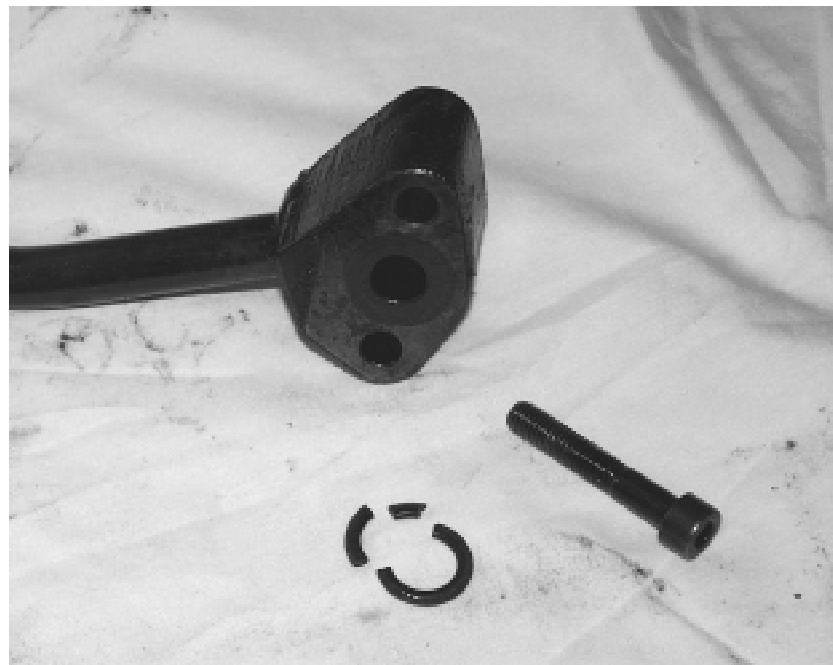
FIGURE 11

The two 8 mm × 45 mm allen screws which had secured the fuel suction pipe flange to the pump body were examined. The upper screw, which was reported to have fallen out and later found on the entablature, was stamped 'B109 18' on the side of the head, while the lower screw, which had remained in situ, although loose, was stamped M9 on its upper face. The two screws were subjected to non-destructive hardness tests and, although of different manufacture, returned similar results.

Pipe flange, 8 mm allen screw and pieces of O-Ring

The O-ring which had failed, at the joint of the suction pipe on no. 2 fuel pump, was found after the incident to be in 3 pieces. It was not clearly established, however, when the two breaks had occurred. ASP suggested in submission that these breaks had occurred after it had been removed from the joint. Compared to a new O-ring it had evidently hardened considerably, either during the 2,079 running hours since the fuel pump had been re-fitted, which the engine builder considered most unlikely in such a relatively short period, or it had been re-used at the time of the 20,000 hour overhaul. The latter possibility was adamantly refuted in a submission from ASP.

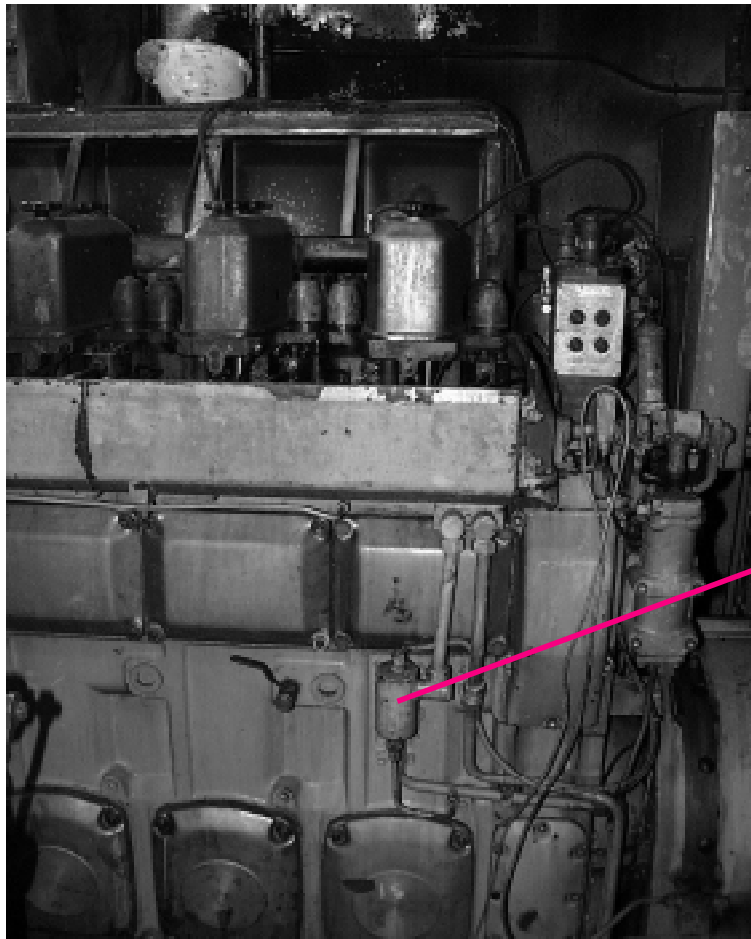
FIGURE 12

The hot box has, at each end, drains which lead down to the fuel oil drain tank. At the forward end, only, there is incorporated into the drain a fuel oil leakage alarm. (fig. 12). The leakage alarm is so designed that small amounts of fuel leakage, which may be considered normal, pass freely to the drain tank down a small pipe, connected to the main drain. However, a substantial quantity of fuel leakage will cause fuel oil to back up in the alarm chamber, thereby activating the leakage alarm.

aft end, the siting of the fuel leakage alarm at the forward end of the engine results in fuel being able to build up to a theoretical depth of approximately 40 mm at the aft end of the fuel gallery before it reaches the forward drain and the leakage alarm. It is probably for this reason that the alarm for channel 12106 'Fuel oil leakage A.E.1' (no. 1 generator) did not activate until after the fire had already started (16 seconds after the fire alarm).

It is clear that the siting of the fuel leakage alarm was overlooked when the generator sets were installed and were orientated with the drive end forward. If the leakage alarm had been correctly sited at the aft end of the engine, there is clearly a possibility that the fire may have been avoided.

Fuel oil leakage detector
