Injury: 1st and 2nd degree burns to hands and face

Location: Gas Plant

Incident Date: December 23, 2004

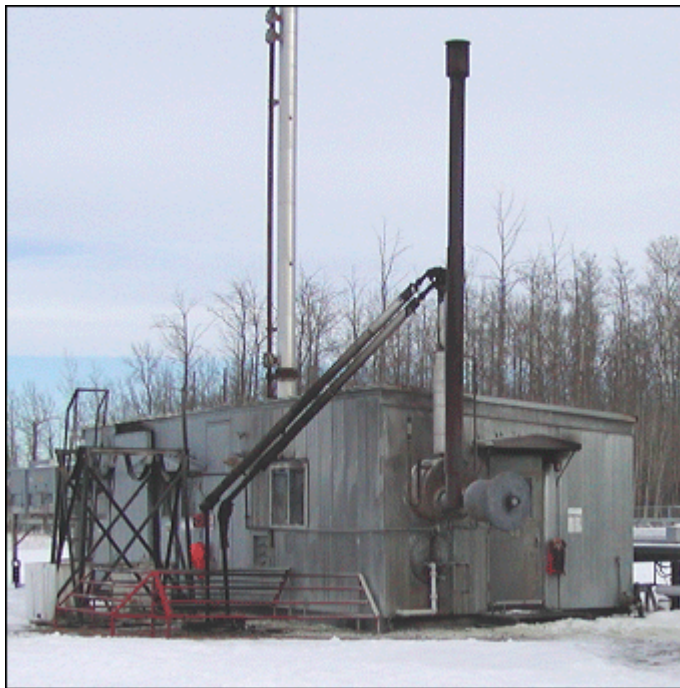
1. Close proximity of the glycol still column vent lines and associated underground tank allowed condensate vapors to accumulate around and in the process building.
2. A faulty flame arrestor allowed the back flash to negate the protection of the flame arrestor resulting in the ignition of the combustible vapors outside the flame arrestor.

View looking northeast at process building.

1. Glycol still column vent lines were re-piped to an above ground storage tank located away from potential ignition sources (e.g. glycol re-boiler burner);
2. A emergency shut down was installed on the glycol re-boiler supply gas linked to a remote manual activation device;
3. The flame arrestor was repaired/tested and the maintenance inspection program was assessed at all properties. Other properties were audited to identify similar process equipment design and retrofitted as determined necessary based on risk assessment.
4. Communicated to all company field staff and contract operators the incident findings, lessons learnt and re-confirmed the need for proper hazard identification and management.
