U. S. CHEMICAL SAFETY AND HAZARD INVESTIGATION BOARD

# INVESTIGATION REPORT

## PROPANE TANK EXPLOSION (2 DEATHS, 7 INJURIES)

Herrig Brothers Feather Creek Farm  
Albert City, Iowa  
APRIL 9, 1998

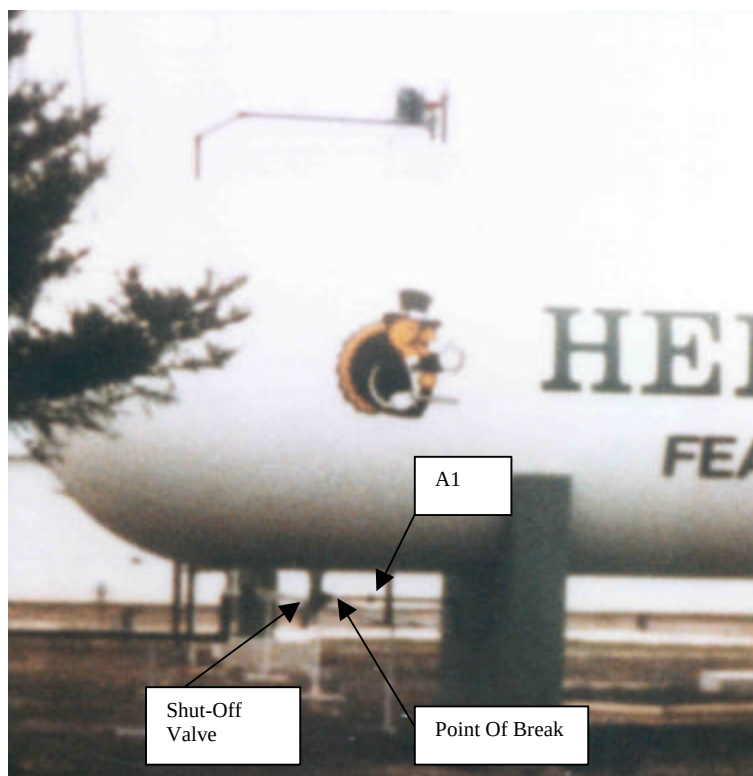
**Figure 4. Liquid Line Shut-Off Valve and Point of Break**

The first component in the liquid line leading to the vaporizer was a 3-inch excess flow valve. This metal valve was threaded into a 3-inch pipe coupling that was welded to the bottom shell of the tank. This excess flow valve was connected to a manual shut-off valve by a 2-inch diameter pipe (nipple) that was 2 inches in length. This metal 90°-angle valve changed the orientation of the liquid line from a downward direction to a horizontal and eastward direction. Two bushings (adapters designed to permit the joining of pipes with different diameters) connected the shut-off valve to a ¾-inch schedule 80 carbon steel pipe (outlet pipe). This outlet pipe ran to the east for approximately 30 inches toward the concrete saddle supporting the tank, and then turned downward for approximately 7 inches. This segment of pipe was subsequently labeled “A1” for evidentiary purposes (See Figure 4 below and Figure 29 in Appendix B). The outlet pipe then turned again to the north and ran to the vaporizers on a series of steel supports spaced at regular intervals. These supports placed the outlet pipe approximately 3 feet above the ground for its entire 37-foot course from the tank to the vaporizers. The arrows in Figure 4 point to liquid line components and to the approximate location of the break that occurred under the tank.

The liquid line (which measured approximately  $\frac{3}{4}$ -inch inside diameter) was completely severed from the tank at the location where it was connected to a manual shut-off valve directly beneath the tank (see Figure 6, item A20). An excess flow valve protecting the liquid line (see Figure 6, item FV3) failed to function, and propane leaked out of the tank at the point of the break. As the liquid propane sprayed out of the tank, it rapidly changed to vapor. Propane vapor may have also leaked from the damaged vapor line.<sup>8</sup> Propane from the damaged pipes formed a cloud, and within a few minutes this propane vapor ignited. Although the source of ignition was not conclusively established, the likely source was the direct-fired vaporizers.<sup>9</sup> A fire, fed by the broken liquid line, began burning vigorously under the tank.

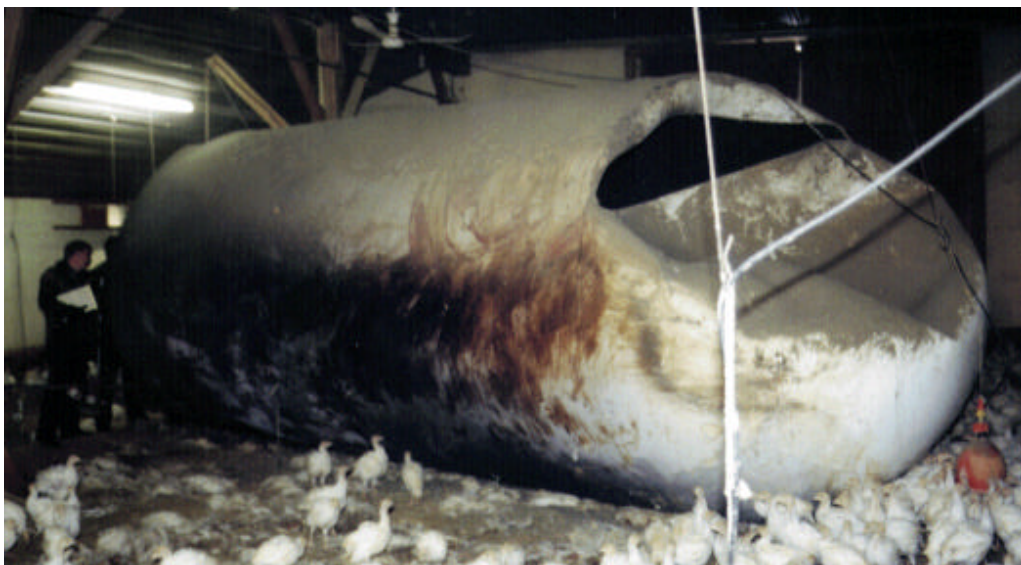
**Figure 10. Piece of 18,000-gallon Tank Inside Turkey Barn (1f)**

diameter) was propelled to the east, through the end of a turkey barn wall (see Figure 2, item 1f) and came to rest inside the barn (see Figure 10). This piece, which represented about one-half of the tank, caused the damage to the west end of turkey barn 1f, shown in Figure 11. A second large fragment traveled north, causing the damage to another turkey barn shown in Figure 12. (See also Figure 2, item 1g for location of the barn). Two other large pieces traveled in a northwesterly direction and landed between a workshop and a feed storage bin. One of these pieces likely caused the damage to the two-story workshop shown in Figure 13. Smaller tank pieces traveled in various directions. Some of these pieces were discovered in the grain fields that surround the property. A map that depicts the location of tank debris following the explosion is provided in Appendix C.

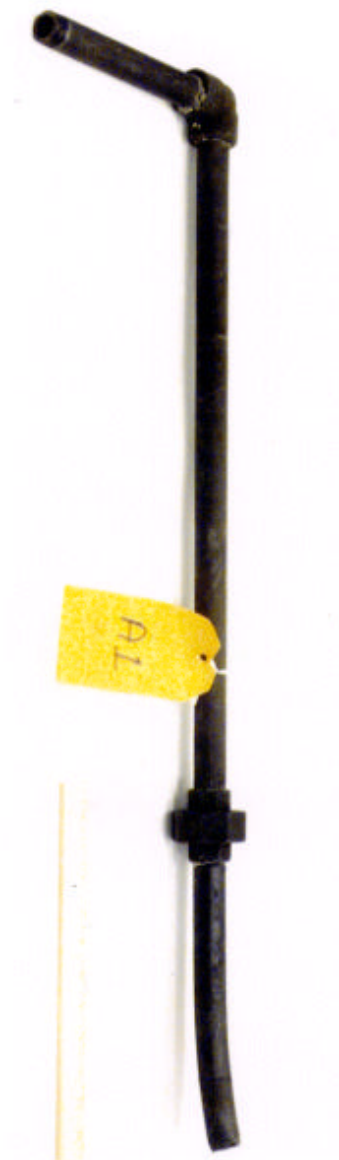
FIGURE 29

observed on other pieces of debris. For example, the shut-off valve (A20) exhibited a number of abrasions that likely occurred as a result of the explosion. As Figure 29 in Appendix B shows, the A1 piece was not dented or damaged. Finally, eyewitness reports of fire under the north and west end of the tank following the impact of the ATV were consistent with a propane leak in the vicinity of the A20/A1 connection under the tank.

View of the pipe that fed liquid propane to the vaporizer units.

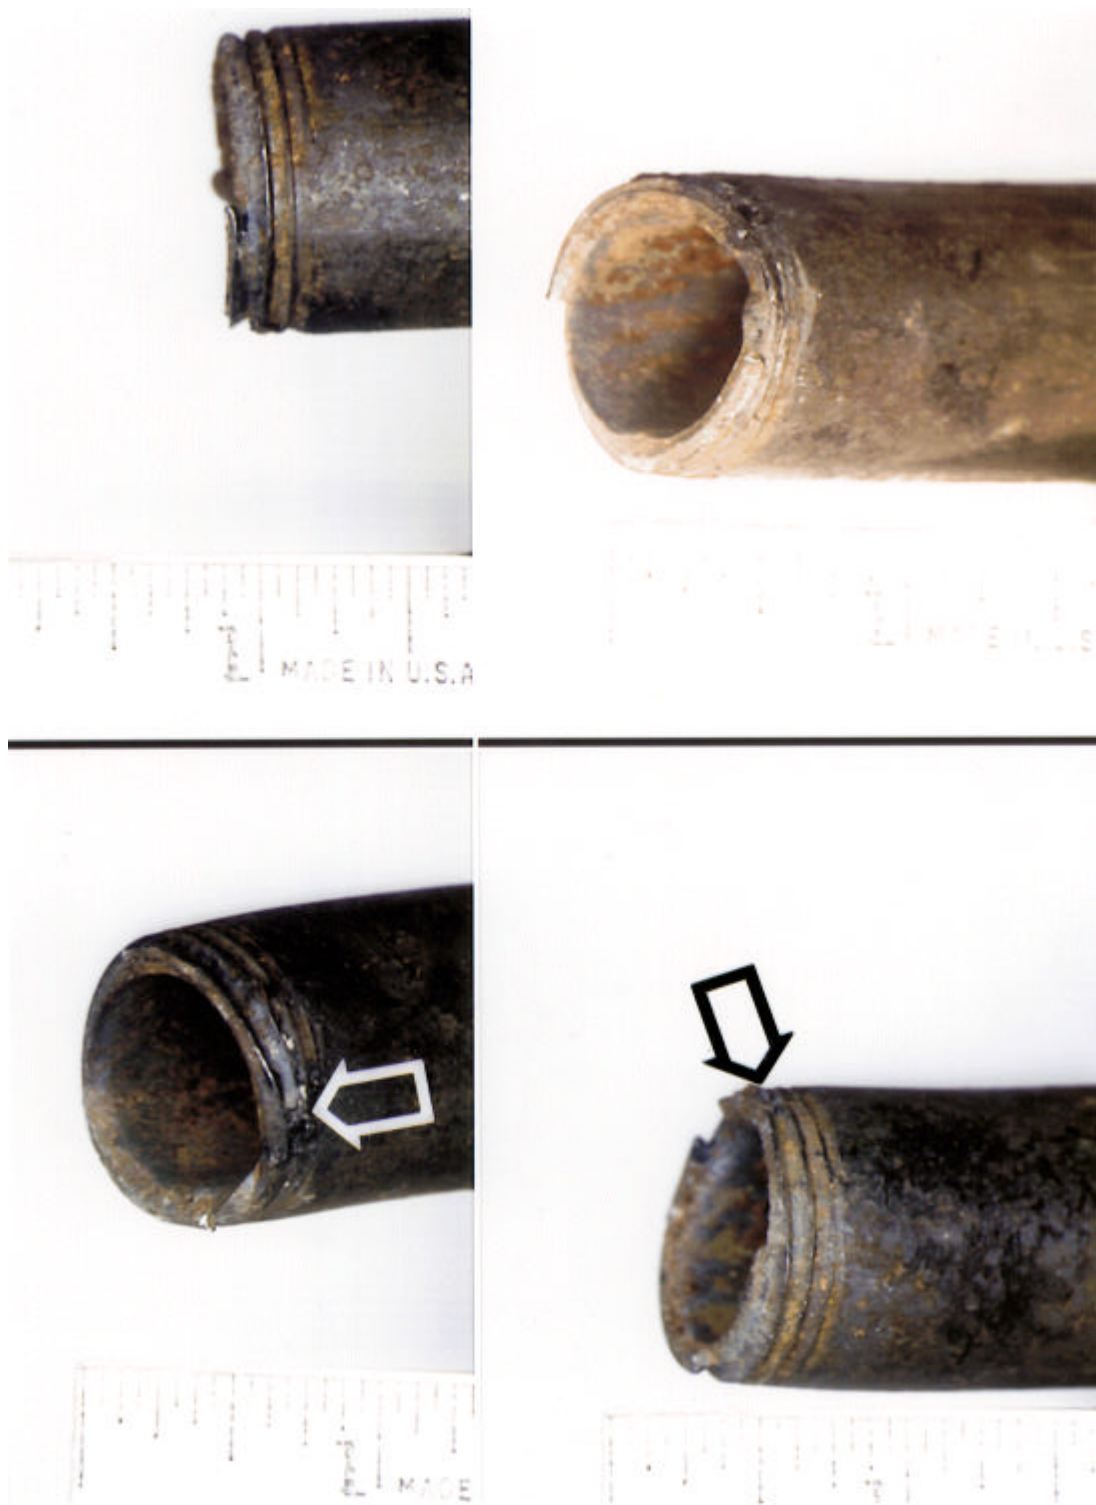
Figure 38

90° rotational view of the threaded end of the one inch pipe (A1). Arrow indicate deformed threads.

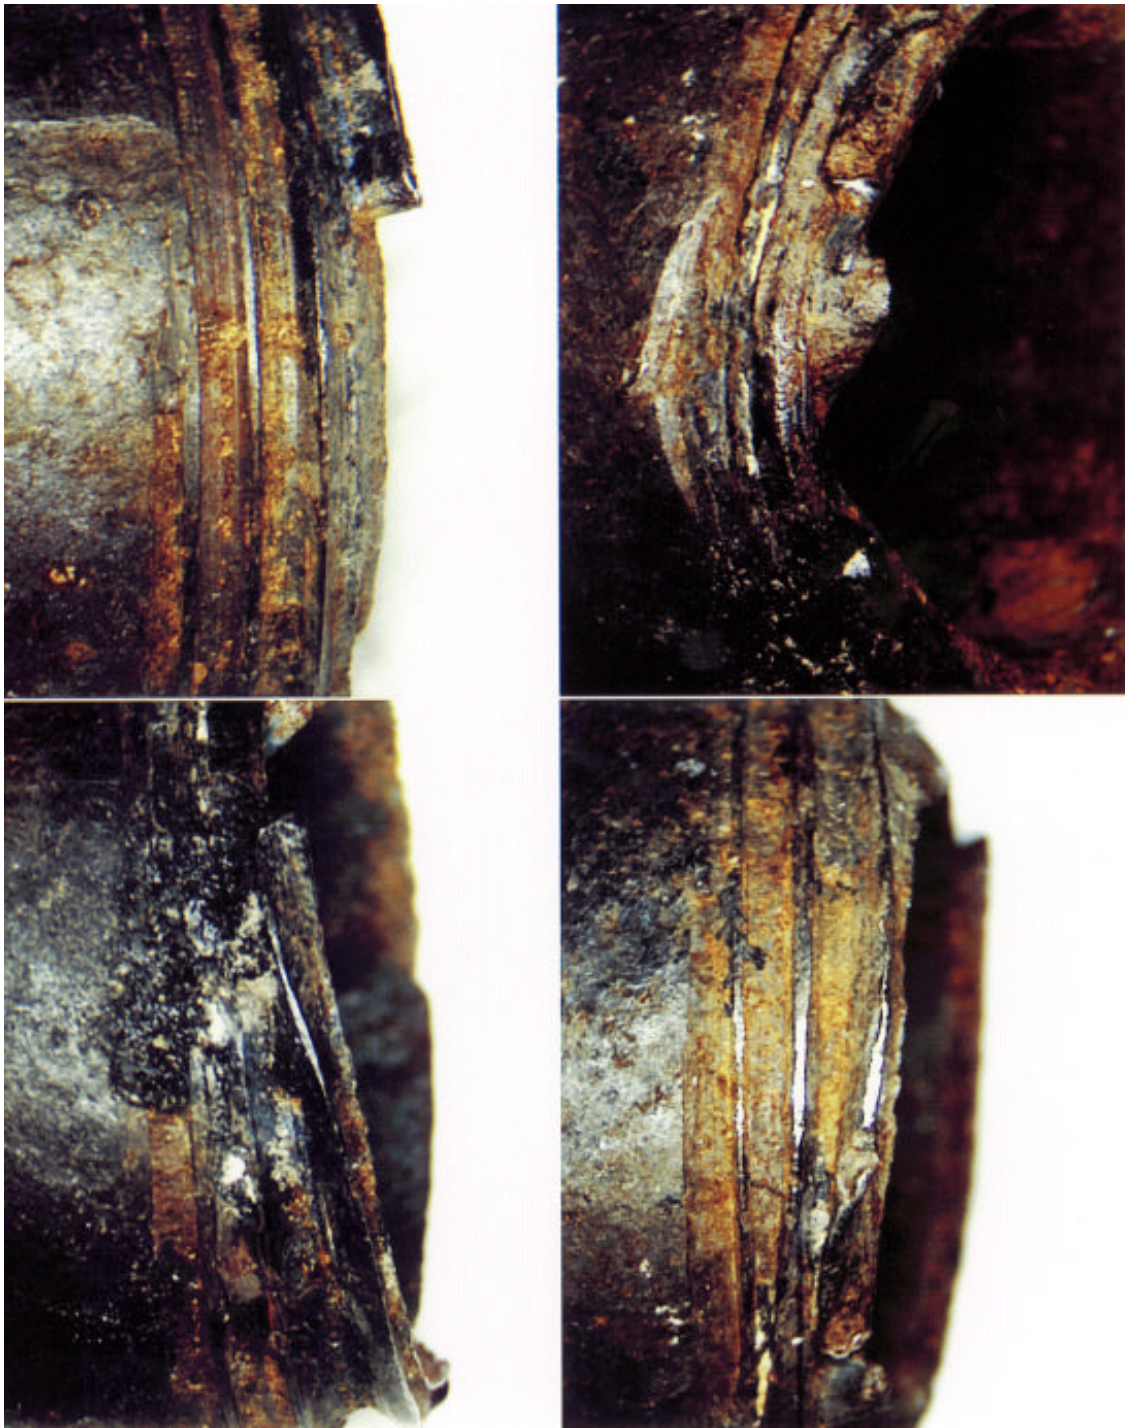
Figure 39  
90° rotational view of the condition of the pipe threads on the one inch pipe (A1).  
MAGNIFICATION: 5X
