U.S. CHEMICAL SAFETY AND HAZARD INVESTIGATION BOARD

# INVESTIGATION REPORT

### MOTIVA ENTERPRISES LLC

DELAWARE CITY REFINERY  
DELAWARE CITY, DELAWARE  
JULY 17, 2001

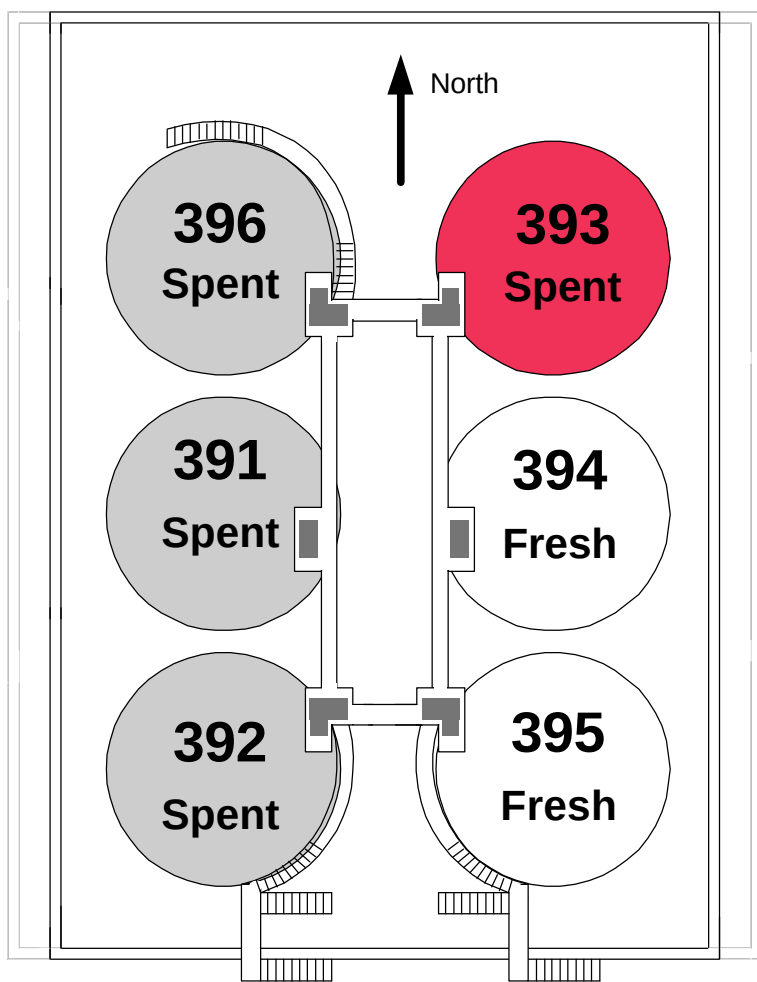
Sulfur dioxide vapors from the storage tanks combined with moisture in the air to form sulfurous acid, which was causing the deterioration of the catwalk.

Figure 1. Layout of acid storage tanks and catwalk.

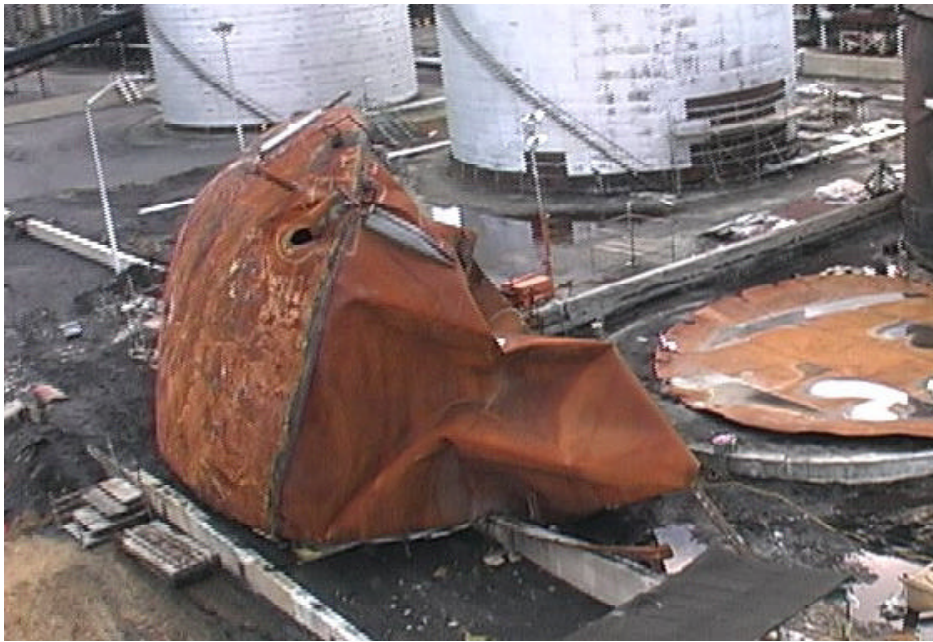
Figure 2. Tank 393, collapsed at northeast corner of storage tank dike.  
(Note floor of tank 393 to the right of tank shell.)

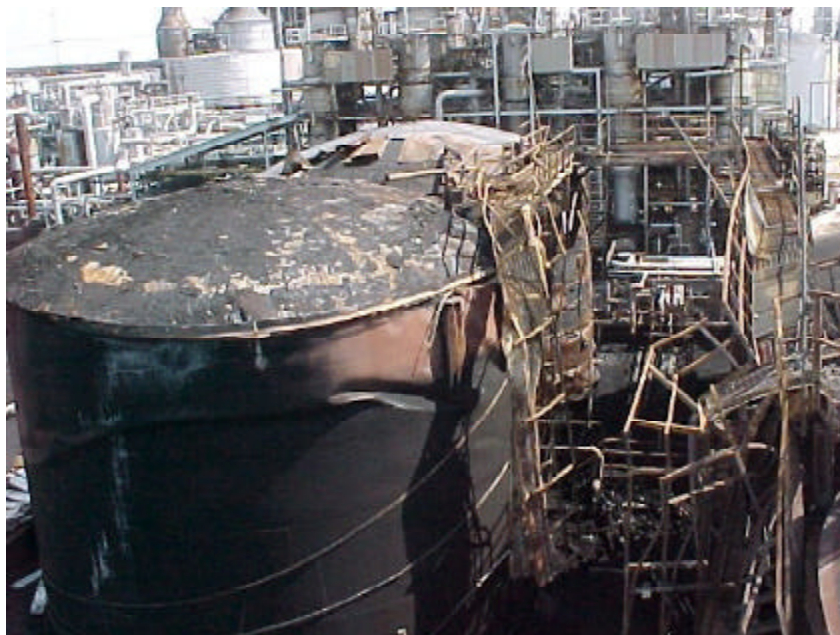
Figure 3. Tank 394 in foreground and remains of catwalk, from the north.

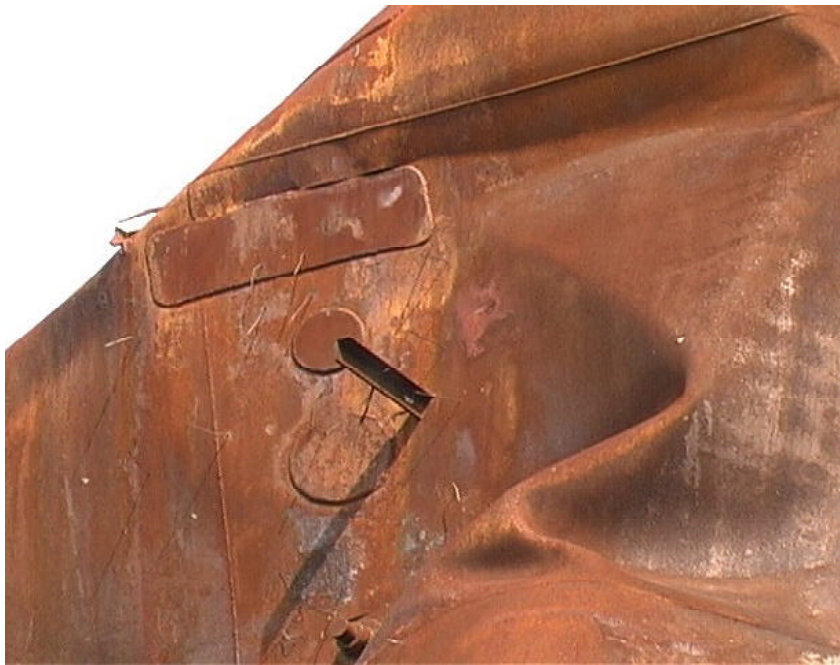
| <b>Date</b> | <b>Inspection Findings</b> |
|---|---|
| July 2000 | <b>Shell leak:</b> leaks from April 2000 were covered with an epoxy patch instead of the recommended CS patch; the patch leaked and was replaced with a CS patch |
| May 2001 | <b>Shell leak:</b> 3- by 1/8-inch-wide leak directly above a previously installed patch; recommended 22- by 22-inch repair patch was not installed |

Figure 4. Side of tank 393 showing series of patches.

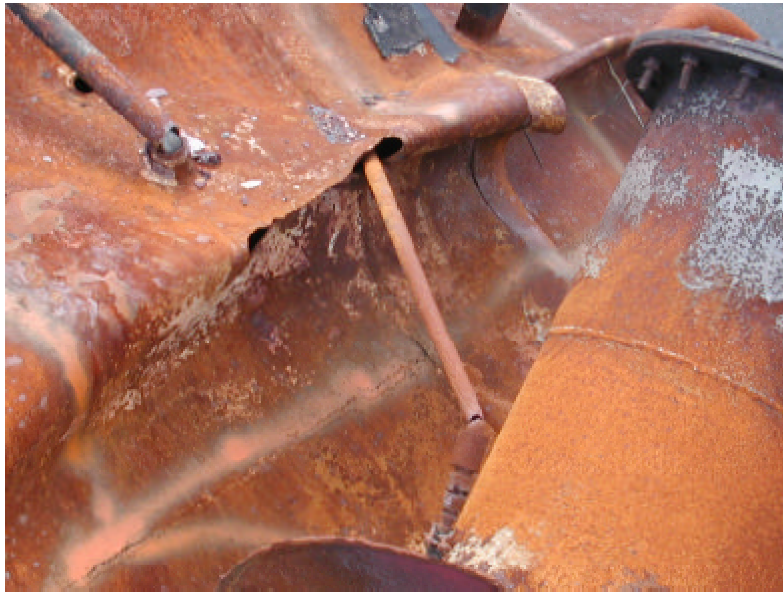
Post-incident analysis revealed three additional openings in the roof and shell of tank 393 that were believed to have been present prior to the incident:

Figure 5. Elongated hole on roof of tank 393 (covered by insulation at time of incident).

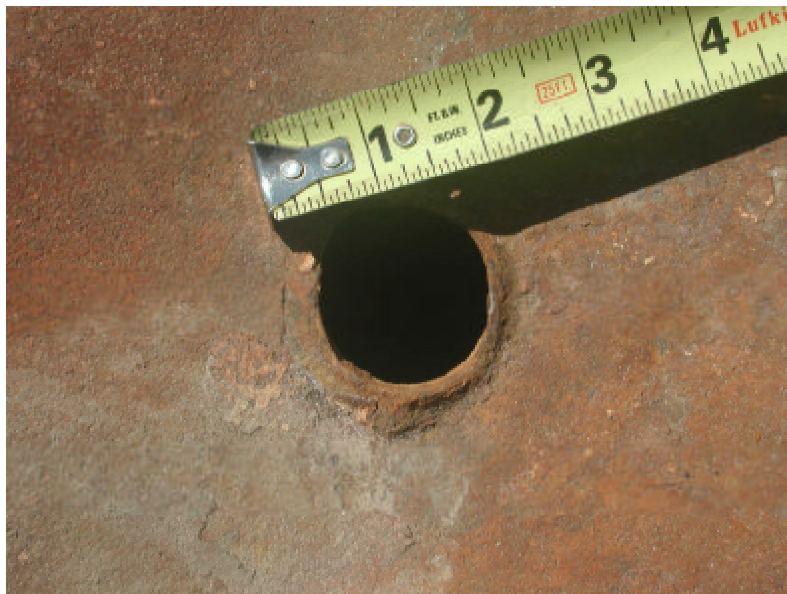
- The hose supplying CO<sub>2</sub> was not attached to tank 393. It was dropped into a hole in the roof, where a nozzle had been located before it corroded. The temporary hose setup was in use for over a year; it was not converted to conventional hard piping, as on the other acid tanks.

393 TK is still being fed a blanket (CO<sub>2</sub>) by a nitrogen hose [a rubber hose typically used for nitrogen] from the regulator on 396 TK. This hose is shoved in a hole in the top of the 393. The hole came from a nozzle that fell off because it was corroded so bad. 396 TK also has a (1½) nozzle that fell off because it was corroded so bad. Now it's open to atmosphere. Note: The one regulator is working for both tanks.

Figure 6. Hole in roof of tank 393 through which temporary hose was inserted.

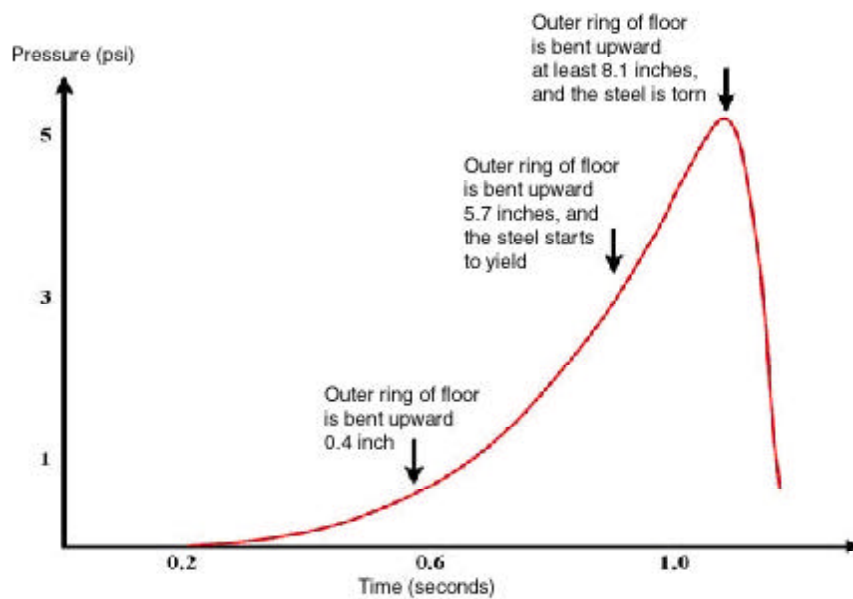
Yielding at the shell-to-floor weld was predicted to have begun at approximately 4.0 psig. Furthermore, by the time the peak pressure of 5.0 psig was reached, the stresses at the corner welds exceeded the tensile strength of the tank (ESI, 2002; Figure 7).

Figure 7. Modeled pressure rise in tank 393 during internal deflagration.

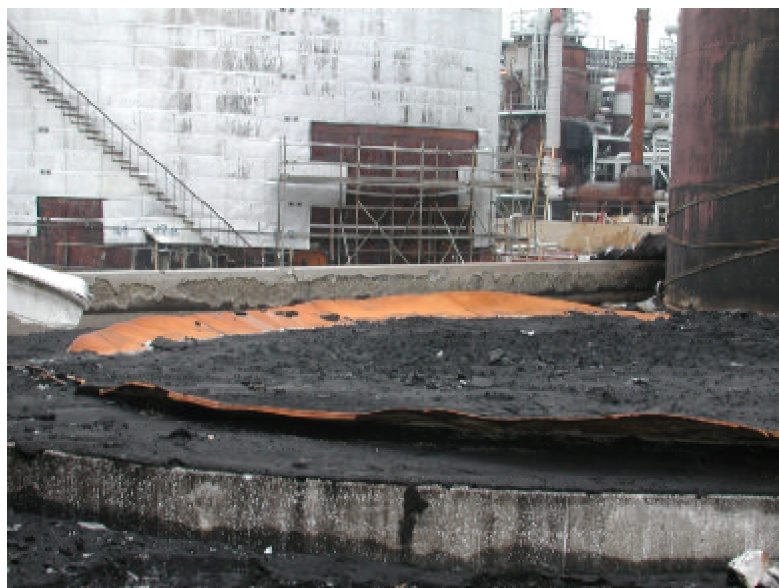
Figure 8 shows the floor of tank 393. The curved edges clearly indicate the uplift that occurred prior to separation of the shell from the floor.

Figure 8. Floor of tank 393 showing uplift due to internal deflagration (before separation of shell).

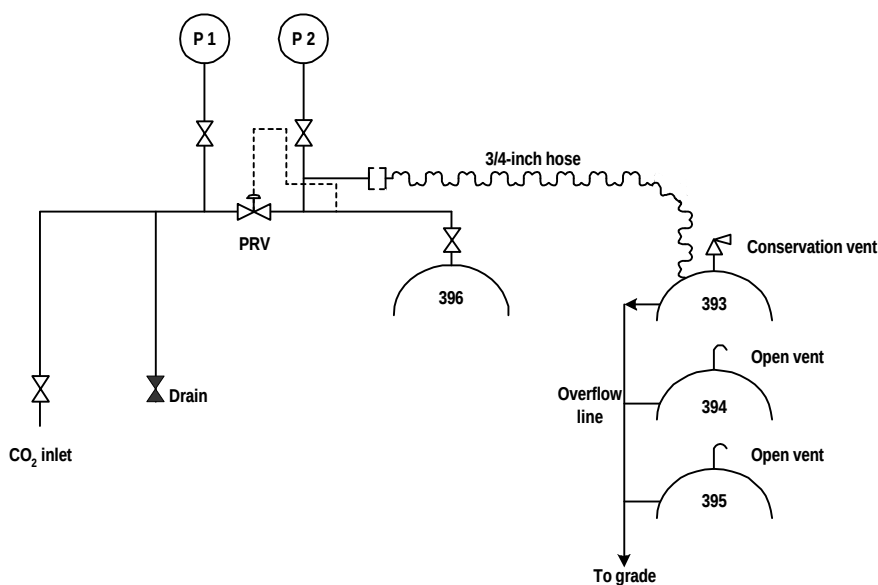
- The  $\text{CO}_2$  inerting supply to tank 393, installed in 2000, was incapable of maintaining a nonflammable atmosphere.
- $\text{CO}_2$  was supplied to tank 393 via a temporary hose run off the inerting system of an adjacent tank. The hose was dropped into a hole in the roof of tank 393.
- No engineering calculations were made to determine proper sizing for the inerting system.
- The tank conversion was completed without review of changes by technical experts, process hazard analyses, or prestartup safety reviews—all elements of a proper MOC program.

When tanks 391 and 396 were converted to spent acid service in 1997, each tank was equipped with a pressure regulator valve to control CO<sub>2</sub> flow and two local pressure gauges. However, when the inerting system on tank 393 was installed in March 2000, it was set up in a different manner (Figure 9).

Figure 9. Inerting system schematic (CO<sub>2</sub> flow to tank 393 and overflow connection to 394/395).
