U.S. CHEMICAL SAFETY AND HAZARD INVESTIGATION BOARD

# INVESTIGATION REPORT

## THERMAL DECOMPOSITION INCIDENT

**BPAMOCO POLYMERS, INC.**

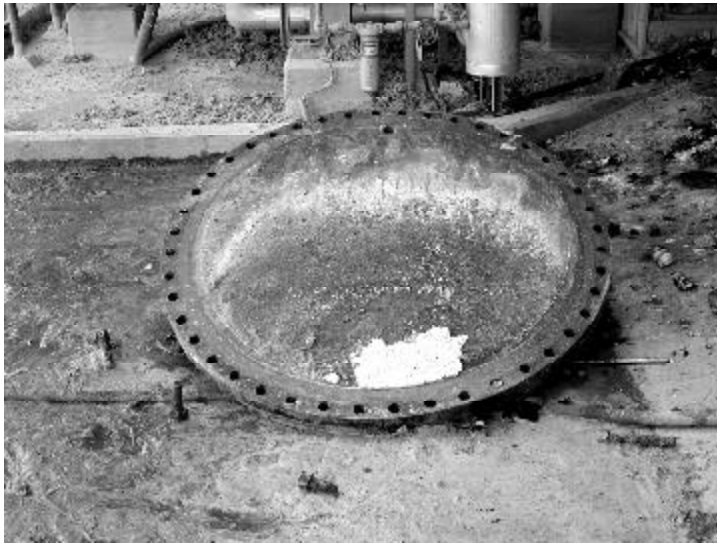
Figure 6. Polymer catch tank cover.

### 3.2.1 Cover Failure and Expulsion of Hot Plastic

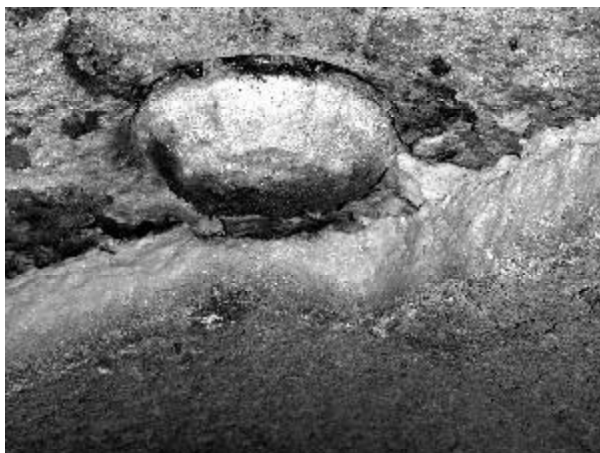
Figure 7. Polymer plugging the polymer catch tank vent nozzle.

Investigators found that most of the contents of the polymer catch tank were expelled during the incident. However, a solid layer of polymer 3 to 5 inches thick remained in the vessel and coated the entire inside surface, including the rear cover (see cover photograph). The vessel nozzles, including the vent nozzle, were completely plugged with polymer (Figure 7). Significant amounts of polymer were found in the vent system. Appendix A provides a more extensive discussion of the physical evidence.

Continued accumulation of polymer in the piping likely created a partial blockage that ultimately restricted the flow of vapor through the vent system. This restriction probably caused the polymer catch tank to become pressurized during the solvent flush. The accumulated pressure in the tank exceeded the sealing capability of the bolted joint between the 4-foot-diameter cover and the vessel flange, which explains why solvent vapor leaked from the top of the cover at 3:45 pm on March 12.

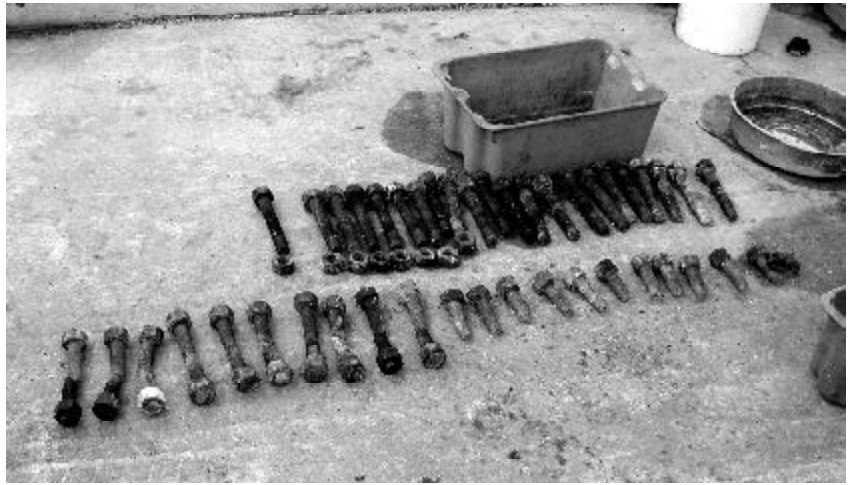
Figure A-2. Failed bolts from polymer catch tank cover.

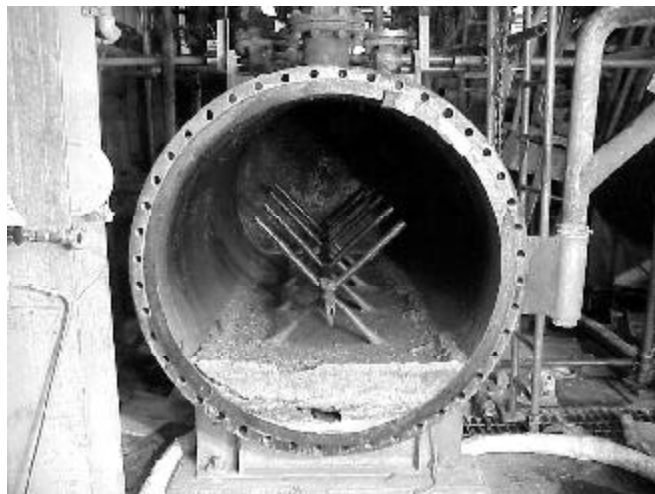
Figure A-3. Reactor knockout pot with internal frame visible.

The reactor knockout pot was not opened until April 17, 2001, to allow time for a hazard analysis and development of a safe work plan. Once opened, the vessel was found to be largely empty except for a 6-inch layer of material on the bottom (Figure A-3).

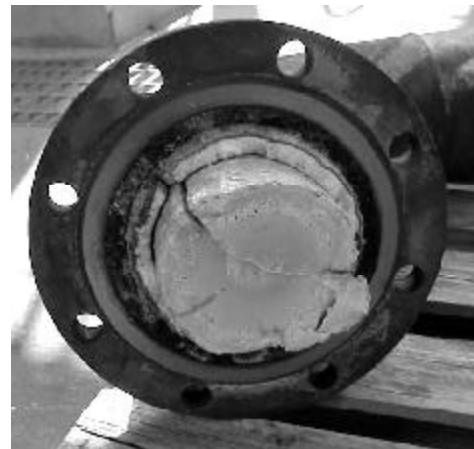
The outlet nozzle for the 6-inch vent line on the polymer catch tank was plugged with solid polymer (Figure A-4). The vent line itself was plugged except for a small hole through the center of the obstruction. A total of 22 feet of 6-inch pipe was plugged with polymer, including the part of the line where the pressure gauge was installed. The plugging extended to the common portion of the vent line shared with the reactor knockout pot, as outlined in Figure 4 (Section 2.3). The polymer inside the pipe had an appearance characteristic of several annular layers, each distinct in color and separated by discontinuities (Figure A-4).

The tap<sup>1</sup> to the pressure gauge on the 6-inch vent line was observed to be clear despite extensive plugging of the line itself.

Figure A-4. Vent line obstructed by polymer layers.

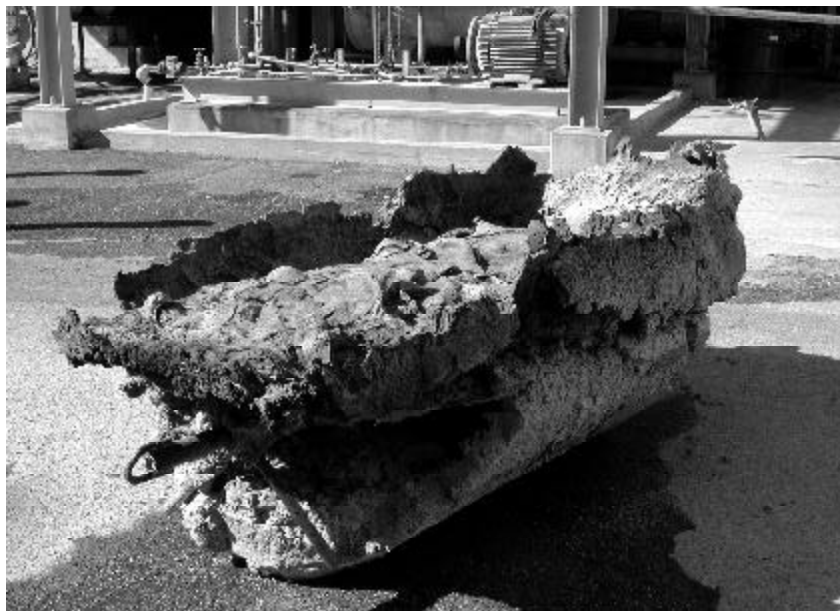
Figure A-6. Material extracted from polymer catch tank on March 11, prior to incident.

Waste polymer cleaned from the catch tank on March 11, following the previous production run, was composed of multiple layers of varying density, with considerable voids between layers (Figure A-6). The waste polymer occupied 55 percent of the vessel and had a bulk density of only 3 lb/gal.

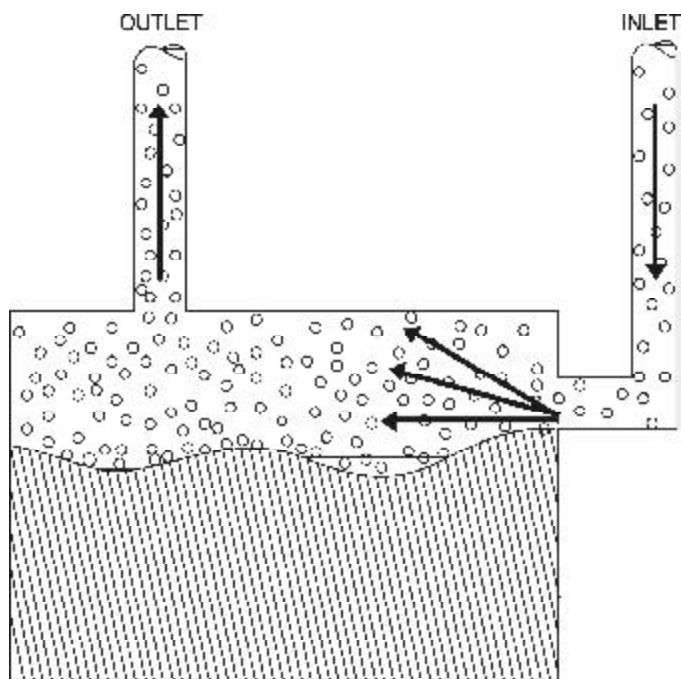
Figure A-8. Polymer catch tank filled beyond working capacity—particles entrained in vent vapor.

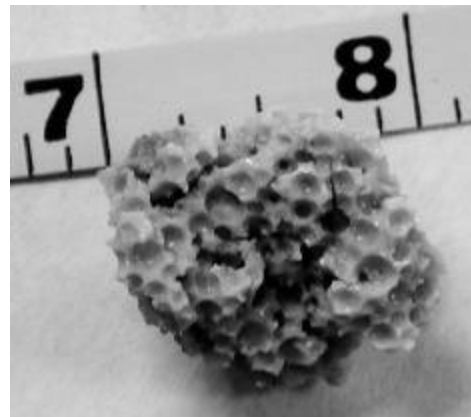
Figure A-9. Sample of material expelled from polymer catch tank (note bubbles and closed cells).

... the plastic was partially molten  
and sticky at the time it  
was expelled ...

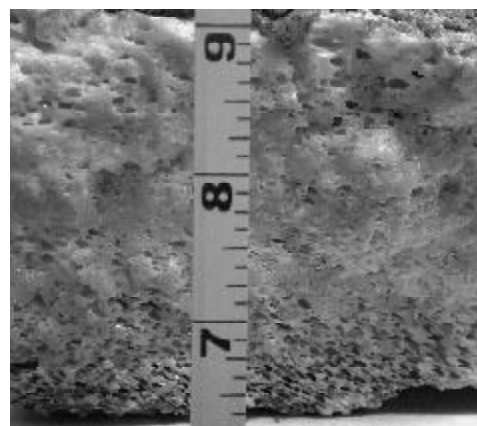
Figure A-10. Layer of hardened polymer taken from inside perimeter of polymer catch tank

A ring of plastic 3 to 5 inches thick remained inside the polymer catch tank after the molten core blew out (Figure A-10). The ring was generally yellow, though some of the outermost portions close to the vessel wall were cream colored. The plastic in the ring contained far
