Accident Investigation Report

Sulfuric Acid Spill and Resulting Injury at 200 Area Effluent Treatment Facility

February 23, 2000

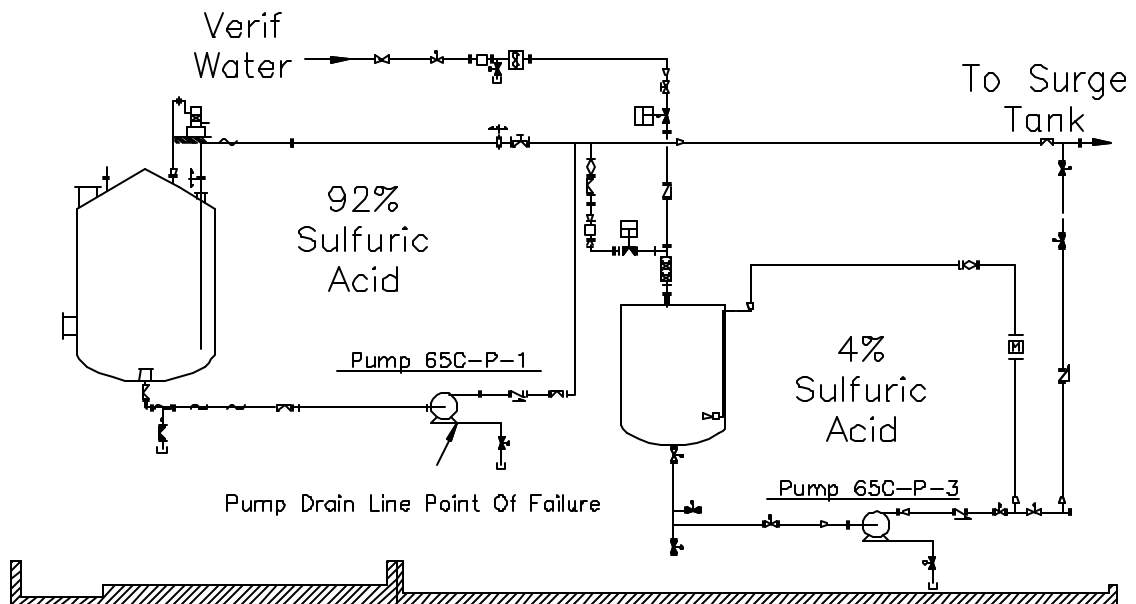
Figure 1. ½ inch diameter drain line off of the Centrifugal Pump, 65C-P-1.

Once the accident scene was sufficiently cleaned to enable a thorough visual inspection of the system hardware, personnel discovered that the ½ inch diameter drain line off of the centrifugal pump, 65C-P-1, had been breached. Although this breached drain line could have been the single source of the fugitive acid, additional testing was conducted to ensure that no additional system leaks were present. Based on the acid leak spray pattern, which discolored the coating on the adjacent wall, and actual operator accounts of where the leak was observed, a specific section of the system was identified for further leak testing.

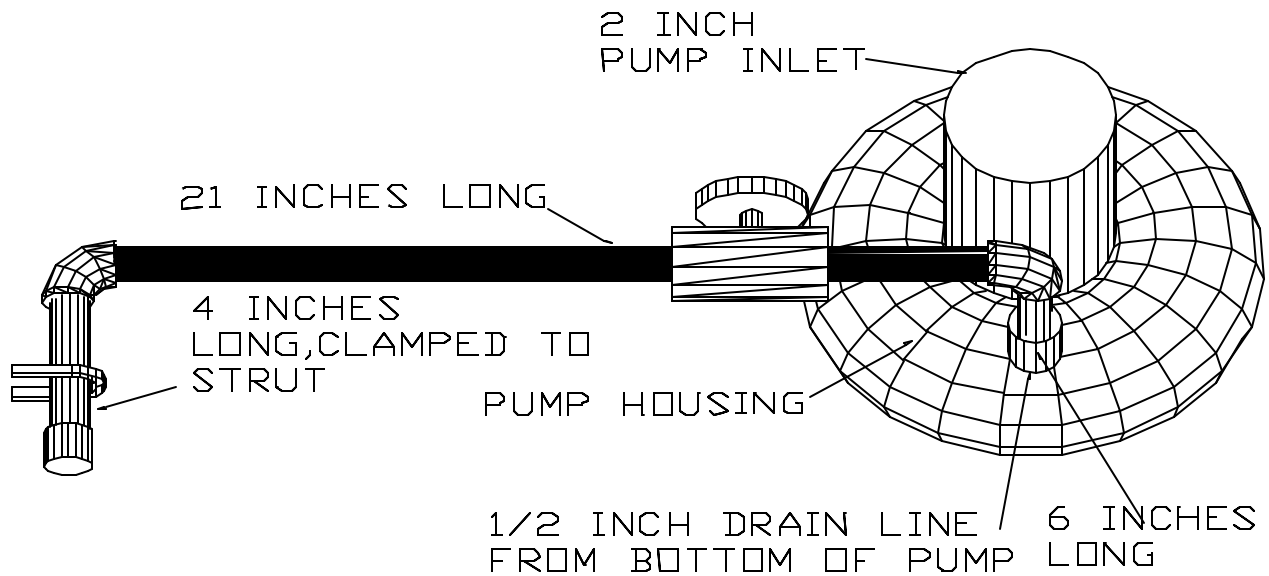
Figure 2. Drain Line Dimensional Layout

The drain line was supported at the pump casing and adjacent to the drain cap. This support configuration was designed to support the pipe and its contents only. No provisions were made to accommodate externally applied forces.

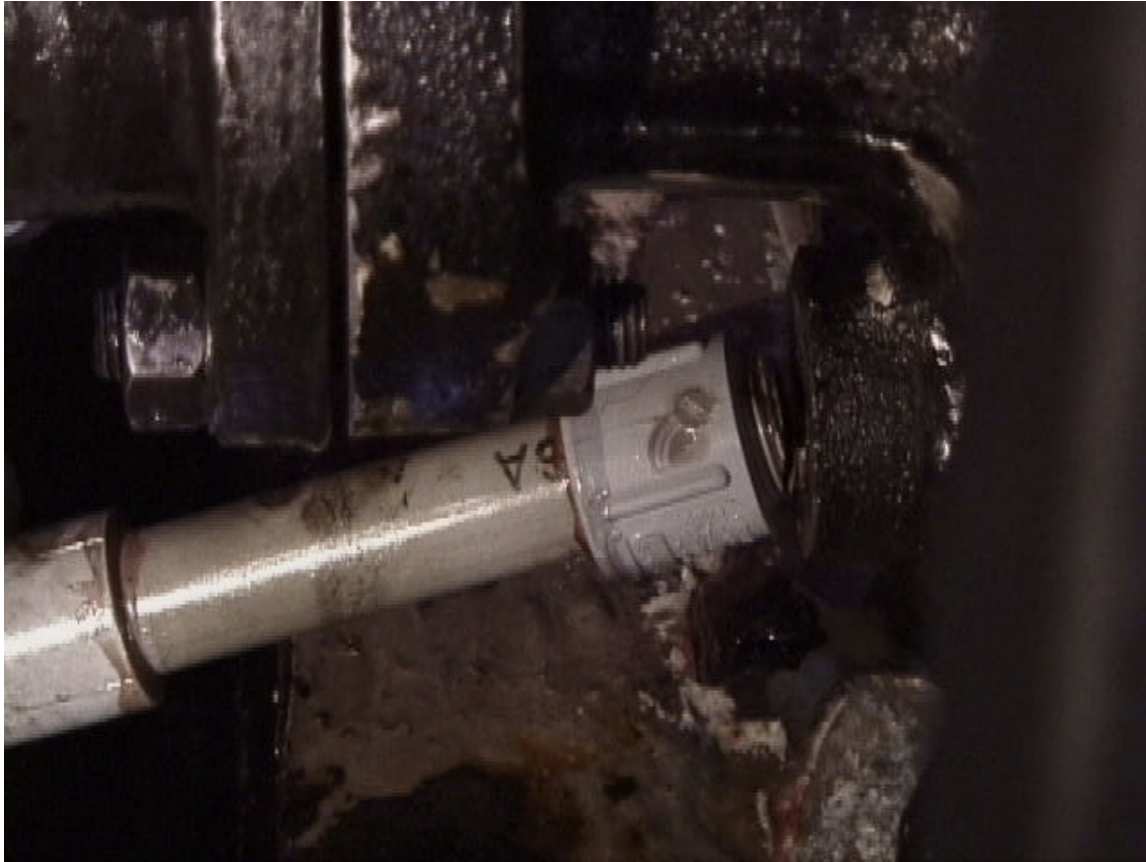
Picture - Fractured drain line

Fractured drain line. Notice line still connected by 20% of lower section.

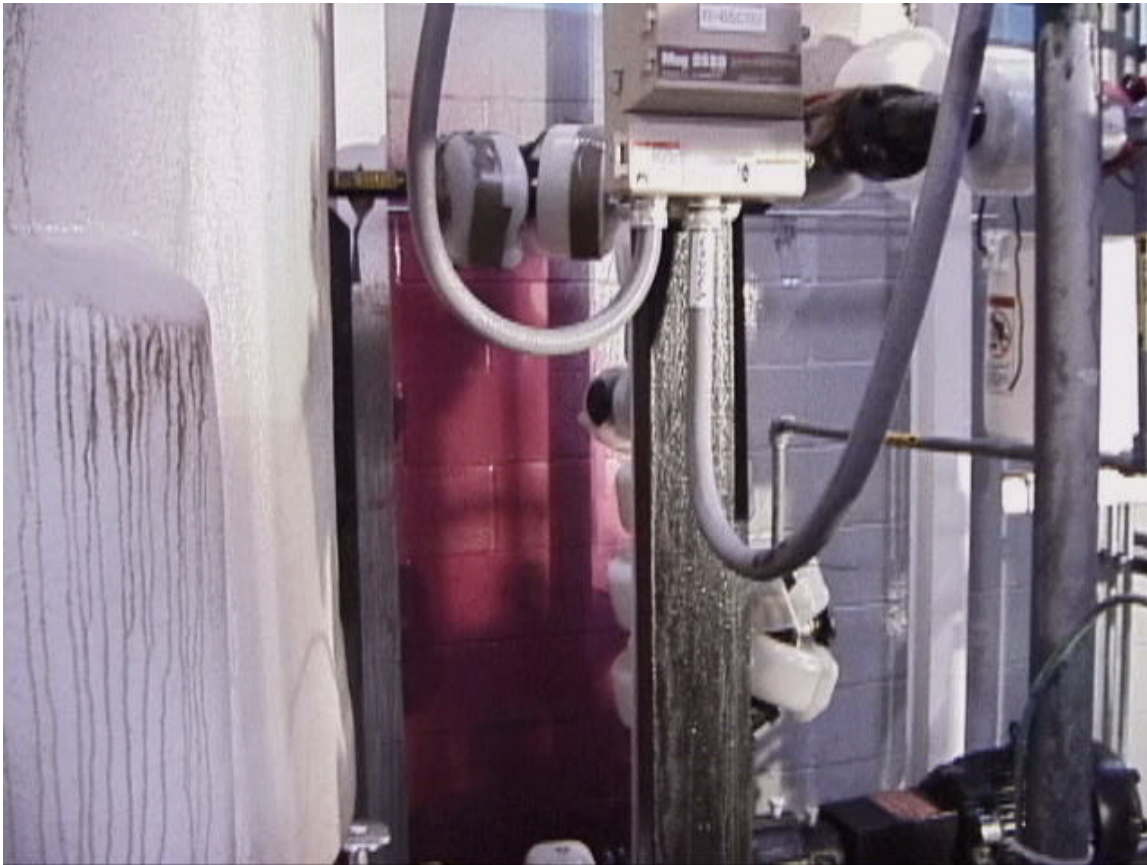
Picture - Chemical Berm Area

**Chemical berm area. Pump located behind unistrut support in center of picture.
Notice spray pattern on wall.**

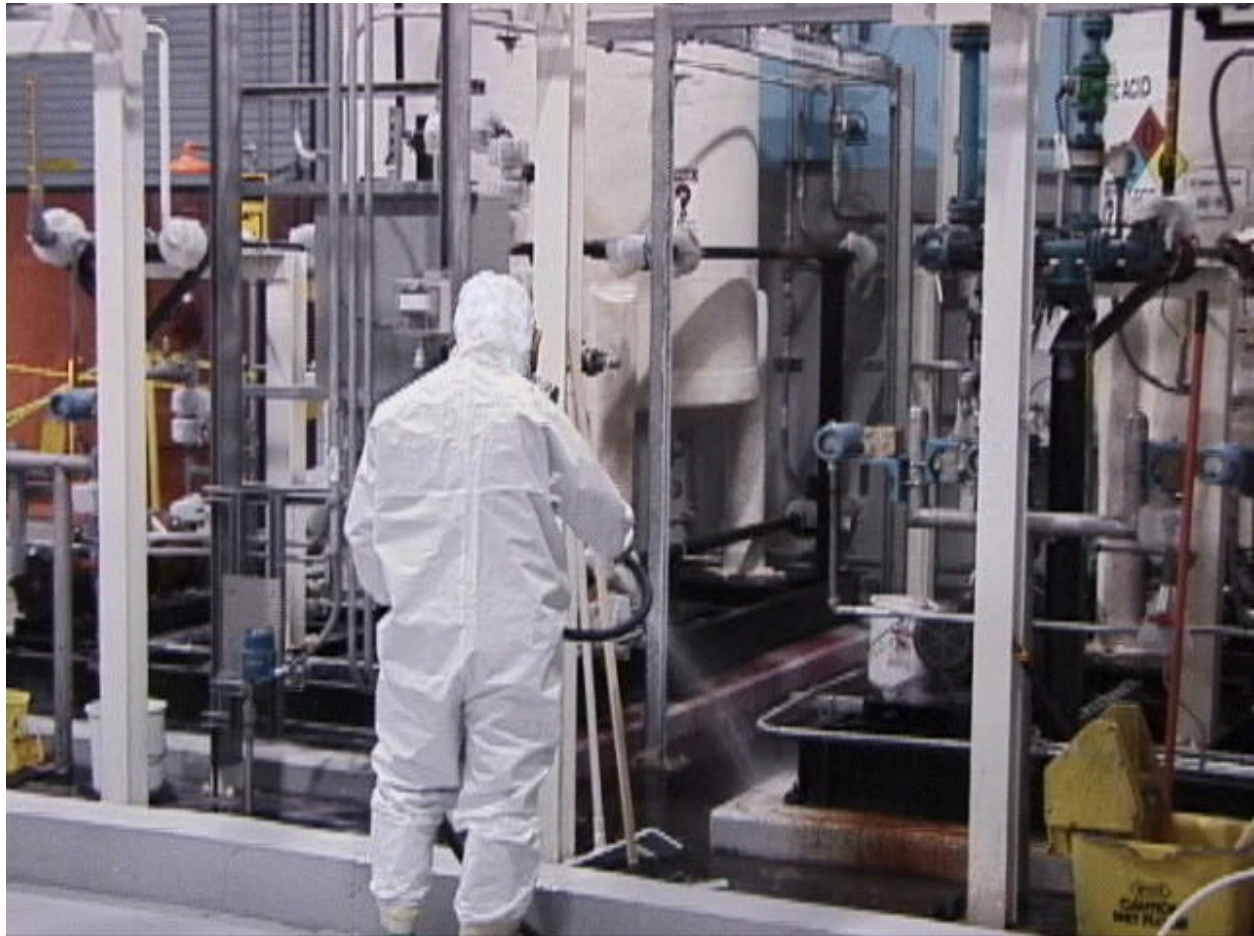
Figure 1. General location of CPVC acid piping failure, Effluent Treatment Facility
(Courtesy of Waste Management Federal Services of Hanford, Inc.)
(acid pump is located to the right and beyond the employee in the containment dike)

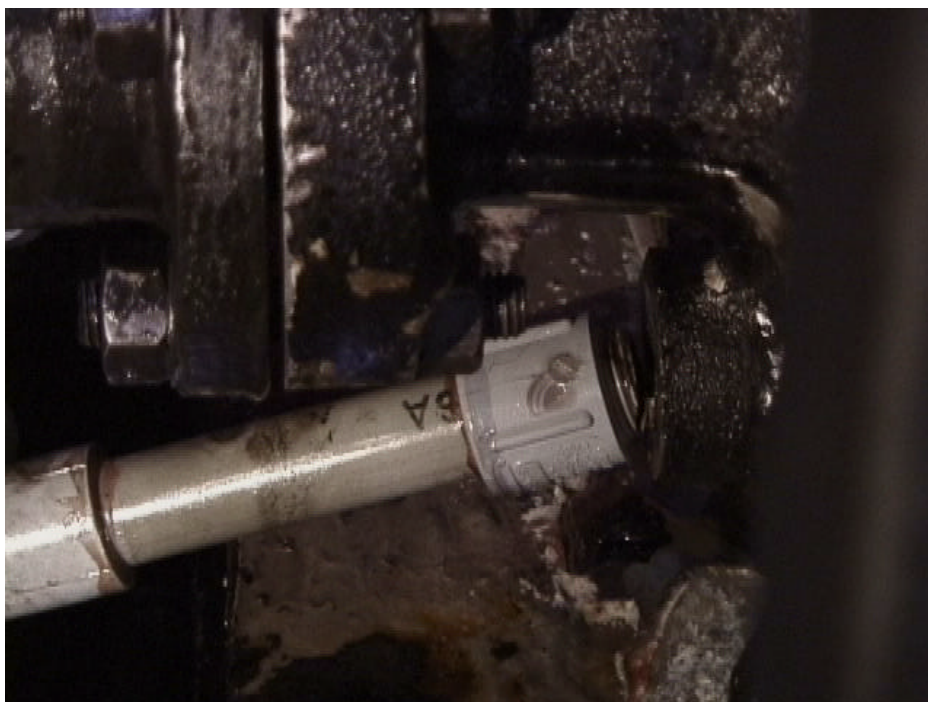
Figure 3. Failed CPVC drain line before removal from pump
(Courtesy of Waste Management Federal Services of Hanford, Inc.)

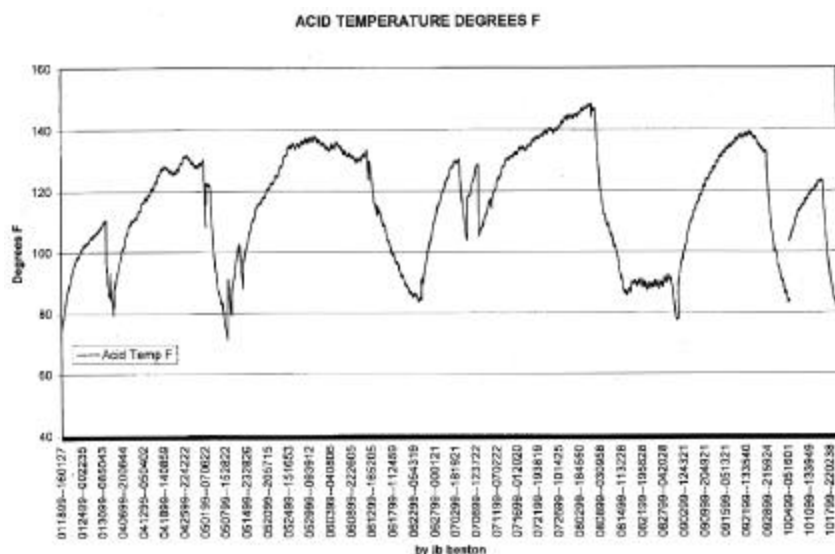
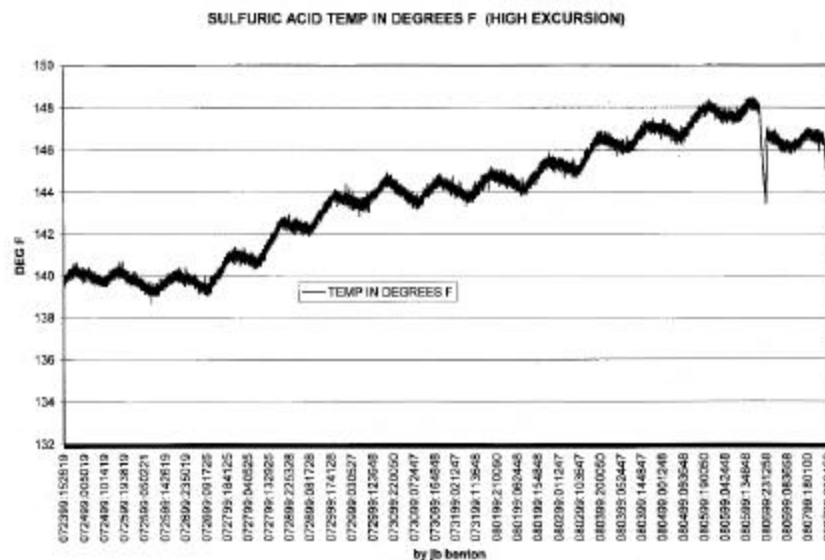
Pump temperatures and pressures are continuously monitored, with data taken every 90 seconds in a programmable loop controller system. Data supplied by the customer indicates that the pump operated at temperatures $>120^{\circ}\text{F}$ on several occasions within the last 12 months, including temperatures $>140^{\circ}\text{F}$ for approximately 15 days, Figures 6 and 7 [6]. Temperatures and pressures are monitored on the inlet side of the pump and are assumed to be representative of those at the fitting/failure location. Per the customer, fluid temperature excursions are believed to be due to pump inefficiency and thermal stratification.

Figure 6. Temperature data for 93% sulfuric acid pump

Figure 7. Abbreviated temperature excursion data for 93% sulfuric acid pump (7/23/99-8/7/99)

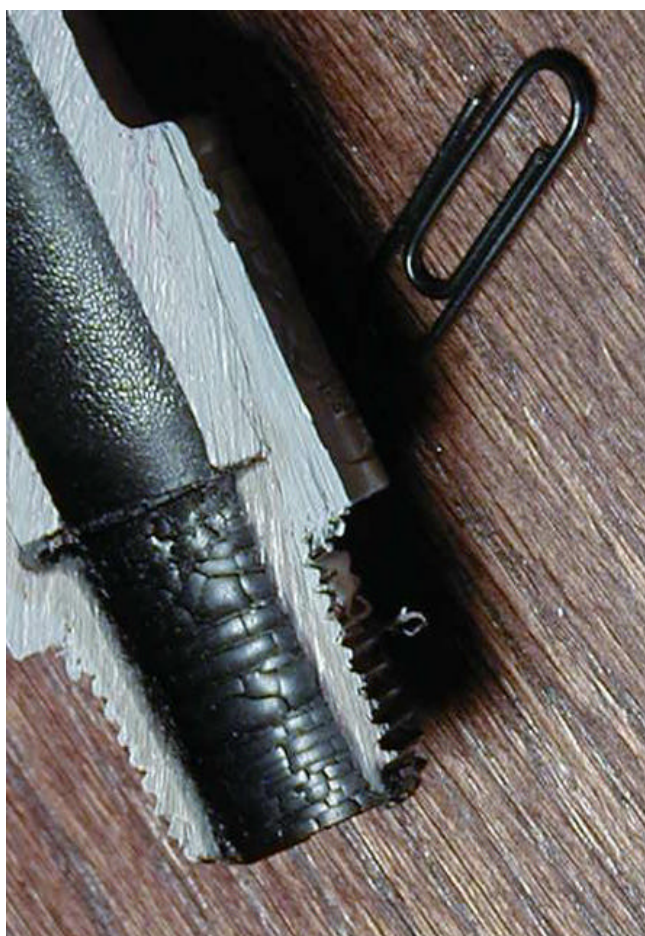
According to the customer, a section of similar CPVC piping had been previously removed from this service in September 1997, Figure 8 [2]. This particular piping assembly was removed to facilitate pump repair and not because of failure. Therefore, the effect of service environment upon material properties of this component were not investigated. However, note the cracking pattern and the greater depth of blackening observed along the interior surface of the threaded male adapter fitting as compared to the adjacent extruded piping.

Although this component was in service for nearly 2 years and did not fail, the appearance clearly indicates degradation and possible variation in chemical resistance between the fitting and piping in this environment. Such behavior could be due to many factors, including variation in composition, morphology, processing, and/or localized service conditions. It must also be noted that although the inner surfaces are blackened, the depth of oxidation and degradation is significantly less than that observed in the more recently failed fitting.

Figure 8. Degraded CPVC piping section, removed from same service in 9/97.
(Courtesy of Waste Management Federal Services of Hanford, Inc.)

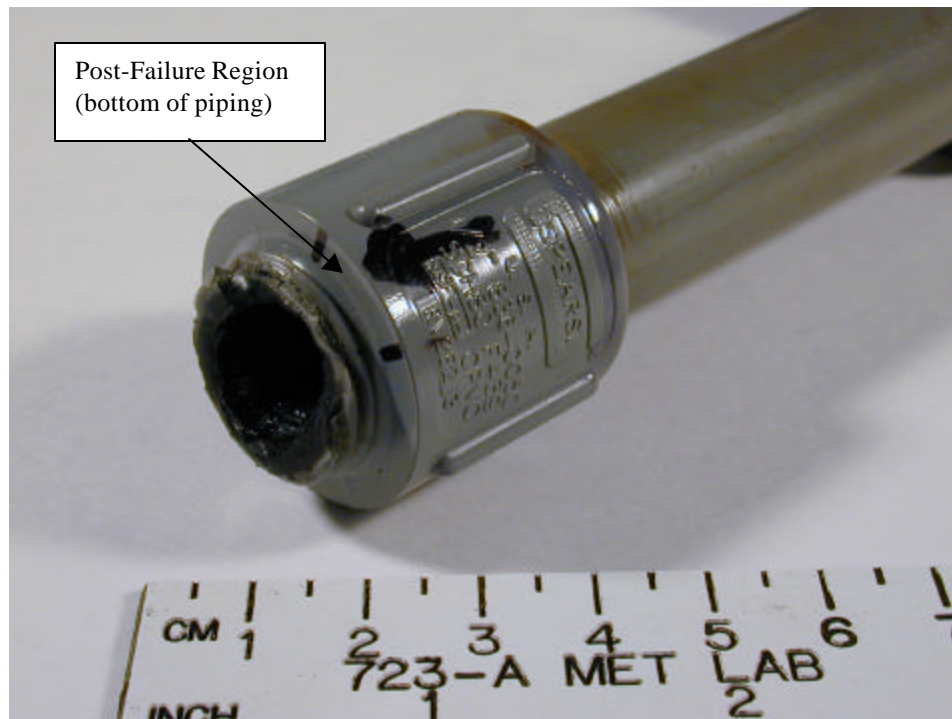
The arrow and markings in Figure 13 indicate the region of post-failure removal (bottom of pipe) from the pump casing. The remaining threaded portion was removed separately, Figure 14. Note that the threads from within the pump casing were more severely discolored on both interior and exterior surfaces, indicating greater degradation due to more severe chemical attack and/or higher temperature. Acid residue also possible on the pump casing threads prior to piping installation.

Figure 13. Failed 1/2" diameter Sch. 80 CPVC fitting, Spears Mfg. Part#836-005C

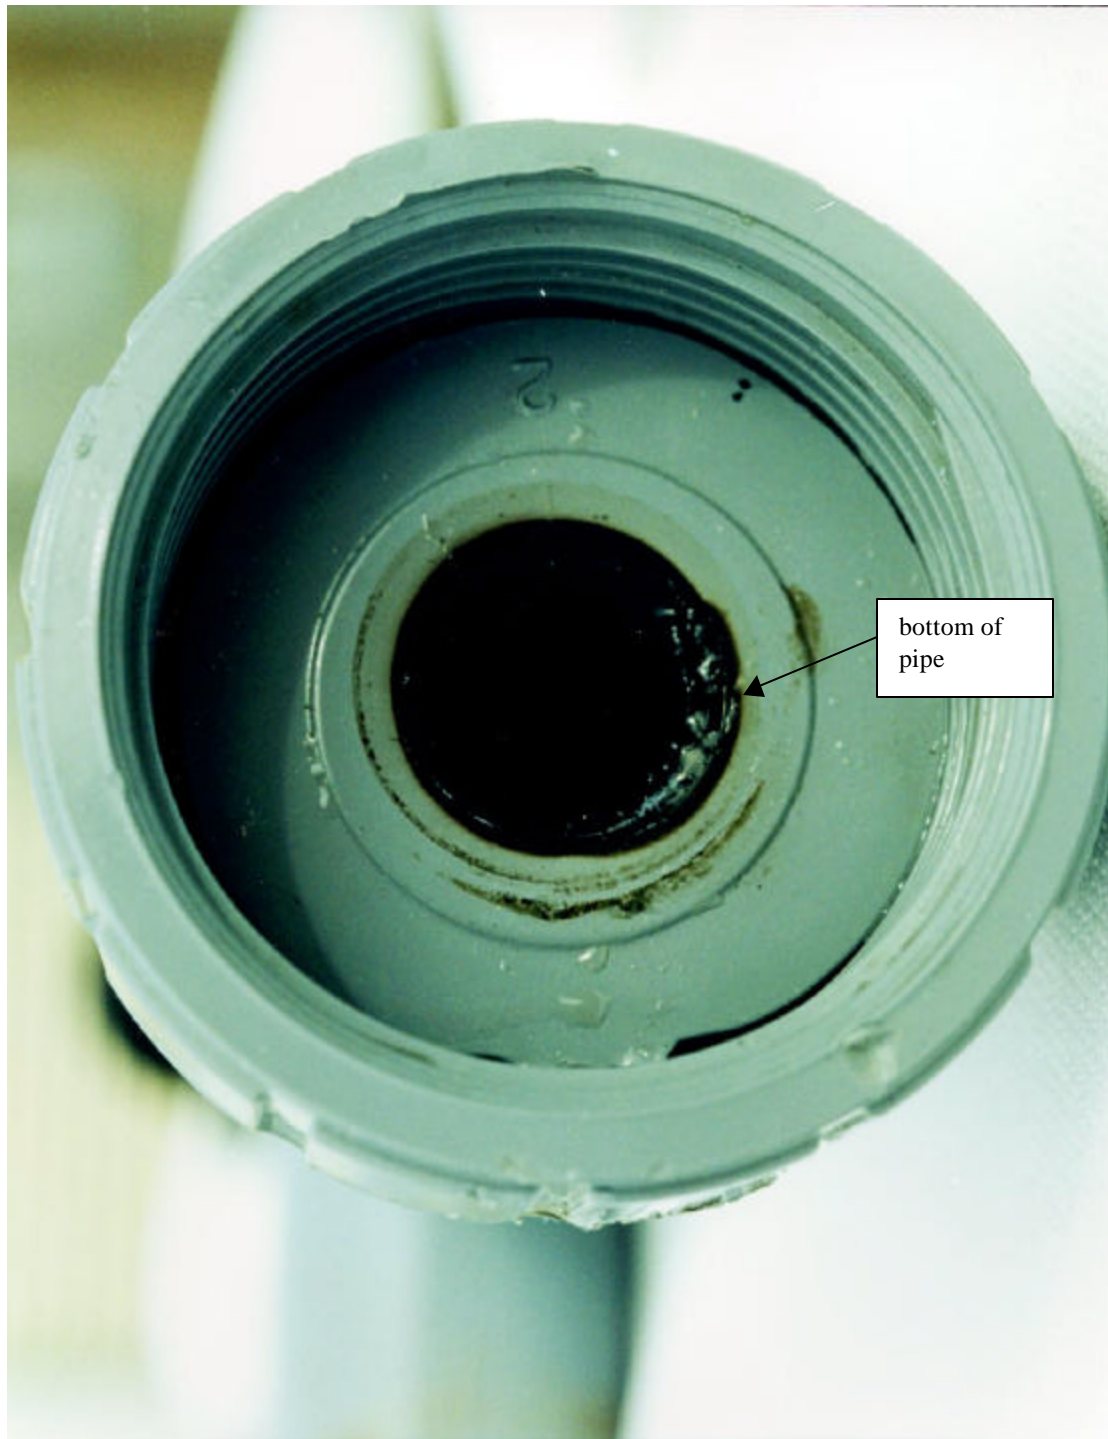
The opposite end of the drain line assembly (valve fitting/adaptor) is shown in Figure 15, revealing similar discoloration and build-up of residue, particularly along the bottom interior surface. A closer view of the fracture surface (fitting side) reveals regions of plastic deformation, final fracture, post-failure fracture, and degree of discoloration and residue build-up particularly at the bottom of the piping assembly, Figure 16. The darker area at the top of the fracture surface is attributed to post-failure acid exposure. The opposing fracture surface (pump side) is shown in Figure 17. Note the severe degree of blackening and cracking observed on the end of the threads installed in the pump casing, Figure 18. The large slot in the wall of the threads is from the tool used for fitting removal from the pump post-failure.

Figure 15. Photograph of the opposite end of the assembly (valve fitting)
(Note blackened interior and residue build-up along bottom of pipe)
(Neg#54967, ~5X)

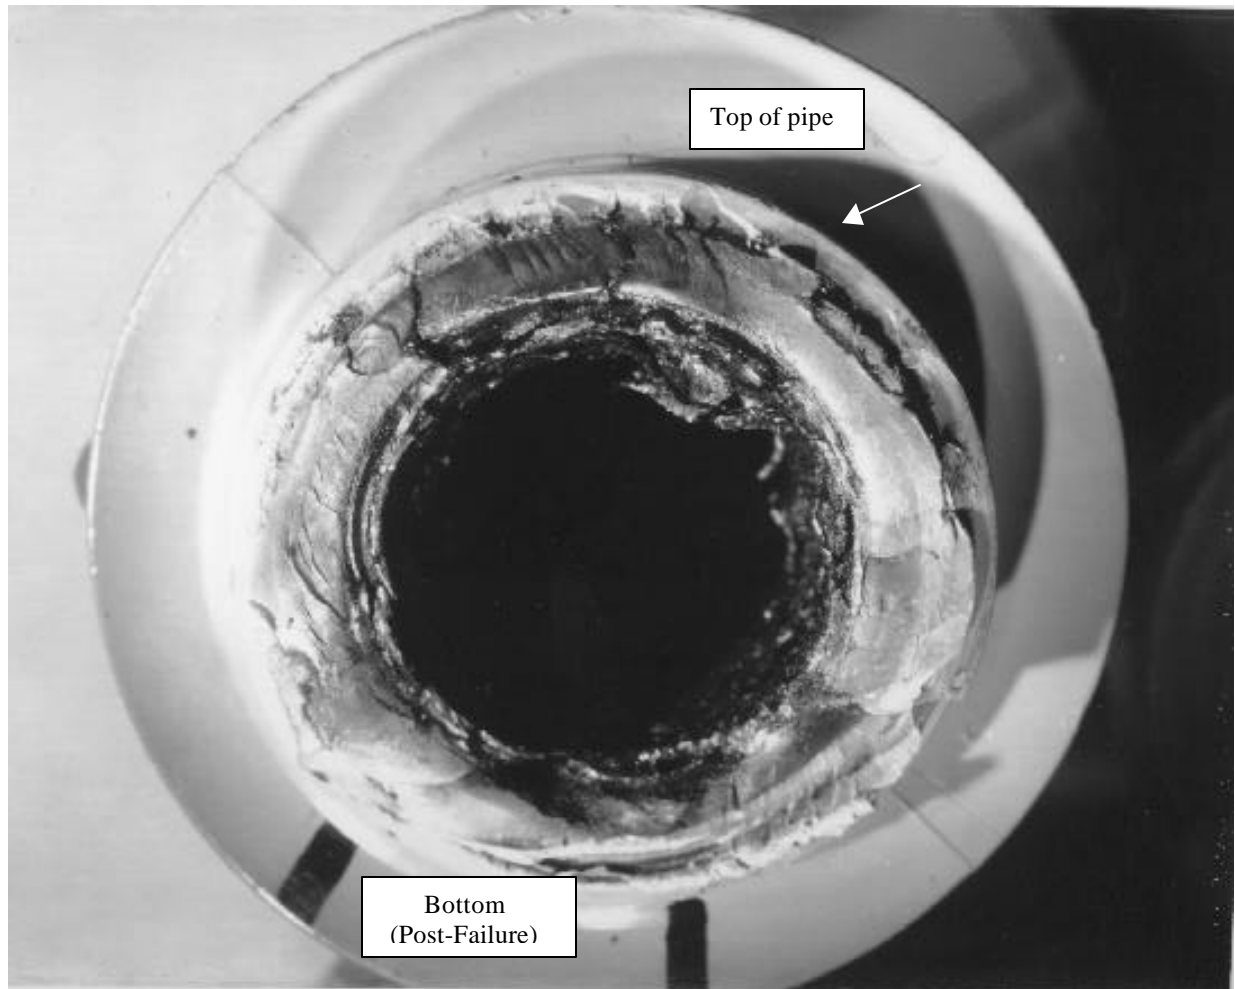
Figure 16. Close-up view of the fitting fracture surface (Neg#54965, ~3X)
(Markings indicate region still attached toward bottom of piping post-failure)

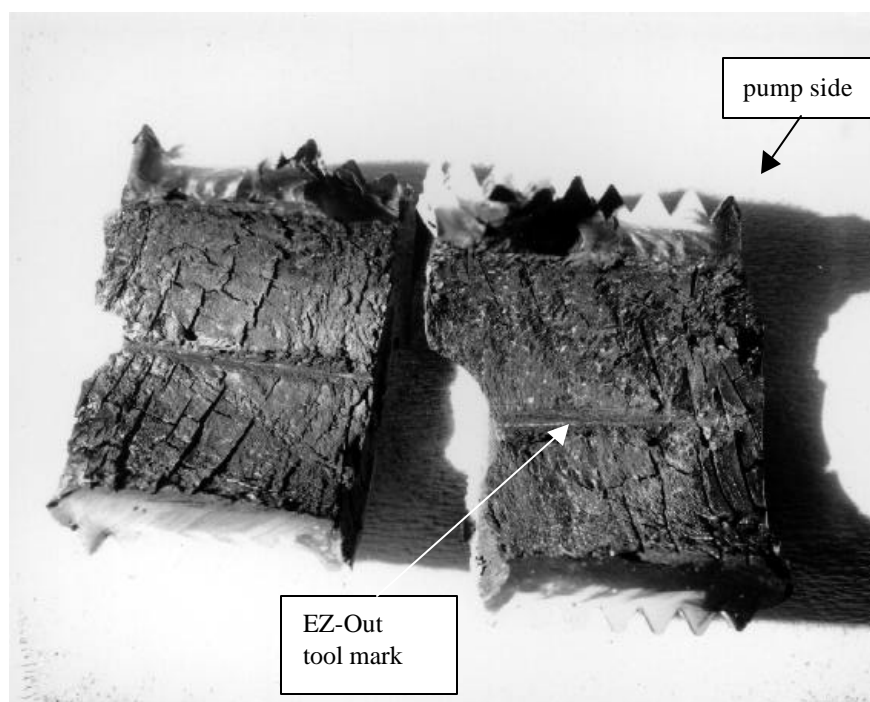
The threads of the failed fitting were sectioned to examine the extent of degradation, Figure 19. Note both the significant degree of darkening and the cracking pattern. A severe lack of structural integrity is also evident at the end from within the pump casing. The depth of discoloration is over 50% through-wall in the threaded region. However, it should be noted that cracks were not observed to initiate from the roots of the threads, which are considered to be the most highly stressed regions.

Figure 19. Interior view of fitting threads (Neg# 54970, ~5.5X)
(severe oxidation and cracking)

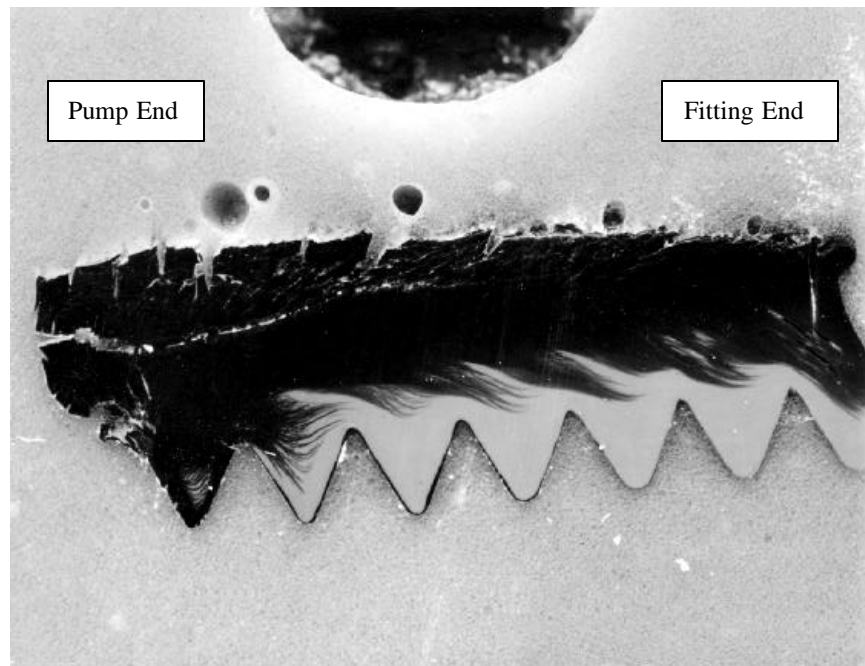
The degradation pattern appears to follow what may be flow lines in the injection-molded fitting, protruding like fingers into the threads (Figure 20). This may be due to a number of factors including variation in resin/chlorine content, degree of fusion, molecular weight, selective attack of one or more additives, and/or molding stresses. It is also possible that solvent cement from the fitting/piping joining process may have run along the interior of the fitting and penetrated the surface, reducing the chemical resistance and providing a path for degradation.

Figure 20. As-polished cross-section of fitting threads (Neg#55000, ~3X)
(Note degradation following what may be flow lines into threads)

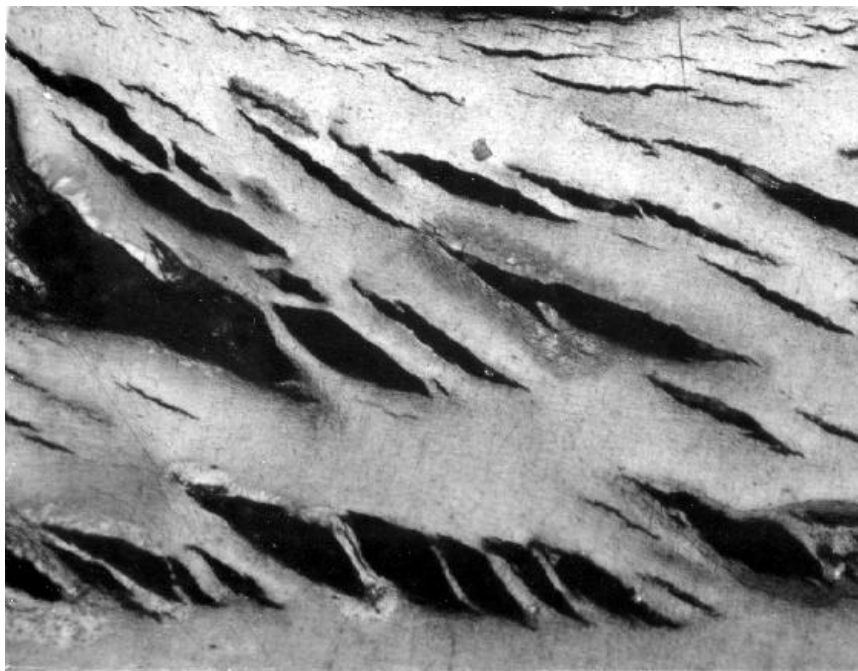
Severe cracking was present near the interior surface of the fitting, Figure 21. Degradation tended to be more severe along solvent-cement paths (Figures 22 and 23), which can be resin-poor and are common failure locations in these systems [27, 28].

Figure 21. Severe cracking along interior surface of threaded fitting (Neg#54970, 100X)

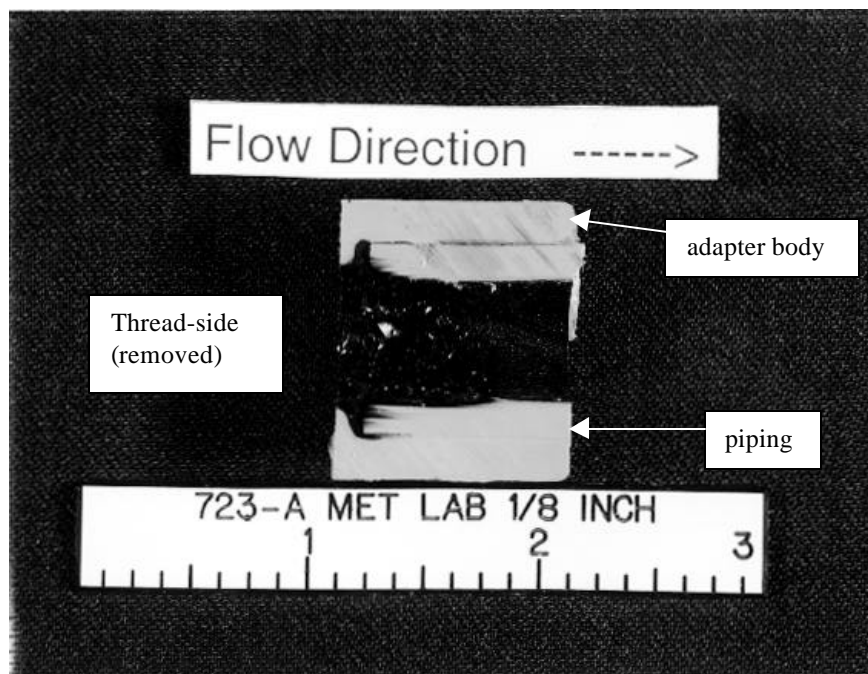
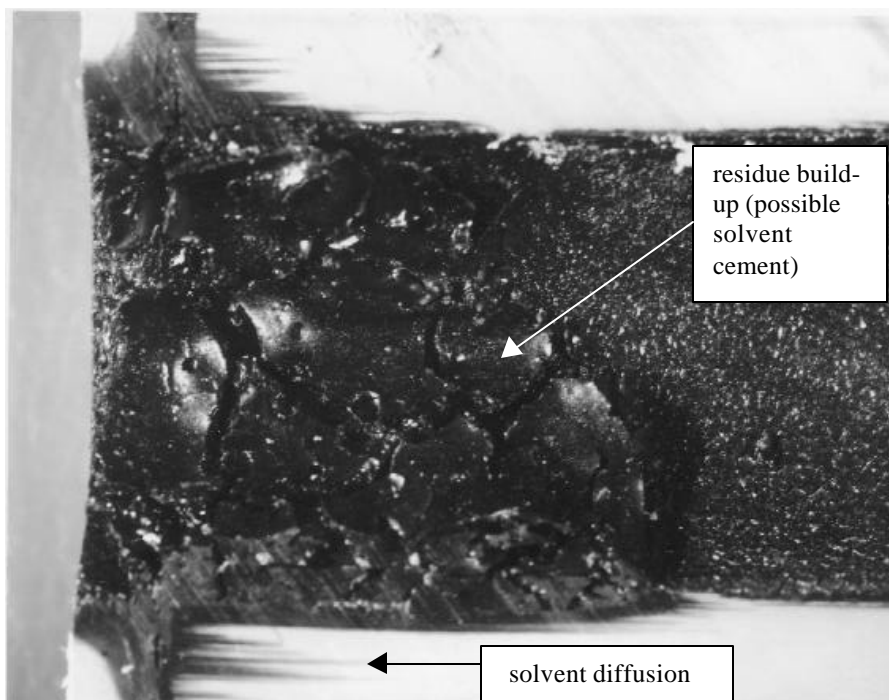
Figure 22. Cross-section of failed fitting adapter and joined piping (Neg#54980, 1X)

Figure 23. Closer view of adapter fitting/piping cross-section (Neg#54980, 5X)

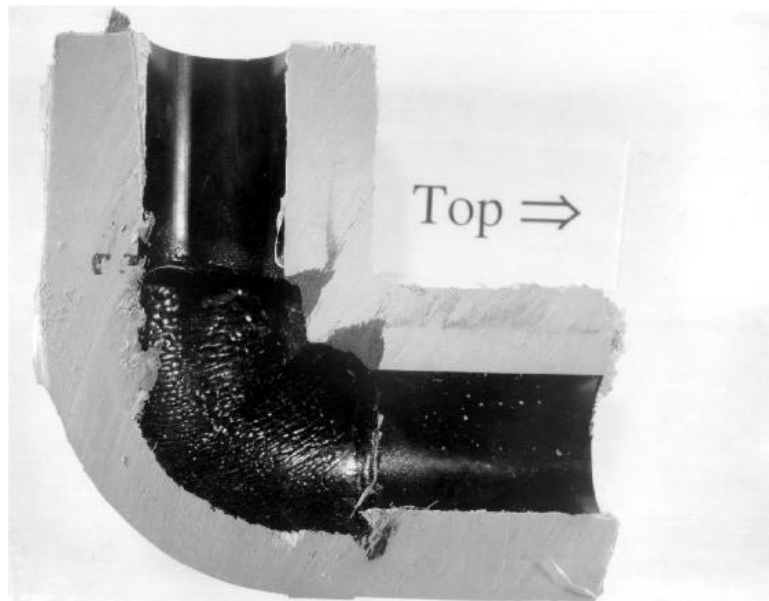
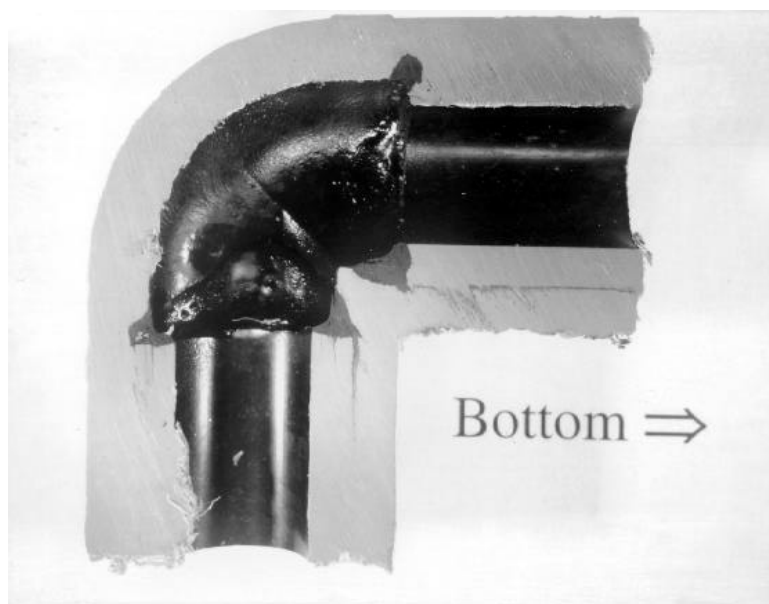
To further evaluate the possibility of chemical resistance variation between piping and fittings, the 90° elbow was also sectioned (Figures 24-25). Cracking and blackening of the elbow is greater than in the adjoining piping, but not nearly to the extent observed for the failed threaded fitting. Attack of the solvent-cement joints is also evident.

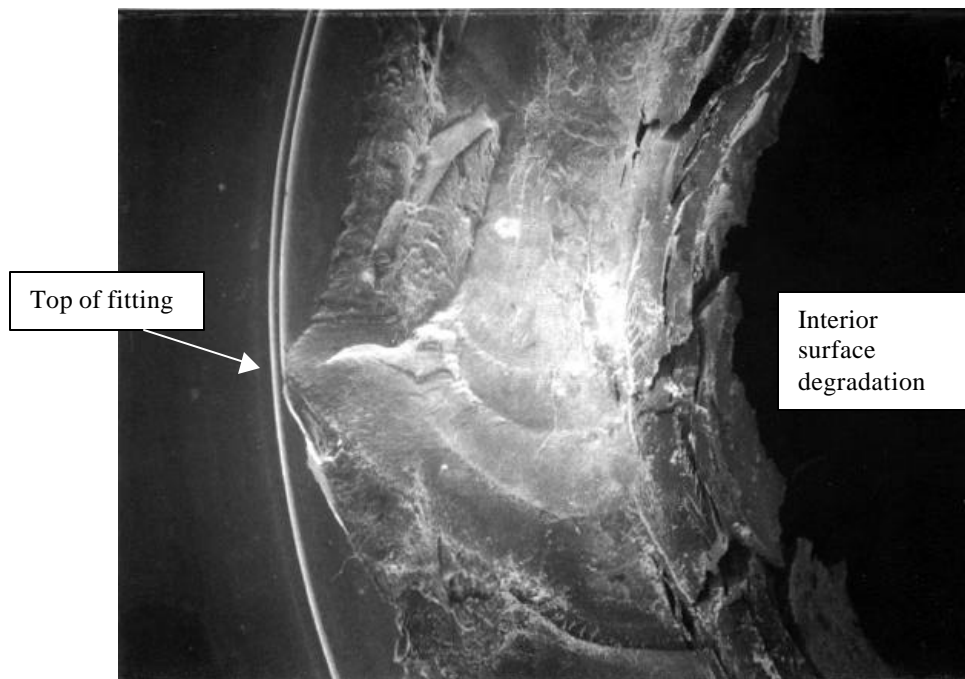
The fracture surface from the fitting was sectioned, gold-coated for conductivity, and examined under the Hitachi S2500 Scanning Electron Microscope (SEM). Several areas of the fracture surface were studied to locate the failure initiation site and to examine specific features. Figure 26 reveals what is believed to be the failure initiation site, located towards the top right of the as-installed piping orientation. It appears that fracture initiated in the thread root under a tensile stress, and rapidly propagated outward and upward towards the edge of the threads.

Note the significant amount of degradation and loss of integrity in the inner diameter surface. Other regions exhibit the characteristics of brittle band formation in amorphous polymers such as PVC/CPVC, which are similar in appearance to fatigue striations [27]. These regions may have been enhanced by cyclic stresses imposed by thermal expansion differences between the fitting and the pump casing.

Figure 26. Probable fracture initiation site and brittle band formation (Neg#54985, 15X)
