FINAL REPORT - NOVEMBER 1997

*Type B Accident  
Investigation  
Board  
Report on the  
Drum Explosion at  
Building C-746-Q,  
Paducah Gaseous  
Diffusion Plant*

Oak Ridge Operations  
U.S. Department of Energy

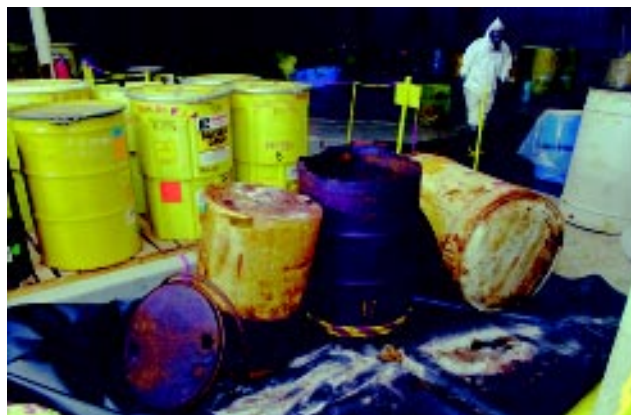
Exhibit ES-1. Components of HC-1093.

ERT discovered an open 110-gal, polyethylene-lined, steel drum (HC-1093) without a lid. Further investigation identified a 55-gal composite steel/polyethylene drum inside HC-1093. (Note: Although not known at this time, additional information discovered later revealed that the accident in-

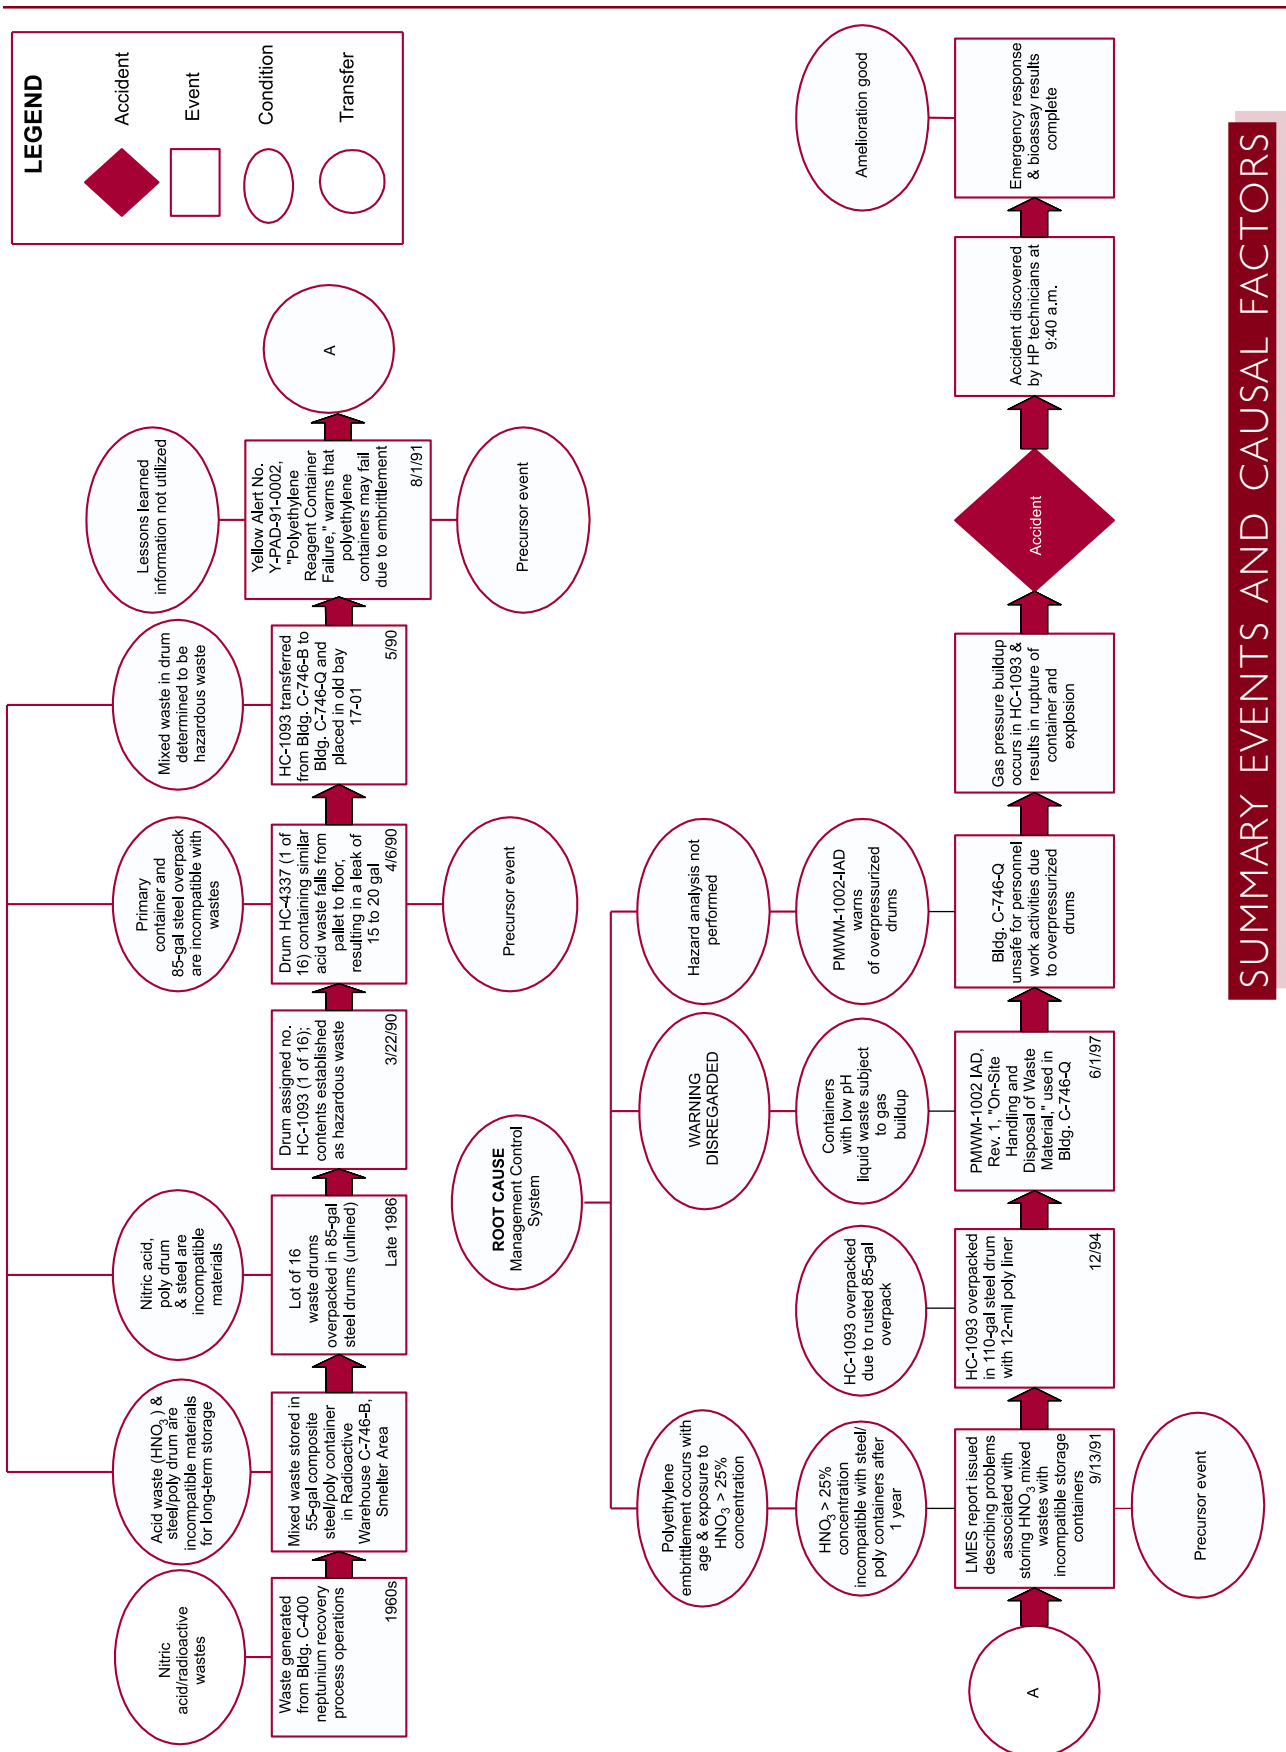
Figure ES-I. Summary Events and Causal Factors Chart

The **direct cause** of the accident was the excessive buildup of pressure due to chemical reactions within the container, resulting in an explosion of the container. However, there were also **contributing causes** (causes that, if corrected, would not by themselves have prevented the accident but are important enough to be recognized as needing corrective action) and a **root cause** (a fundamen-

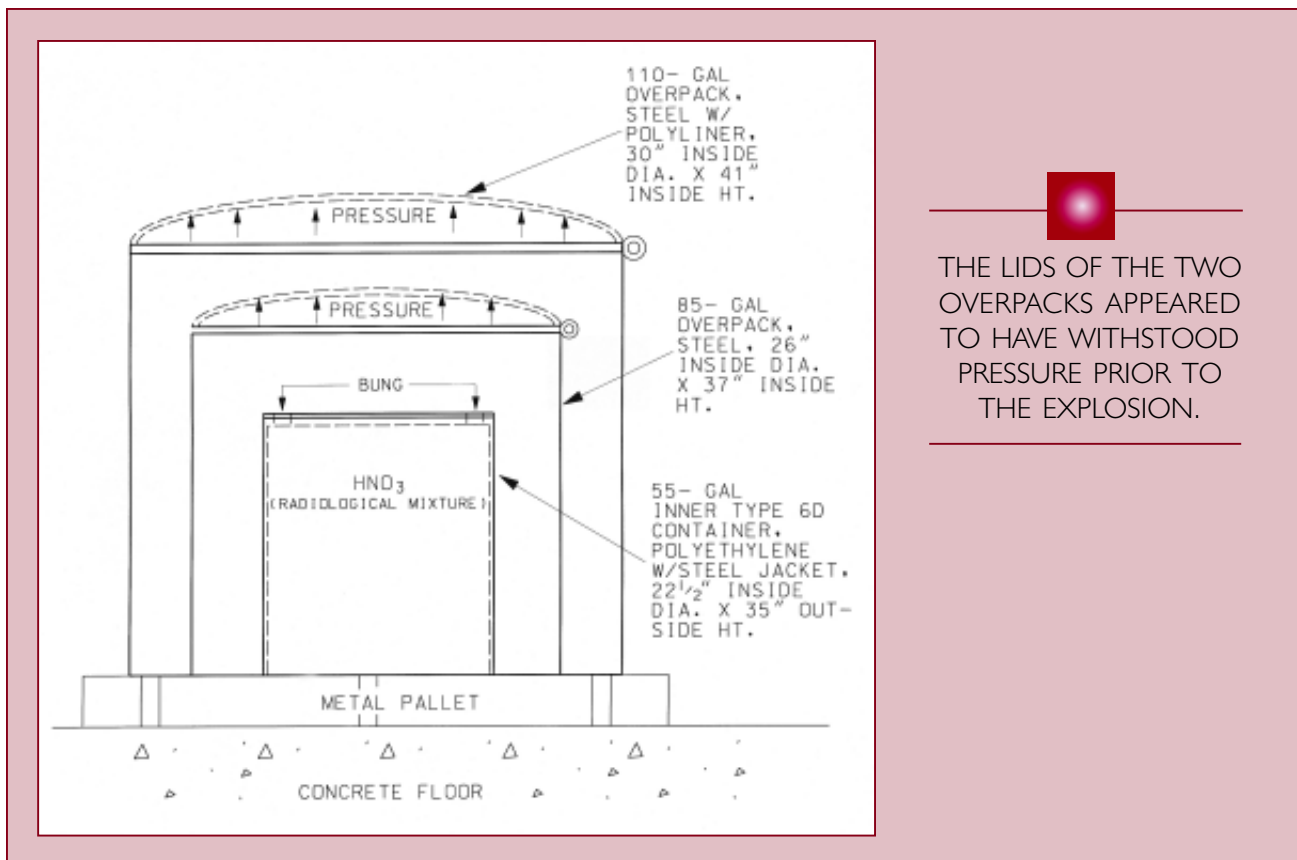
Figure 2-1. Overpack Configuration Prior To Explosion.

- Found inside HC-1093 was a 55-gal composite steel/polyethylene drum. (Note: Although not known at this time, additional information discovered later revealed the accident involved three drums in one configuration. Prior to the explosion, the configuration consisted of a 55-gal composite steel/polyethylene drum overpacked in an 85-gal steel drum that was overpacked in a 110-gal, polyethylene-lined, steel drum. The 85-gal steel drum was ejected from the configuration due to overpressurization.)

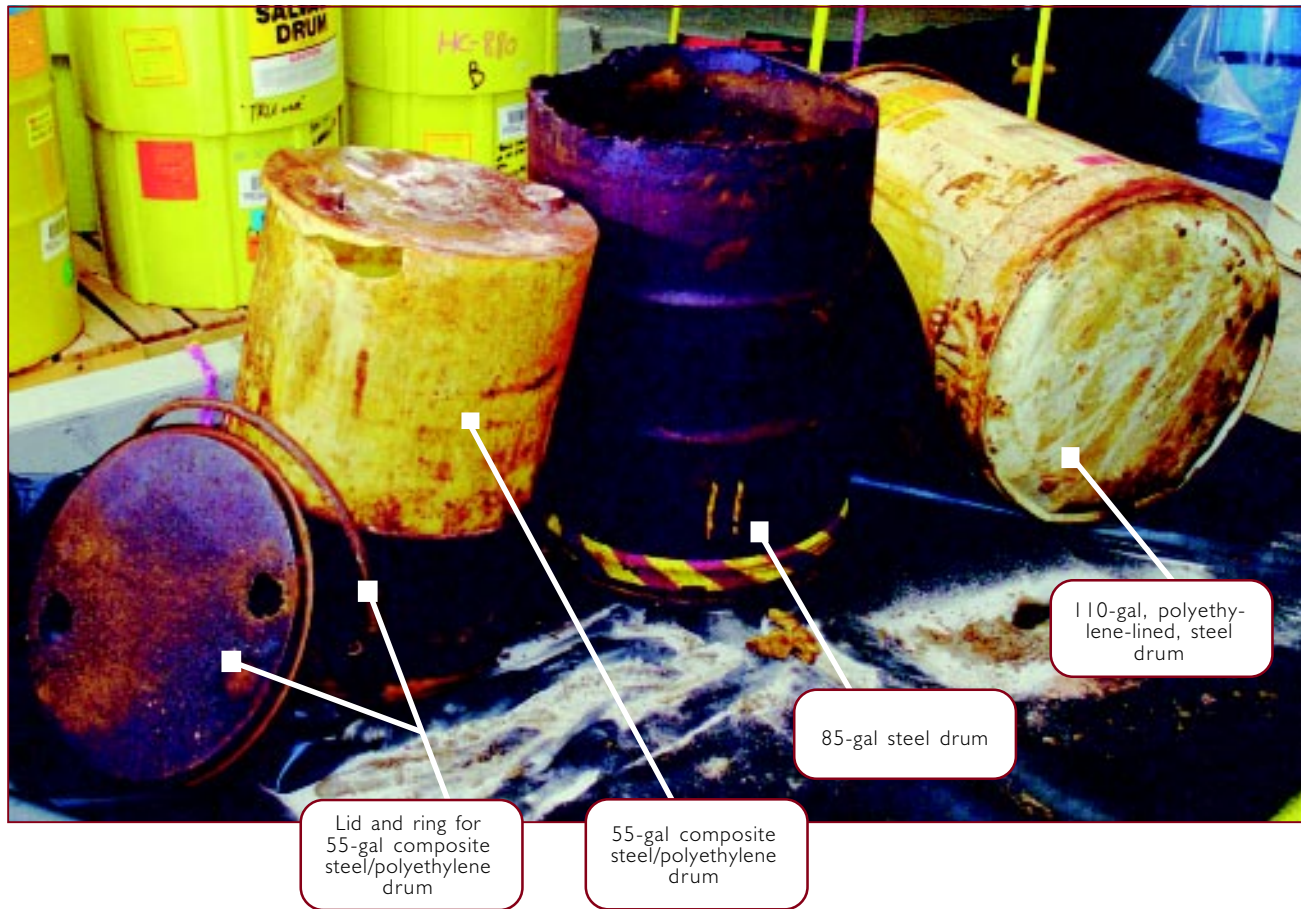
Exhibit 2-1. Components of HC-1093.

- 55-gal composite steel/polyethylene drum. The polyethylene drum was the innermost drum of the configuration. There were two bungs located on the top of the drum that were in place and tightly closed. The polyethylene drum was brittle. The drum contained a 12- to 15-in. horizontal breach approximately 1 in. from the top. On the bottom, a 24- to 26-in. breach near the side and a thin 10-in.-diameter area in the polyethylene were found. Within this thin area was one 4-in. breach. All that remained of the 55-gal steel drum surrounding the polyethylene drum was the lid, the ring, and approximately 14 to 16 in. of the area nearest the top. The remains of this steel drum were rusty, corroded, brittle, and thin.

- 85-gal steel drum (first overpack). This drum was the middle drum in the configuration. This drum was ejected from the configuration and found lying on its side approximately 15 ft away from its original location in an adjacent diked area. This drum contained a drum lid and ring in place on the drum. The drum lid was convex, giving the appearance that it may have withstood pressure prior to the explosion. The bottom inch of the drum was missing, leaving an open container. The drum was rusty overall, with a rough and jagged bottom edge.

- 110-gal steel, polyethylene-lined drum (second and outer overpack). This drum was the outermost drum in the configuration. This drum was found with the drum ring in place on the drum, but the drum lid had been blown off. The drum lid was found approximately 10 ft away on the floor within the diked area (B-08). The drum lid was uniformly convex, giving the appearance that it may have withstood pressure prior to being blown off the drum. The bottom of the drum was also convex, giving the appearance that it may have withstood pressure prior to the explosion. There were three holes in the bottom of this drum believed to have been caused by acid corrosion after the event. No holes or breaches were visible in the polyethylene liner; however, after the accident, acid material was leaking from this drum.

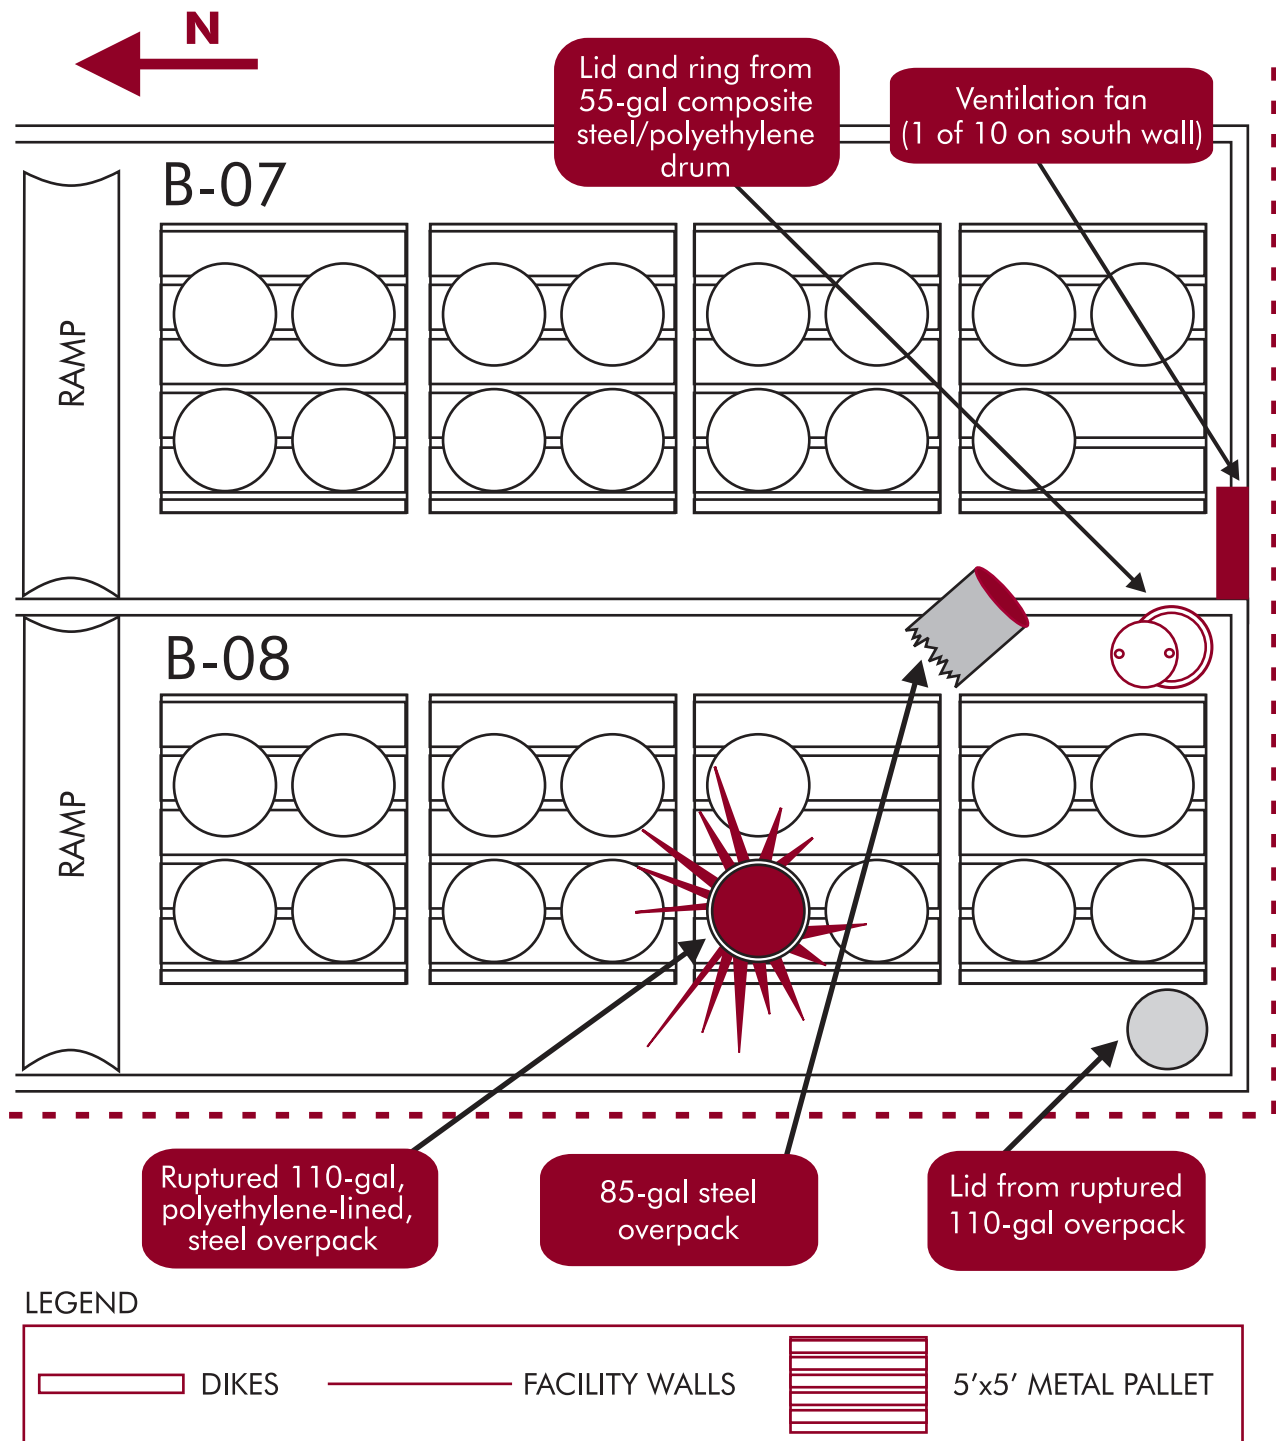
Figure 2-3. Accident Layout.

- The explosion did not displace the outer drum (HC-1093) from its original location. HC-1093 was found with the drum ring in place on the drum, but the drum lid had been blown off. The drum lid was found approximately 10 ft away on the floor within the diked area (B-08). The drum lid was uniformly convex, giving the appearance that it may have withstood pressure prior to being blown off the drum.

- A 55-gal composite steel/polyethylene drum, containing two bungs in the top, was found inside HC-1093.
  - An 85-gal steel drum was ejected from HC-1093, hit the ceiling of Building C-746-Q, and landed approximately 15 ft away from HC-1093. The 85-gal steel drum was lying on its side within an adjacent diked area (B-07) with its lid and ring in place on the drum. The drum lid was convex, giving the appearance that it may have withstood pressure prior to the explosion. The bottom inch of the 85-gal drum appeared to have been corroded by acid.

- A steel drum lid and ring was found lying adjacent to the 85-gal steel drum. The steel drum lid and ring were originally thought to be the lid and ring of the 85-gal steel drum. Closer inspection of the steel drum lid and ring showed that the drum lid had two holes in it (bung holes) and that the ring fit the drum lid. Later, it was determined to be the lid and ring of the 55-gal composite steel/polyethylene drum.

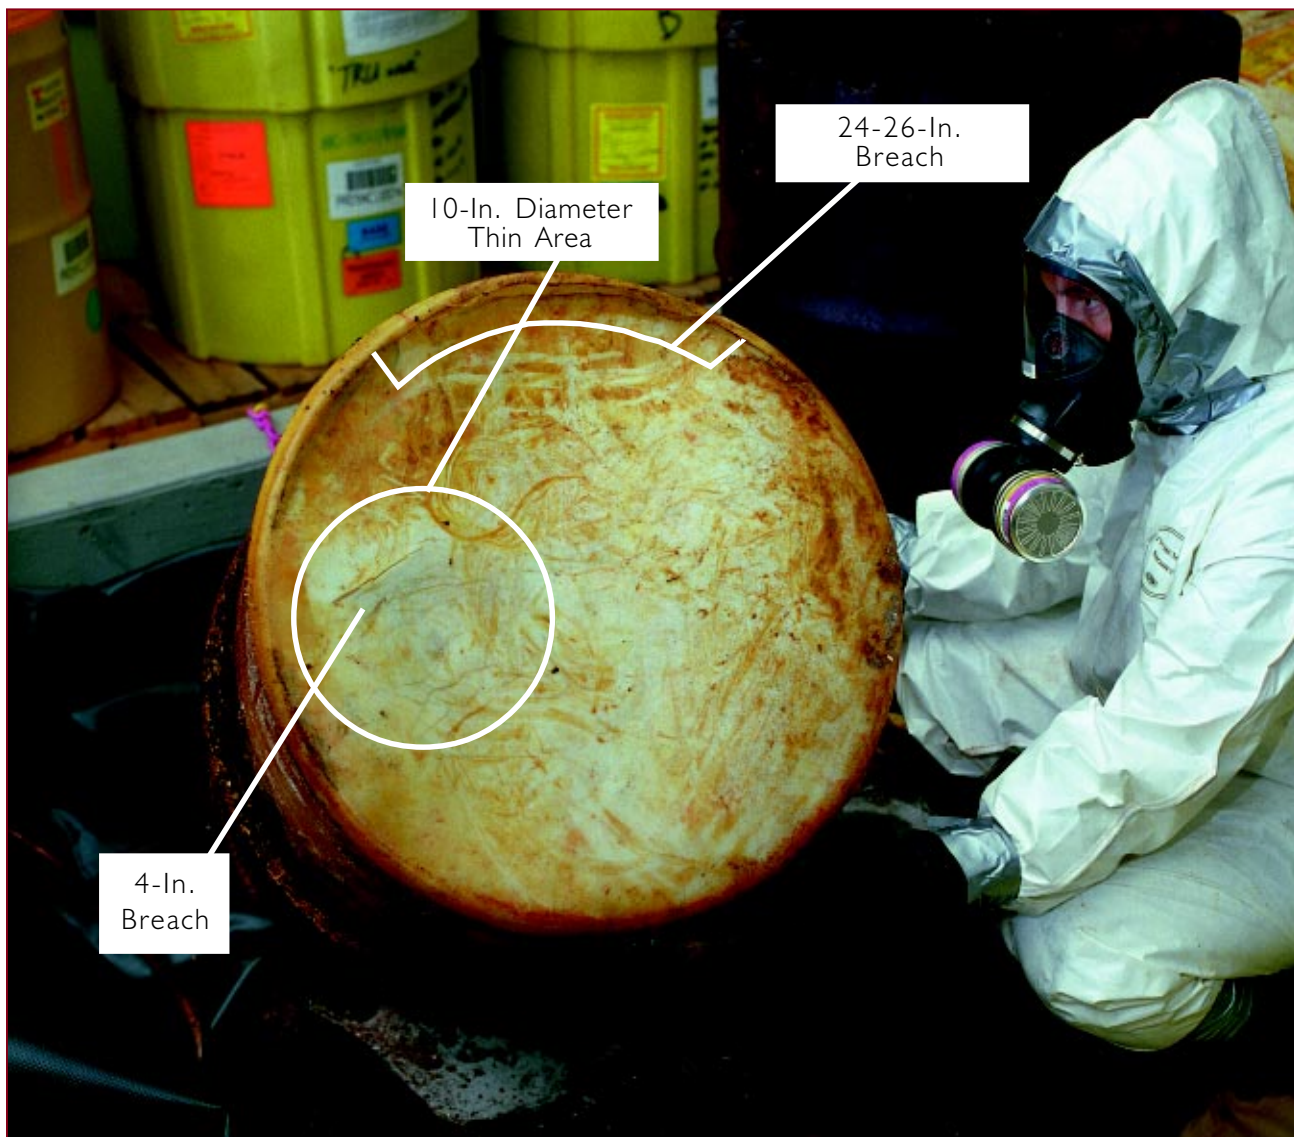
Exhibit 2-2. Bottom of 55-gal Polyethylene Drum.

- The concentrated nitric acid stored in contact with the polyethylene liner over an extended period (from approximately 1960 to 1997) caused the polyethylene liner to become extremely brittle. The concentrated nitric acid slowly seeped through the hairline fractures of the degraded polyethylene liner. During this time, the continual cycle of heating and cooling of the drum contents due to natural environmental conditions as well as the continual degradation of the polyethylene liner induced by the concentrated nitric acid caused “wicking” of minute quantities of escaped acid between the surfaces of the composite steel/polyethylene drum. In this case, wicking means the movement of liquids (condensation and concentrated nitric acid) along the outer walls of the polyethylene liner and the inner walls of the steel drum. The wicking of the concentrated nitric acid resulted in an extremely corroded, thin, and weak 55-gal steel drum. Over time, more and more hairline cracks developed in the polyethylene, weakening this liner.

- It can be seen in **Exhibit 2-2** that the polyethylene drum is very thin within a 10-in.-diameter bottom area. The 4-in. breach in the thin and brittle bottom of the polyethylene drum could have been

caused by the sampling tool (caliwas) during the sampling event on July 28, 1997. The sampling event and the subsequent movements of HC-1093 provided enough additional stress to the inner polyethylene liner to cause a breach large enough to allow acid to reach a greater surface area of the metal and intensify the acid/metal reaction. The

resulting gases produced from the intensified acid/metal reaction caused the overpressurization of the 85-gal steel overpack and HC-1093. Pressure initially built up within the 85-gal steel overpack from the acid attack on the inner metal surface of this container as well as the intense acid attack on the aged and extremely brittle 55-gal steel drum. The 55-gal steel drum provided very fine iron particles/powder that reacted with the concentrated nitric acid, causing a rapid buildup of gases.
