**TYPE A ACCIDENT  
INVESTIGATION BOARD REPORT  
OF THE JULY 28, 1998  
FATALITY AND MULTIPLE INJURIES  
RESULTING FROM RELEASE OF  
CARBON DIOXIDE  
AT  
BUILDING 648, TEST REACTOR AREA  
IDAHO NATIONAL ENGINEERING AND ENVIRONMENTAL  
LABORATORY**

**September 1998**

**Office of Oversight  
Environment, Safety and Health  
U.S. Department of Energy**

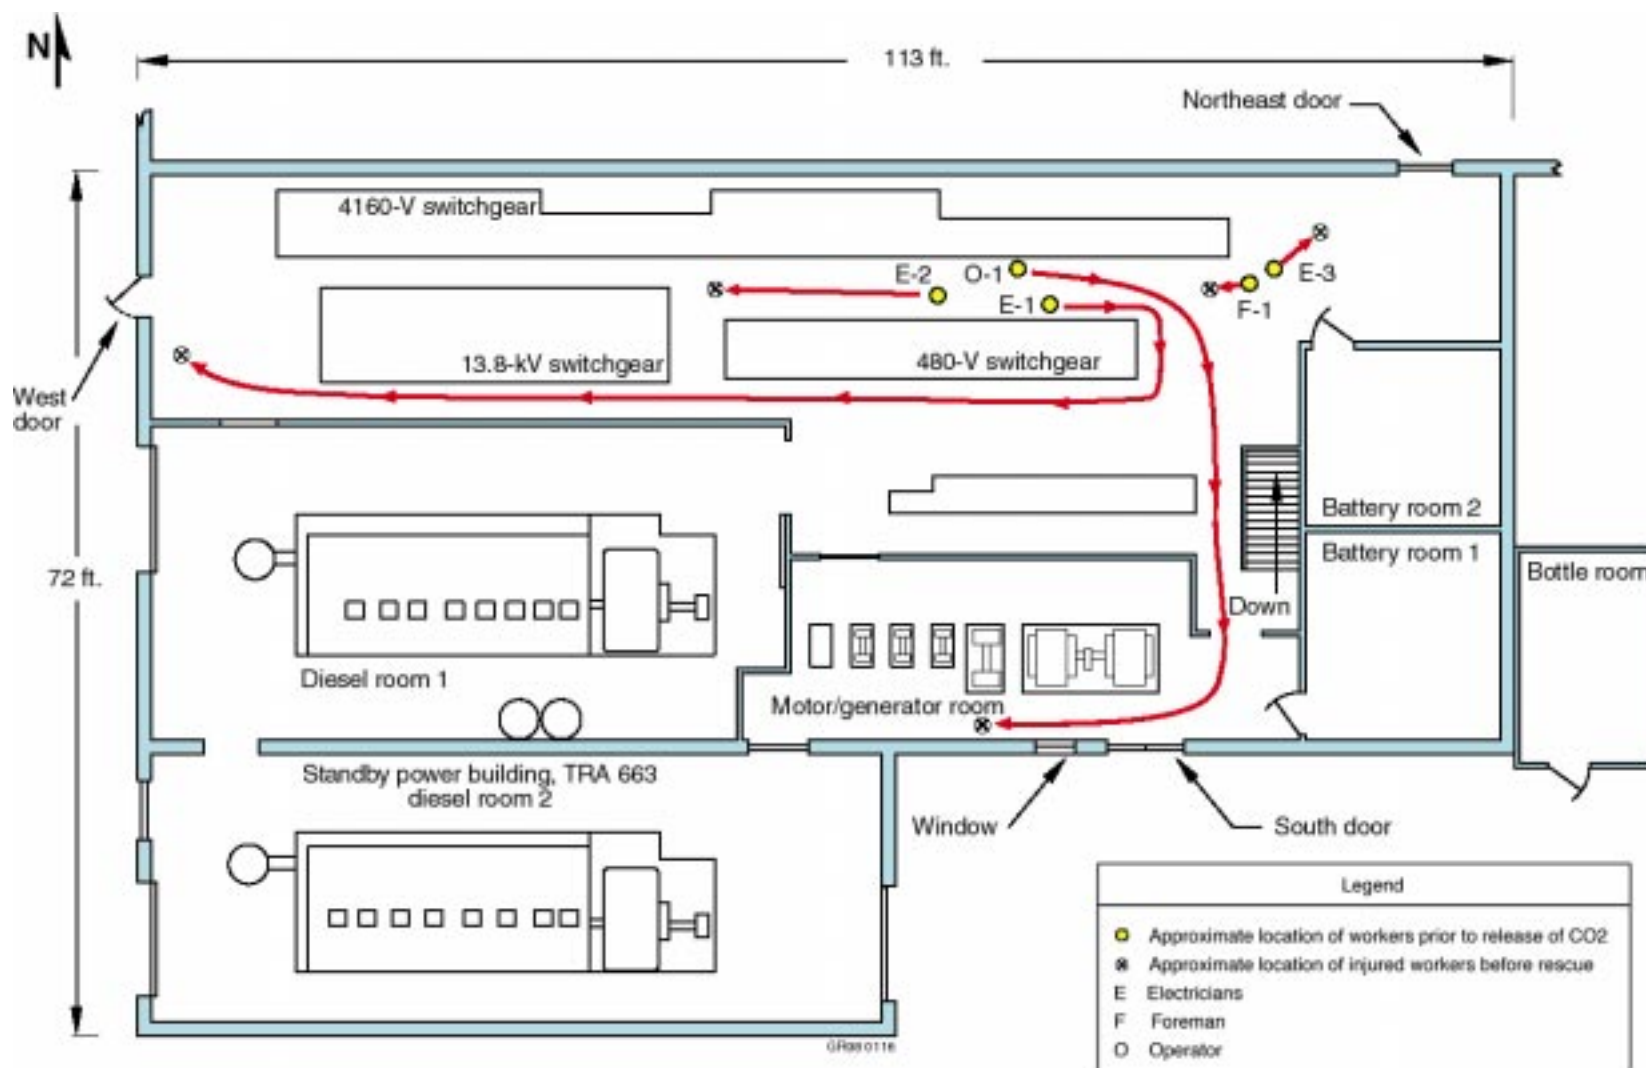
**Exhibit 2-1. Building 648 Layout with Escape Routes of Five Injured Workers**

No evacuation warning alarm occurred prior to the unexpected CO<sub>2</sub> discharge. Escape from the area was significantly impeded by various pathway obstacles, low visibility, the disorienting effects of CO<sub>2</sub>, the failure to designate emergency exit pathways, and inadequate exit path lighting, particularly in the northeast corner and in the pump and motor generator set rooms.

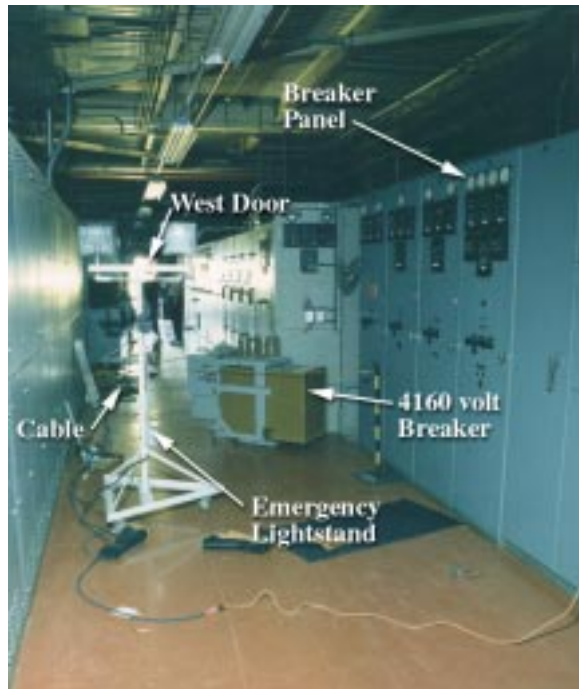
**Exhibit 2-2. Switchgear Looking West Toward Exit Door**

Within seconds after the opening of the last 4160 volt breaker, the CO<sub>2</sub> fire suppression system unexpectedly discharged and without warning created a lethal atmosphere deprived of oxygen with near zero visibility. Witnesses described hearing a hissing sound and then a “woosh,” followed by “total whiteout” conditions within seconds, in which they could not see anything at all. Most individuals instinctively ran toward the west door by which they entered and which was still open (because cables to the lights were run through it), allowing daylight to shine into the area. Transcribed interviews revealed that escape necessitated groping along switchgear and running into and around obstacles (see Exhibit 2-2). One individual (E-2) describes running into something (perhaps the rolled out 4160 volt breaker), falling down, and then passing out as he took a breath of CO<sub>2</sub>.

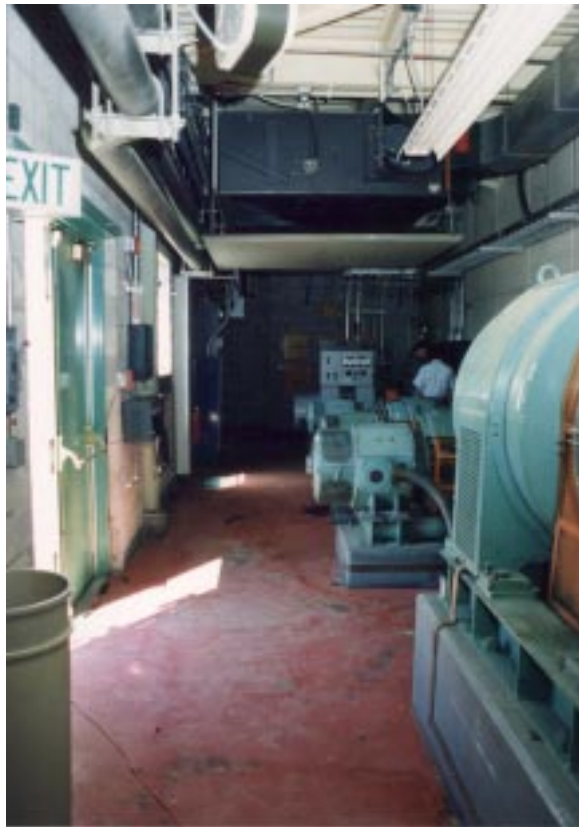
**Exhibit 2-3. Motor Generator Room Near South Door**

One other individual (O-1) headed in a different direction, through the pump and motor generator room toward an exit door on the south side of the building (Exhibit 2-3). Unable to find the door in the whiteout conditions, he reached a window just past the door. In desperation, he put his hand through the thick glass window embedded with wire, sustaining severe arm lacerations and blood loss before losing consciousness (see Exhibit 2-4). Another individual (E-1) groped along switchgear, only to become entangled in an instrument cart and cable wires en route to the west door (Exhibit 2-5). He tripped, rolled, hit his head, and passed out inside the building.

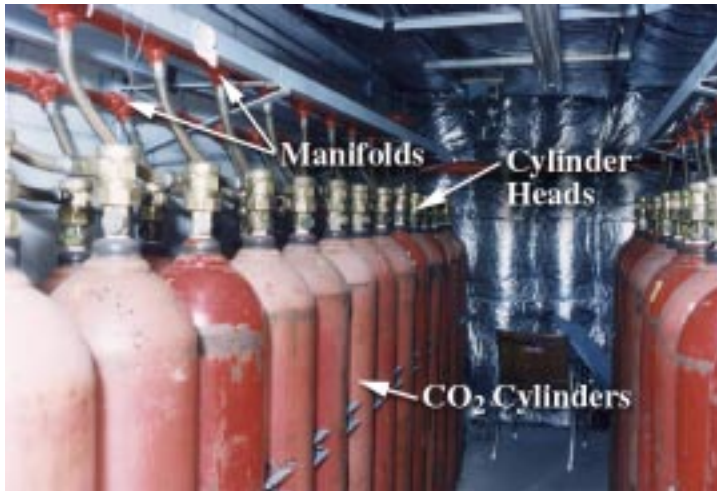
**Exhibit 3-2. CO<sub>2</sub> Cylinders and Manifolds**

The CO<sub>2</sub> extinguishing system is a high-pressure, total flooding system. It consists of 55 100-pound CO<sub>2</sub> cylinders connected

together by manifolds, all of which are located in a CO<sub>2</sub> shed attached to the south side of the building (see Exhibit 3-2). The CO<sub>2</sub> manifolds connect to a system of piping and ceiling nozzles inside Building 648.

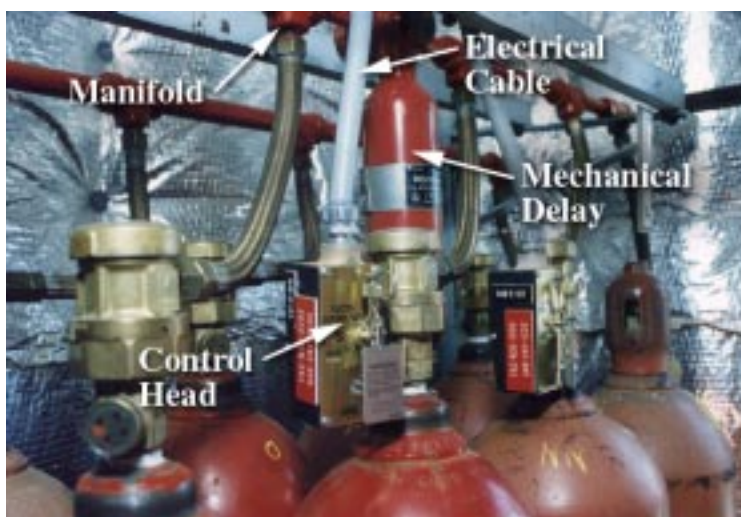
**Exhibit 3-3. Control Head and Mechanical Delay Mechanism**

- Recommending additional performance testing to further isolate facts regarding CO<sub>2</sub> system activation:
    - The removal of the 25-second mechanical delay from the CO<sub>2</sub> system header and bench testing to verify the length of the time delay. This test is pending.

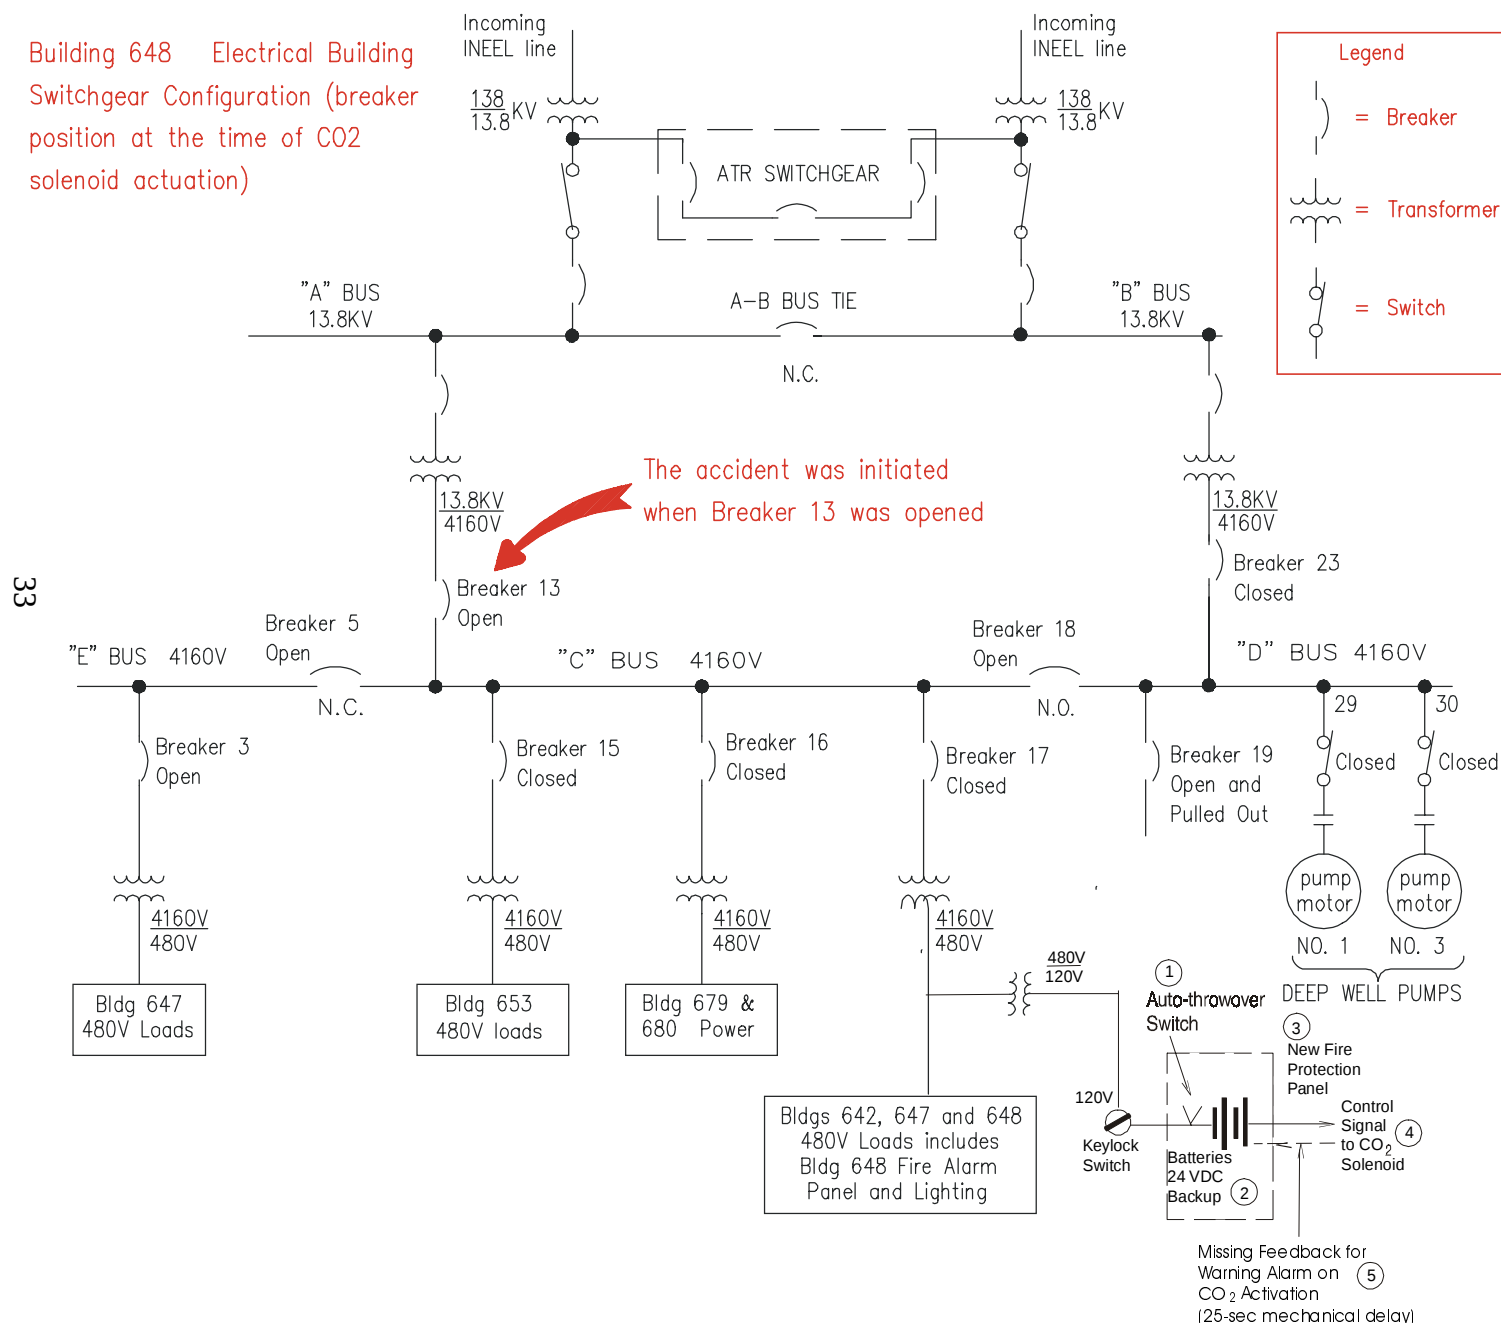
**Figure 3-1. Simplified Schematic of Switchgear**

Fire protection systems in Building 648, as well as building lighting systems, are fed electrical power from 4160 volt switchgear Breaker No. 17, that feeds a 480 volt switchgear Breaker No. 11C, and a 480 volt distribution panel (648-E-25). The fire protection system is fed from this distribution panel, through Lighting Panel K, to a 240 volt transformer, sub-panel KA circuit Breaker No. 5 which supplies 110 volt alternative current (AC) service to the Notifier AFP-200 panel. The fire alarm panel was provided with 60 hours of dedicated emergency battery backup power.

installation deviations were significant with respect to the accidental CO<sub>2</sub> discharge. The auxiliary power supply is suspect because opening Breaker No. 13 appears to have been the cause of the CO<sub>2</sub> discharge, presumably as a consequence of a voltage surge or spike. The fact that this power supply is unregulated and unfiltered may make it easier for a transient input to that supply to get through to the panel and trip the releasing circuits. The shielding on the addressable circuits is suspect because it is intended to dissipate transient signals before they can affect system operation.

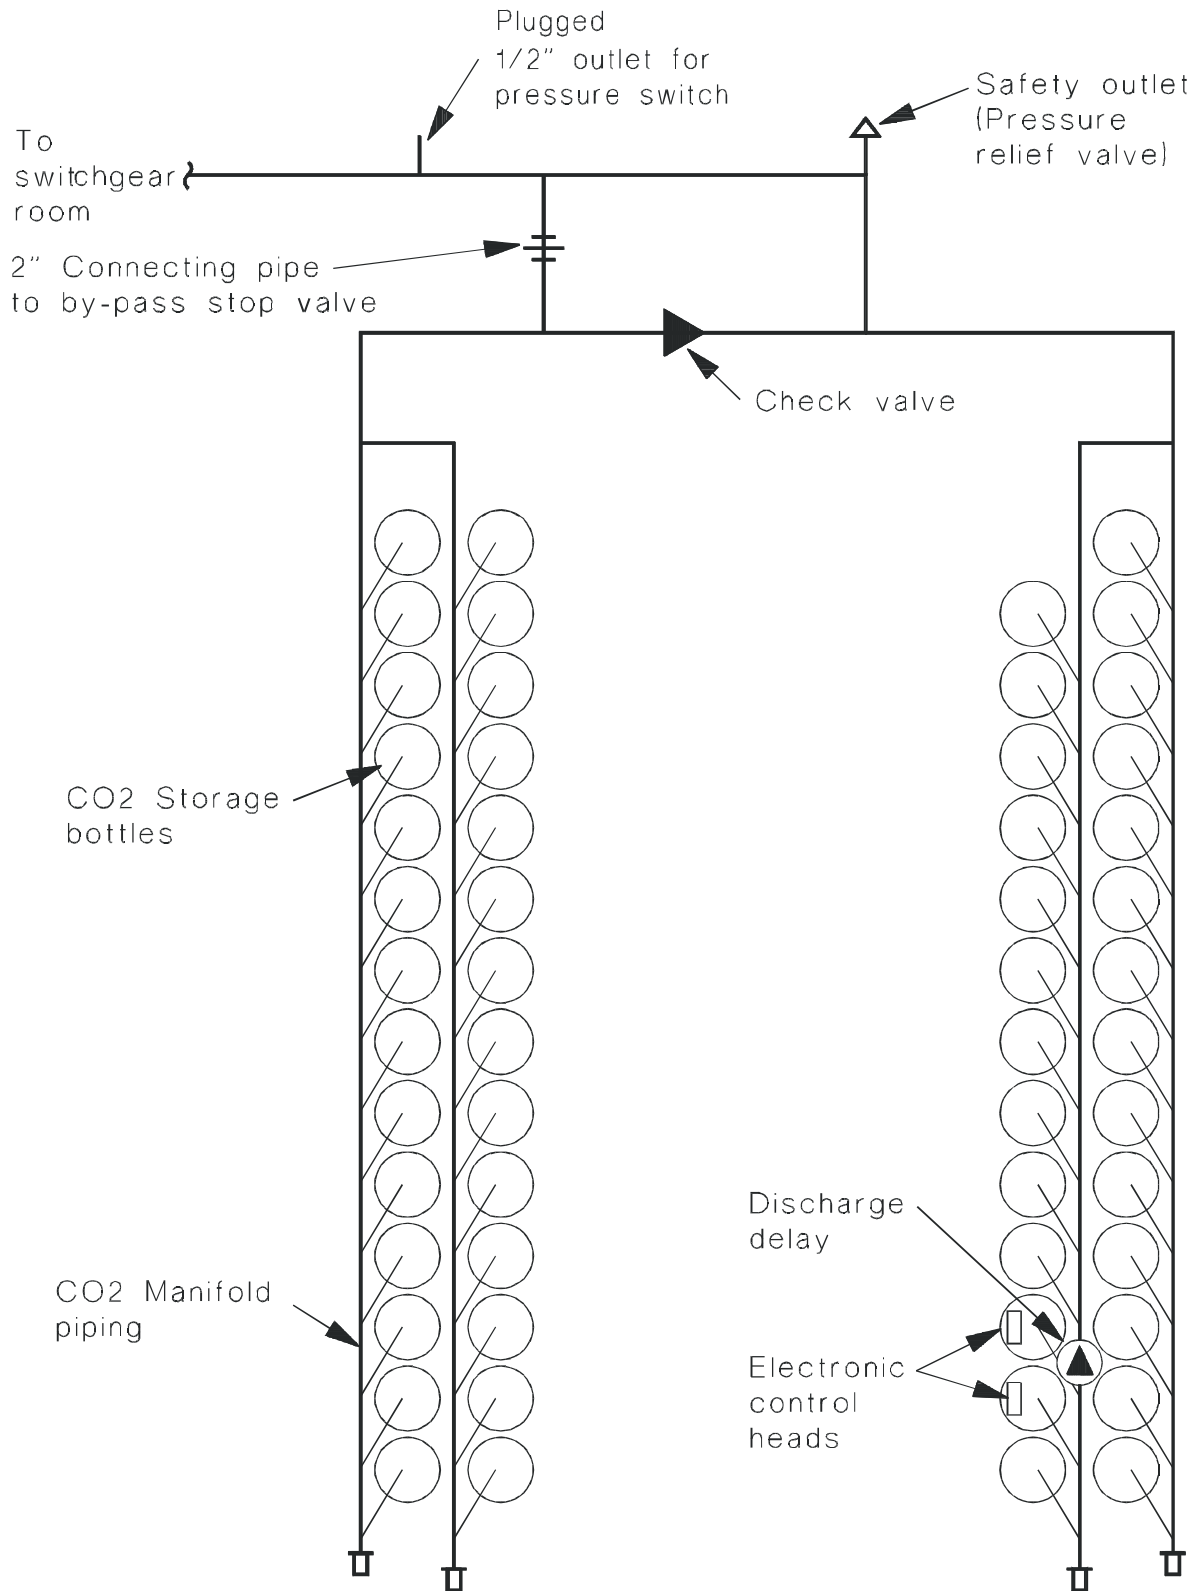
**Figure 3-3. Carbon Dioxide System Arrangement Post Line Item Project**

*The failure to install a carbon dioxide system discharge monitoring circuit prevented a 25-second pre-discharge warning alarm and safe escape.*

*Deviations in the fire alarm system installation could have made it easier for a transient electrical input to trigger the unexpected discharge.*
