**Type B Accident Investigation Board Report  
on the September 4, 1998,  
Flammable Liquid Fire/Explosion  
at Fermi National Accelerator Laboratory  
Batavia, Illinois**

**October 16, 1998**

**Chicago Operations Office  
U.S. Department of Energy**

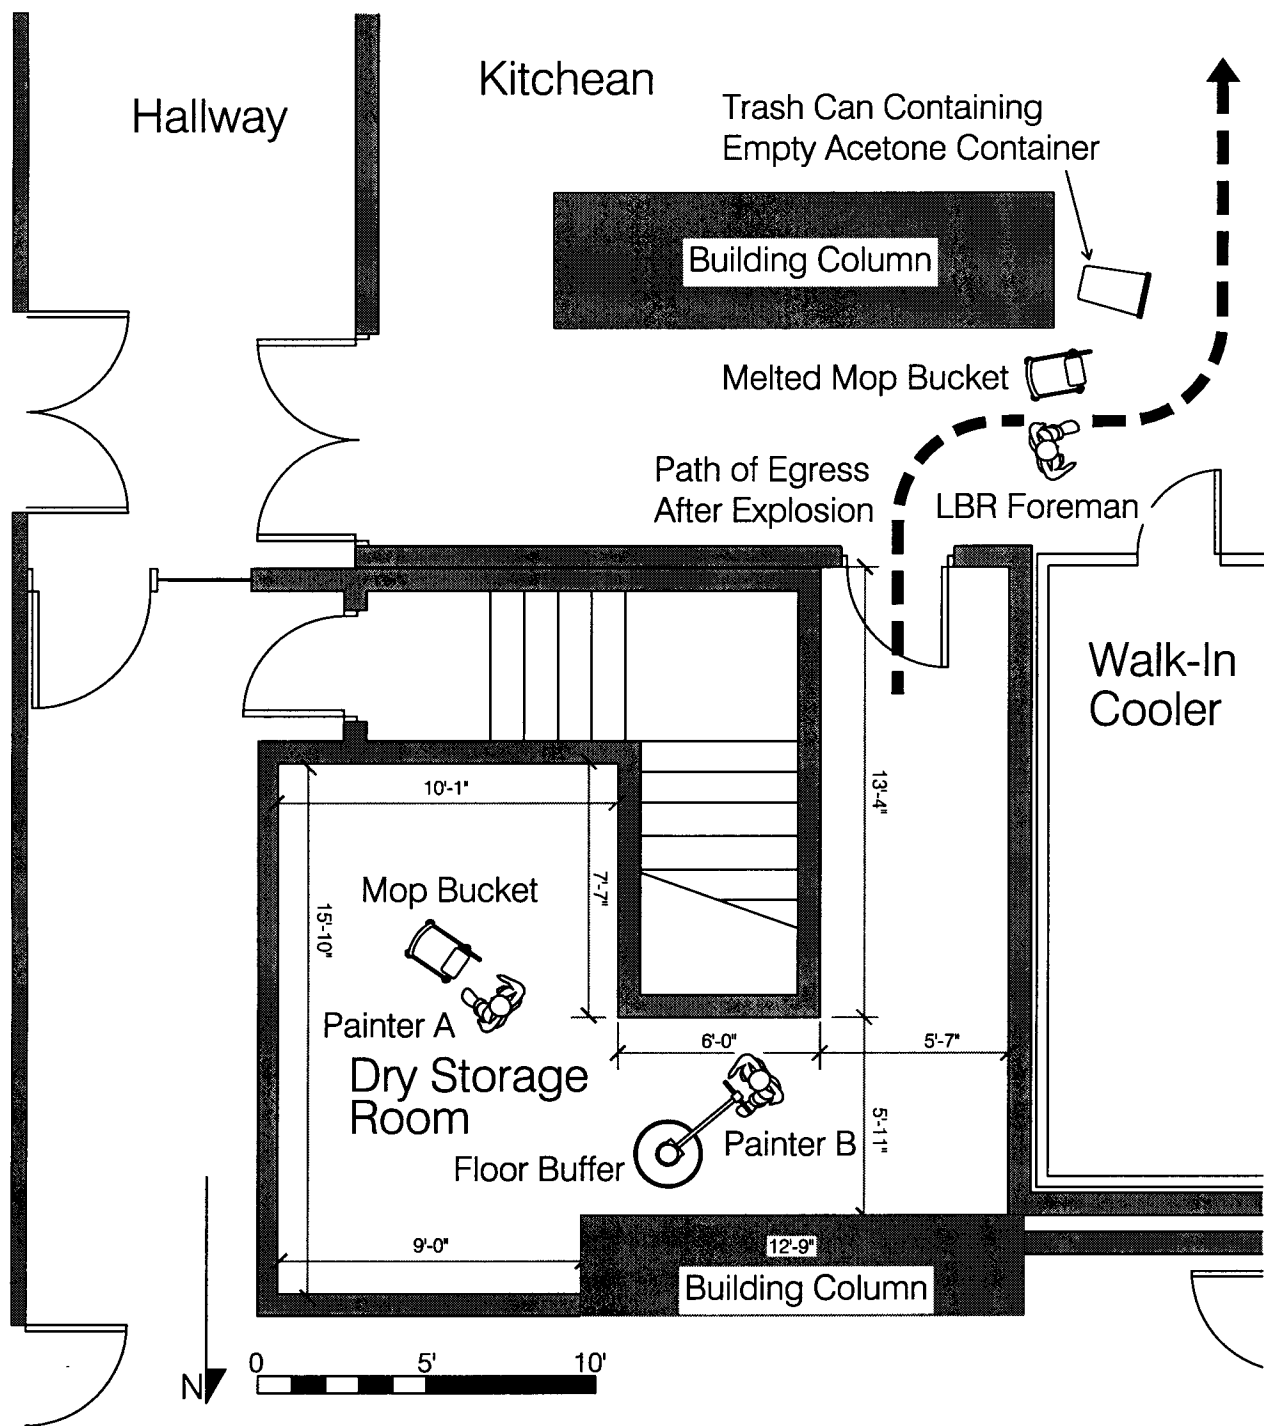
**FIGURE 3 Layout of the Dry Storage Room Showing the Approximate Locations of the Contractor Foreman and Painters when the Flammable Liquid Fire/Explosion Occurred**

Painter B, who was operating the floor buffer and closest to the door when the explosion occurred, ran out of the room first with the back of his shirt on fire. Painter A, who was 10-12 feet away from

the floor buffer, reported that the floor surrounding him became engulfed in flames, he had to jump over the floor buffer to escape, and he exited the room with flames on his face. Both the Contractor Foreman and Painter A helped extinguish the flames on Painter B. Once the flames were extinguished, all three exited the kitchen area and building.

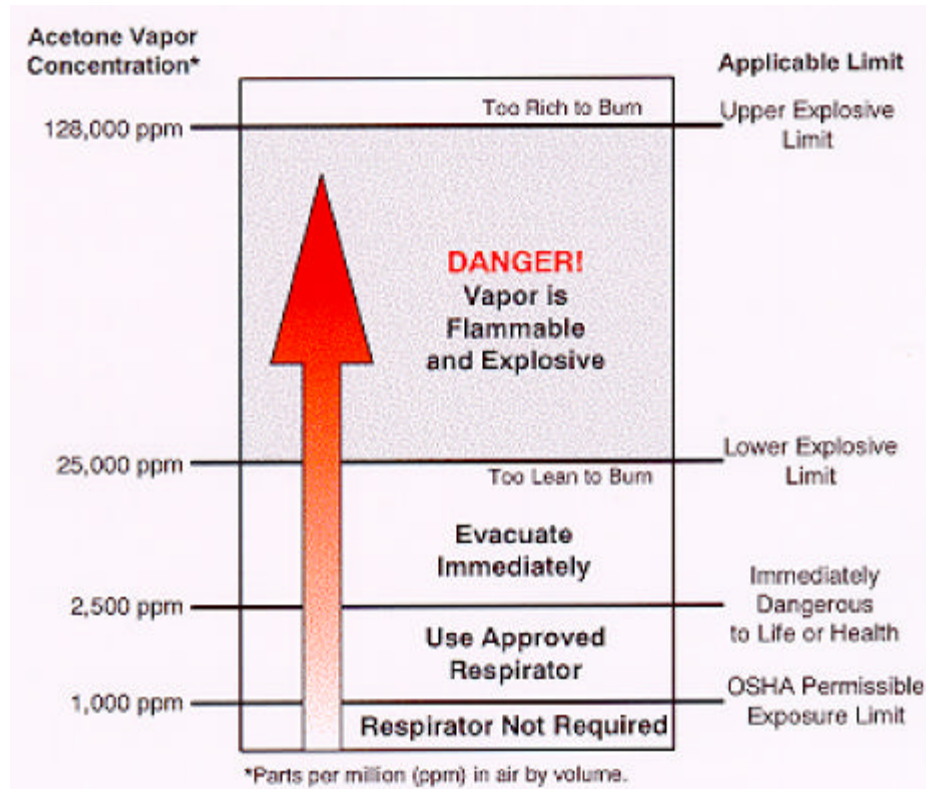
**FIGURE 7 Hazards of Acetone Vapors in Air**

The Board concluded that two hazards existed in the course of this accident. The first was a health hazard when the workers were potentially exposed to acetone vapors above the permissible exposure limit. The second was a physical hazard when the acetone vapor concentration exceeded the lower explosive limit and the vapors were ignited.
