**Office of Oversight  
Environment, Safety and Health**

*Type A Accident Investigation  
of the December 8, 1999*

**Multiple Injury Accident  
Resulting from the  
Sodium-Potassium Explosion  
in Building 9201-5  
at the Y-12 Plant**

February 2000

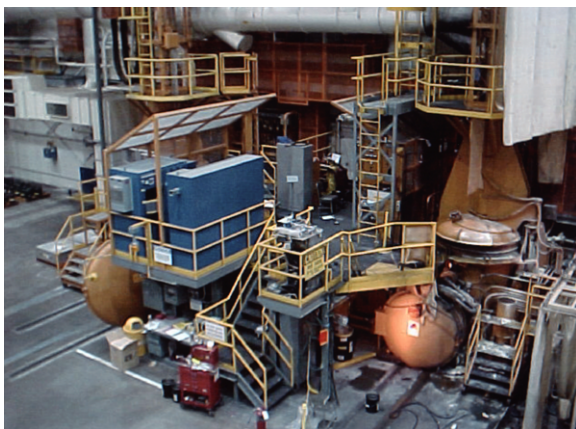
Exhibit #1. Skull Caster Furnace and Accident Scene

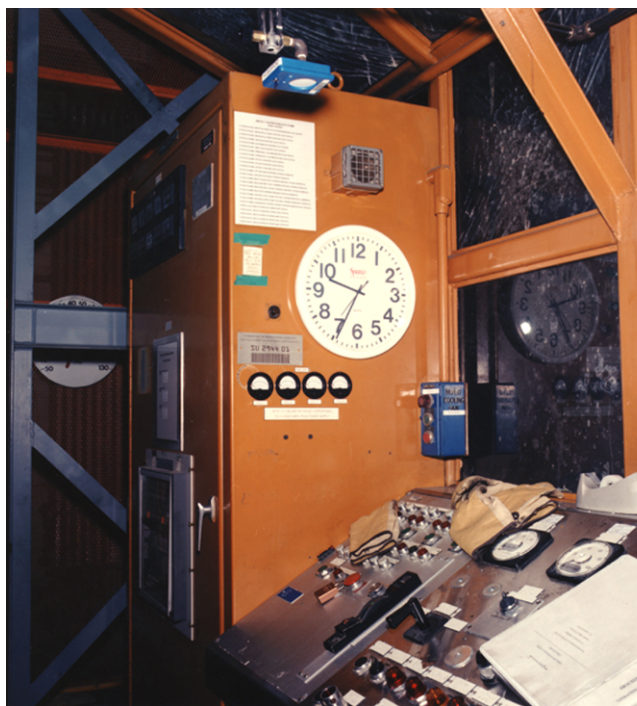
**Exhibit #4. Skull Caster Furnace Control Panel Showing Clock Stopped as a Result of the Accident**

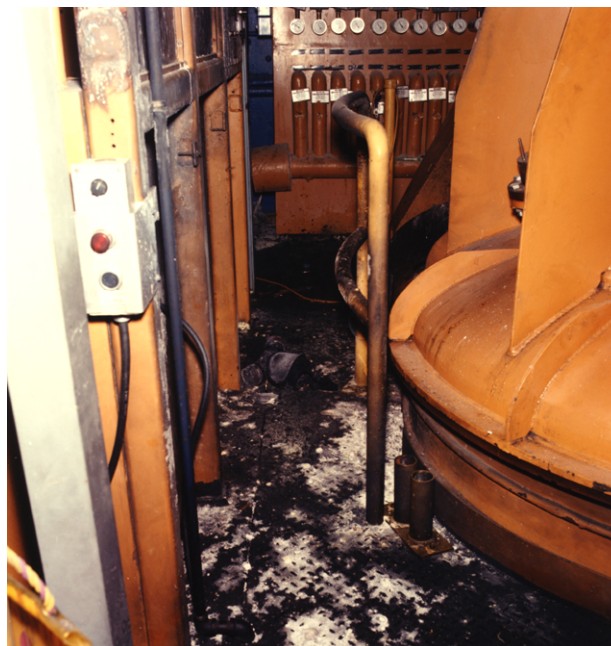
Exhibit #7. Residual NaK from Explosion Near Furnace

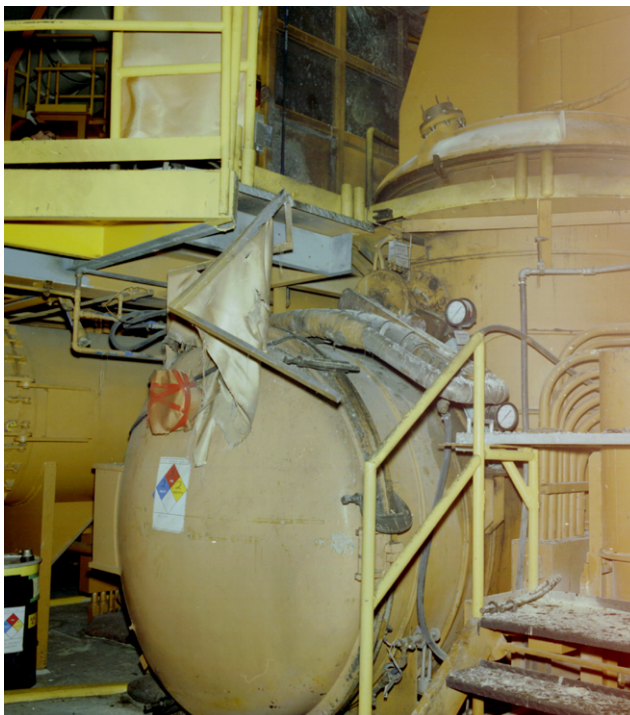
**Exhibit #8. Furnace Showing Explosion Damage**

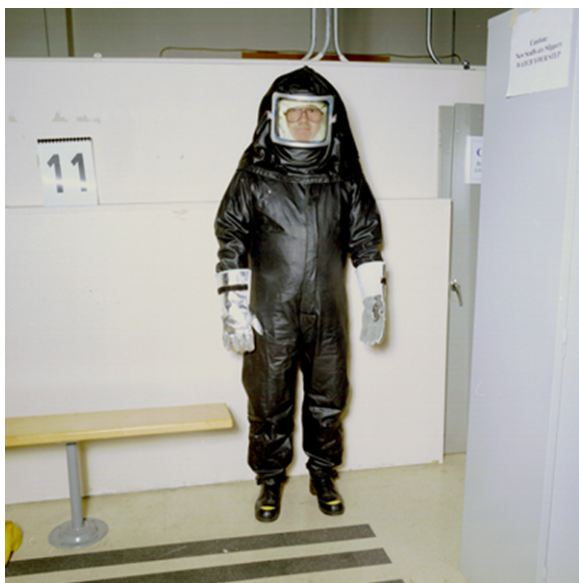
PPE for Workers Contacting NaK

- Impervious NaK suit including respiratory protection and chrome gloves
- Full protection against thermal and chemical burns
- Not worn and not staged

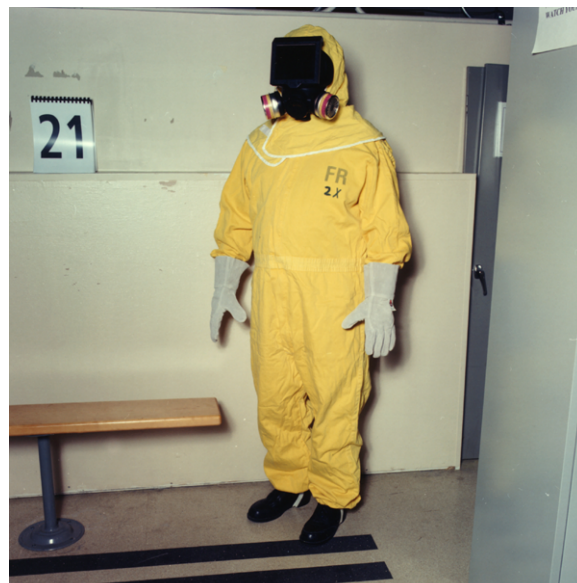
PPE for Support Personnel

- Derived from site requirements
- Includes full face respiratory protection and flame-retardant materials
- Not worn

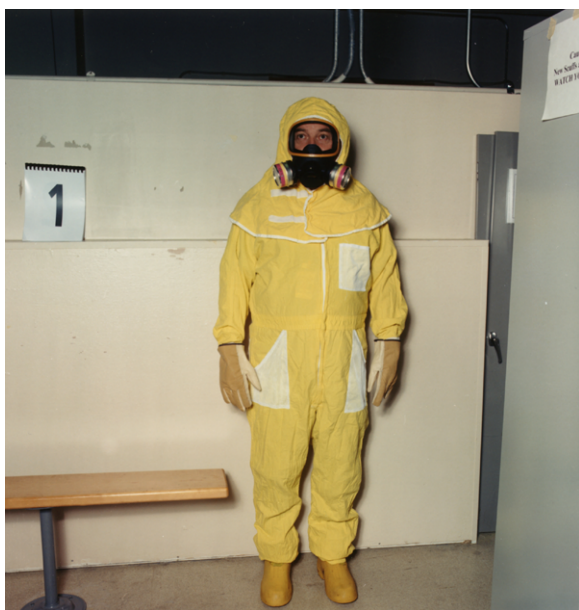
PPE Worn by Three Workers

- Standard coveralls (not flame-resistant)
- Leather gloves (not flame-resistant)
- Cartridge-type respirator (not supplied air)

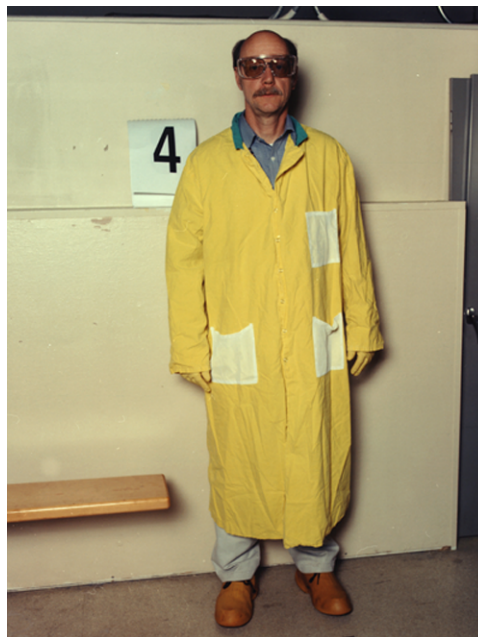
PPE Typical of That Worn by Other Workers

- Standard lab coats (not flame-resistant)
- Standard shoe covers and gloves (not flame-resistant)
- No respirator

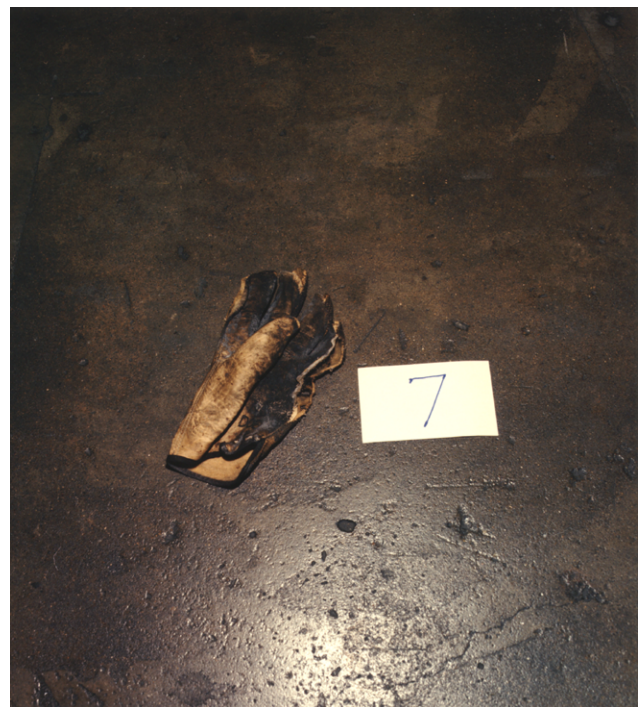
**Standard Work Glove Burned from Explosion/Fire**

Contrary to the manufacturer’s recommendations, some crucible changeout activities specified leather gloves dipped in mineral oil (not dry), and failed to specify flame retardant clothing, clothing without cuffs or pockets, or an SCBA. The 1988 final safety analysis report required PPE consisting of a “face shield, flame proof coveralls, hard hat and shoes when [operators] are working with NaK.” The current crucible changeout procedure (and recovery plan) also omitted some PPE requirements that were in older versions of the procedure. For example, earlier procedures required Nomex® (flame-retardant) coveralls for crucible removal, repair, cleaning, and installation. The Nomex® requirement was included in procedures until November 1989.

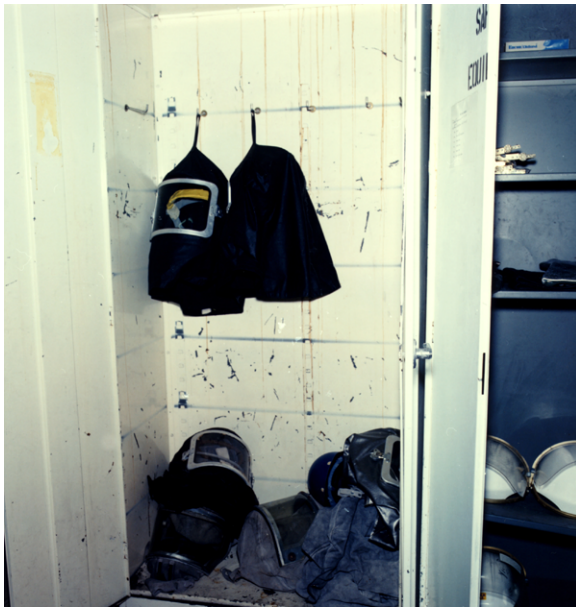
NaK suits were not staged at the furnace for the spill recovery on December 8 for either planned work evolutions or response to abnormal events (see Table 4 and Exhibit #12). Section 9 of the recovery plan requires an NaK suit for cleaning the furnace walls and floor. For abnormal response actions, Section 2 of the recovery plan refers to the abnormal response action of the crucible changeout procedure (Section 4.8), which requires the use of an NaK suit for both NaK spills and external NaK oxidation events, either of which could have occurred in removing the spilled NaK from the furnace.

**Exhibit #12. NaK Locker Showing the Lack of NaK Suits**

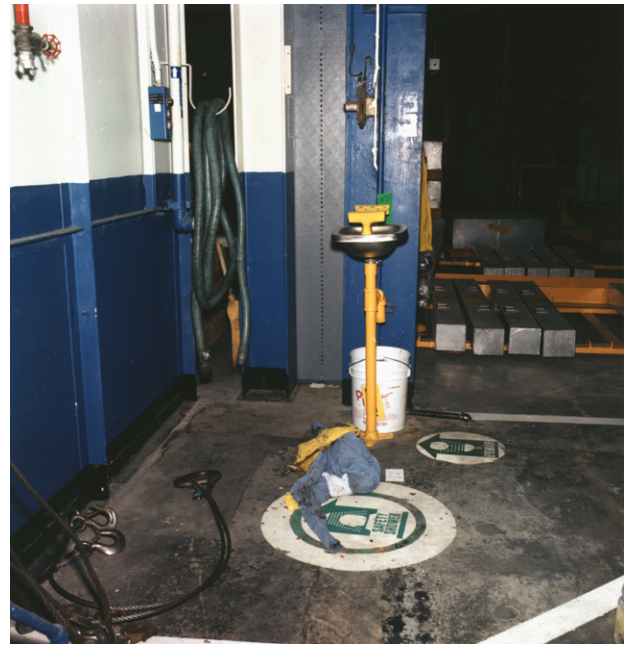
**Exhibit #13. Safety Shower Showing Lack of Berms and Burned Clothing**

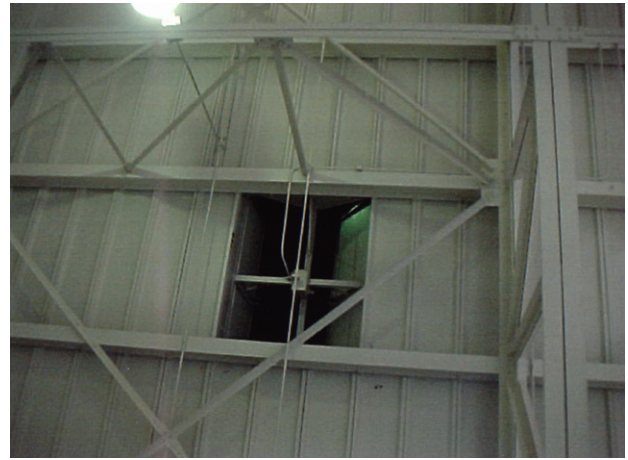
As originally designed, the high bay area above the skull caster furnace had seven smoke detectors that would cause a fire alarm and would open the roof vents to vent smoke. Modifications in the late 1960s removed these detectors from service. The accident investigation team found no justifications or fire hazards analysis for their removal. However, fire protection and engineering staff stated that they may have been removed due to nuisance alarms caused by heat and smoke from operation of the furnace. Those modifications left the high bay without adequate fire alarm protection. Additional modifications shown on

**Exhibit #14. Open Roof Vents**

design drawings connected the two roof vents over the skull melt furnace to a push button switch located in an office; however, as noted above, building personnel were unaware of the switch, and no switch was located. During a fire protection system upgrade, the other two roof vents were connected to smoke detectors for a large industrial saw and an oven in the general area, but away from the skull caster furnace. During testing of the new system before the spill and accident, the roof vents did not function, so they were presumably electrically inoperable at the time of the spill and accident. A work request was initiated to correct the deficiency, but the work had not been completed before the NaK spill and accident.
