EPA CHEMICAL ACCIDENT INVESTIGATION REPORT

**Powell Duffryn
Terminals, Inc.
Savannah, Georgia**

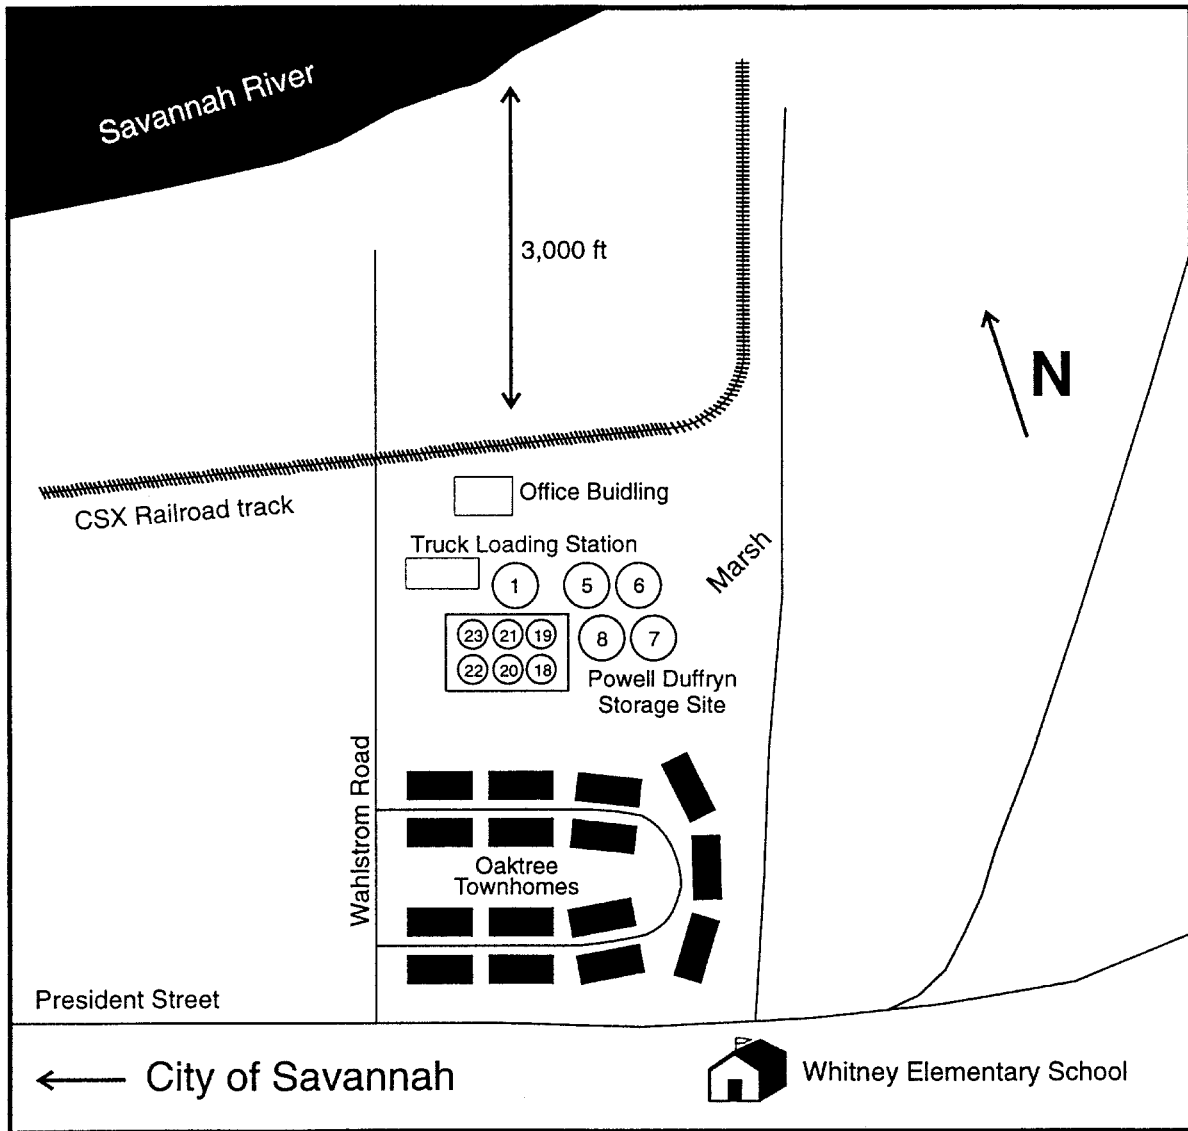
Exhibit 1 Powell Duffryn Terminal Site

- Parts of another extension cord were observed lying between Tank 1 (the caustic soda tank) and the six-tank enclosure wall. This cord ran around the enclosure wall to the area of the stairs on the enclosure wall.^{7, 42} (See Exhibit 1.)

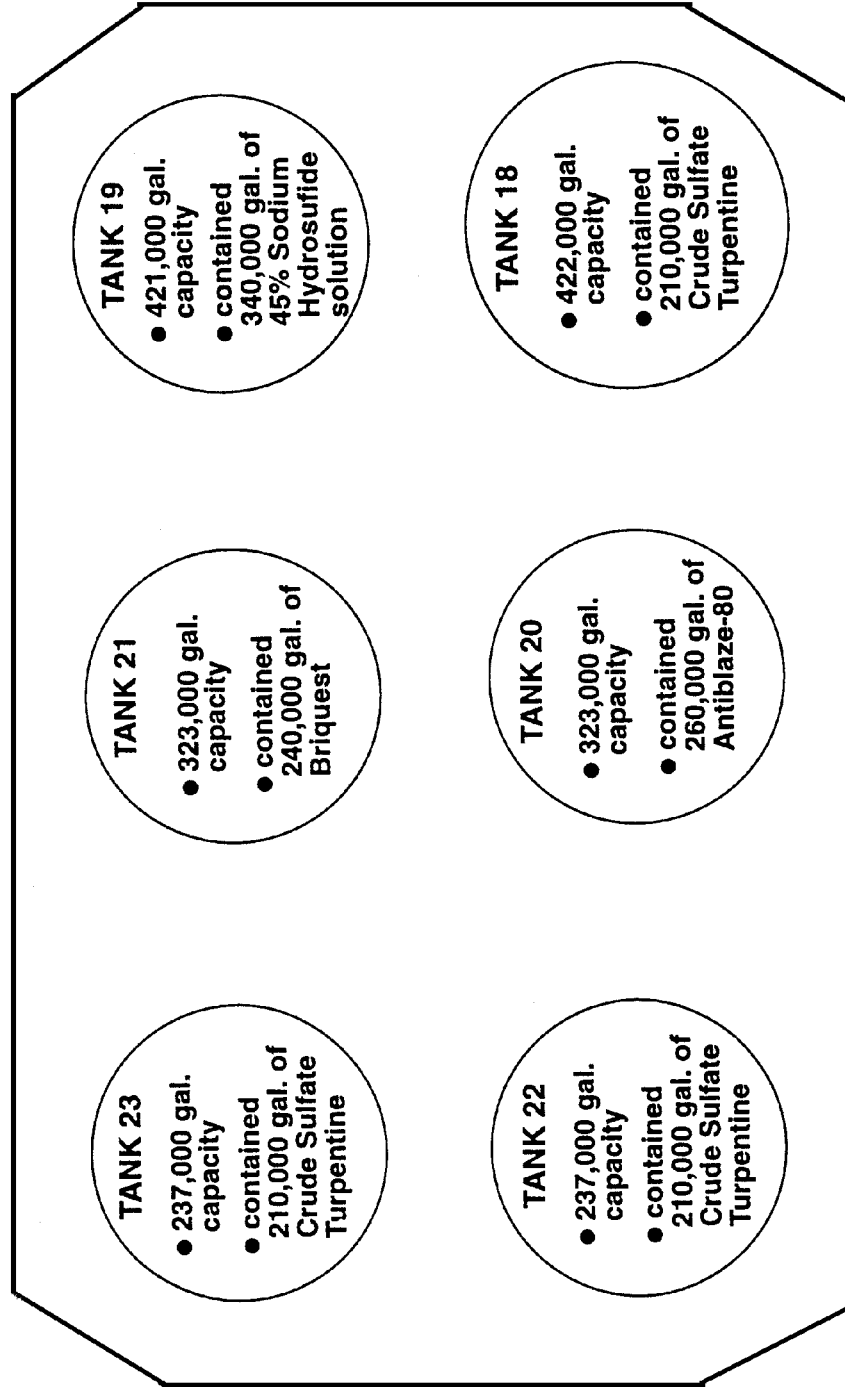
Exhibit 2
Six-Tank Enclosure, Site of Fire
(100 x 200 feet, surrounded by 5-foot Concrete Berm)

The six-tank enclosure area is about 100 by 200 feet (20,000 square feet in area). A diagram of the enclosure area along with the approximate capacity and contents of each tank is presented in Exhibit 2. The enclosure area is located slightly north of the midpoint of Powell Duffryn's southern property line. Five other tanks, much larger than the tanks in the enclosure, are located to the north and east of the enclosure.^{8, 9} (These other tanks are also shown in Exhibit 1.)

Sodium hydrosulfide solution, stored in the same enclosure, is strongly alkaline (pH of 10.4 to 11.5) and corrosive. When sodium hydrosulfide is exposed to heat or mixed with an acid (e.g., Briquest), hydrogen sulfide, a toxic gas, can be produced. During the fire hydrogen sulfide was probably produced as a result of the heat from the fire. Since hydrogen sulfide is combustible, hydrogen sulfide produced from heating was probably consumed in the fire. After the fire, the reaction between the sodium hydrosulfide solution and acids in the enclosure area is most likely the source of the hydrogen sulfide released at the PDTI site. As shown in Exhibit 2, Tank 19, containing sodium hydrosulfide, and Tank 21, containing Briquest, were located next to each other in the enclosure.¹⁵

- Facilities should examine process and storage areas and equipment to ensure that potentially incompatible substances are kept separated. Leaks or spills of incompatible substances from equipment should not go into the same containment or other areas as a result of fire or other incident.

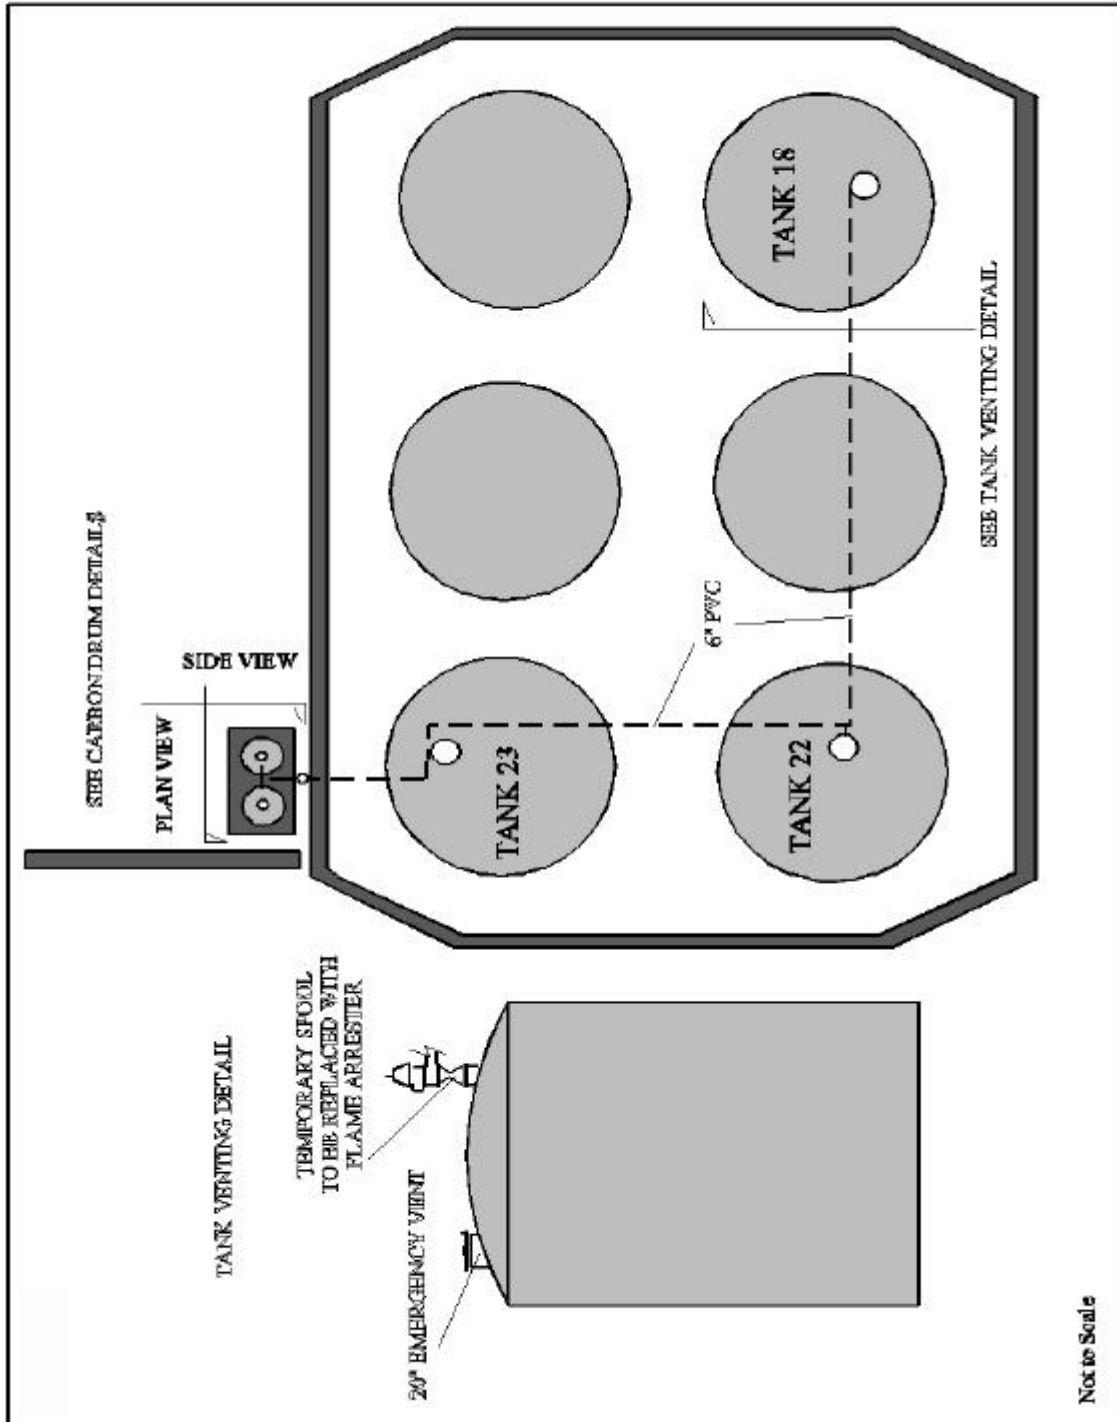
Exhibit 3. Vapor Control System

The system consisted of two metal drums (50-gallon size) containing activated carbon used for absorbing CST vapor, polyvinyl chloride (PVC) piping connecting the drums to the three flame arresters, and three pressure release vents located on the storage tanks.²⁵ It was intended that vapor from the tanks would travel through the flame arresters to the PVC piping that was mounted to existing cat walks and enter two drums of activated carbon located at ground level just outside of the enclosure area. Each tank was supposed to be equipped with a

flame arrester at its connection to the PVC pipe; however, at the time of the accident, the flame arresters were not installed. The VC system was in place, with the exception of the flame arresters, for more than a month before the accident. Piping “spools” (small fixed sections) were installed in place of the flame arresters. (However, the system was not completely closed to the atmosphere until the last foamer was installed and sealed at 2 p.m. on the afternoon of the accident - see below.)

The VC system was designed without electrical grounding for the drums containing activated carbon. The metal drums were connected to the storage tanks by non-conducting PVC pipes. This permitted possible development of differences in electric potential between the drums containing activated carbon and the CST storage tanks. A spark in the PVC pipe resulting from static discharge could possibly ignite the CST vapor and trigger a vapor explosion and fire. However, the weather conditions at the time of the fire, low wind speed and high humidity, make this an unlikely possibility.

The CAIT concludes that the most likely cause of the incident at the PDTI facility was ignition of CST vapors in the carbon adsorption drums due to the inadvertent addition of atmospheric air. The fire then traveled back to the storage tanks through the vent piping, igniting the contents triggering explosions and fire.

- Facilities designing or adding on environmental control, fire safety, or hazard control systems, must ensure that these systems do not adversely impact the processes or equipment where they are to be added and that they are properly designed and installed. Designs should be reviewed by competent professionals or recognized experts. The hazards associated with the new systems and the impact of the new system on the existing systems should be thoroughly assessed. There are many formal hazard evaluation techniques available (such as HAZOP or What If) that can facilitate this assessment.

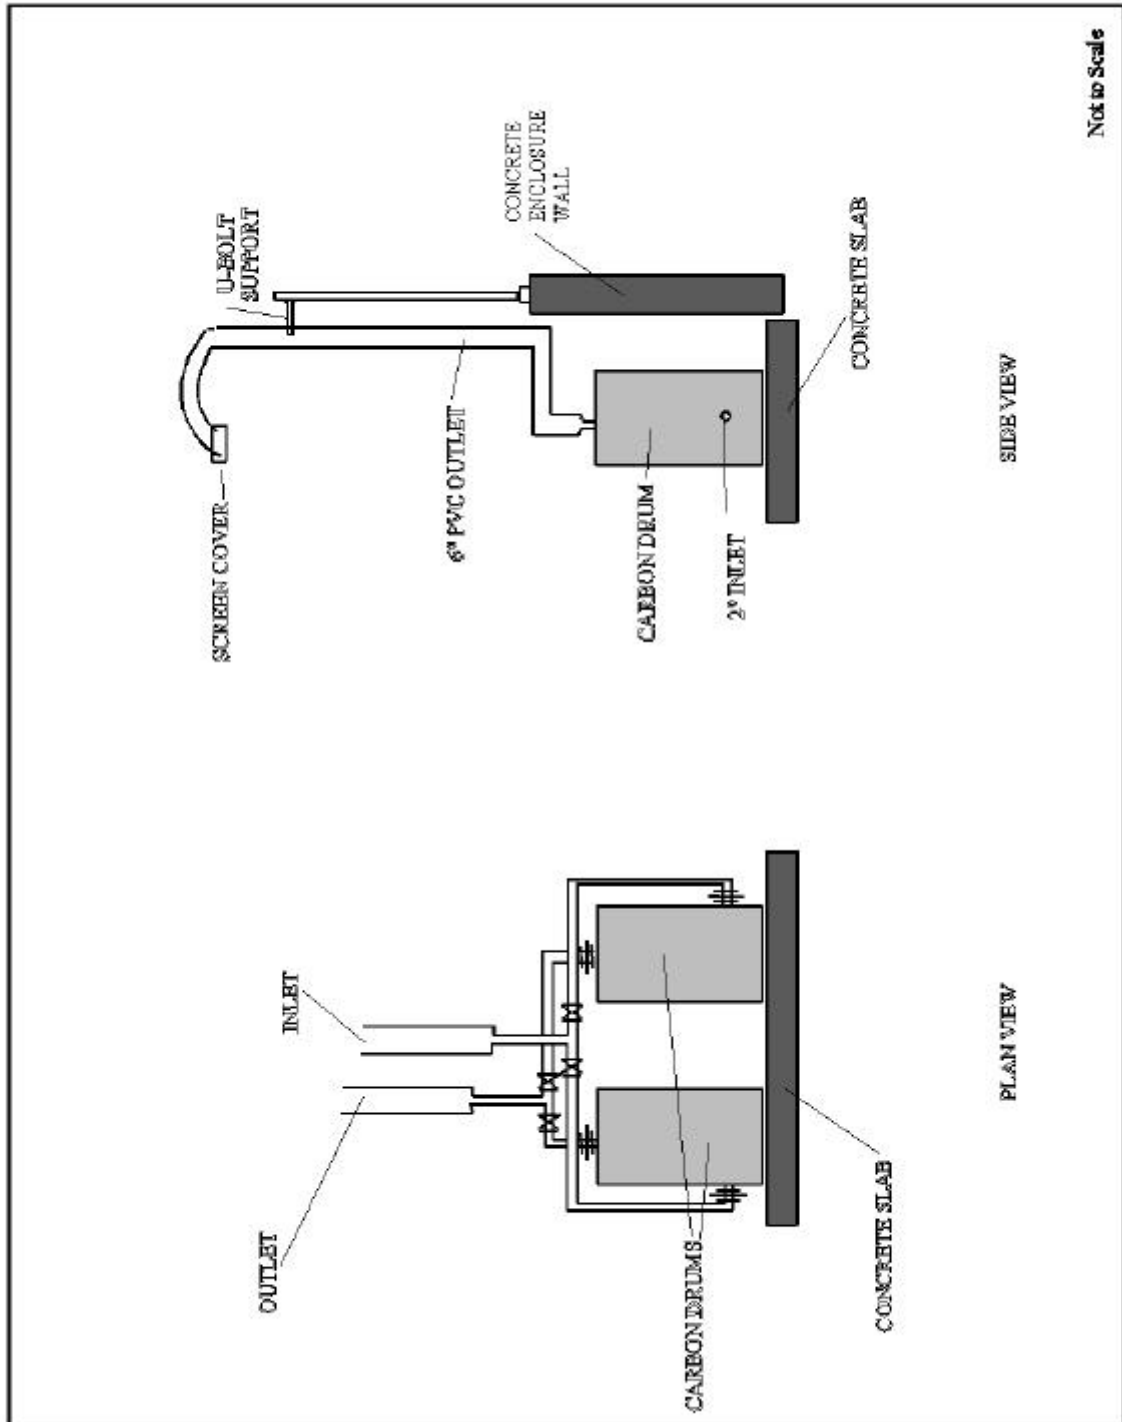
Exhibit 4. Carbon Drums

Product literature from Calgon, the manufacturer of the activated carbon, highlighted the hazards of exotherms (high temperatures) caused by adsorption of organic sulfur compounds, present in CST, onto activated carbon. Heat generated from the adsorption of CST vapor on the activated carbon can raise the temperature in the drums above the autoignition temperature of the CST vapor.

Although the temperature of the activated carbon may have become hot when CST vapor was vented from the storage tanks to the carbon drums, the low level of oxygen present in the drums probably averted a fire. However, the VC system did not have a bypass for preventing outside air from being drawn into the drums when cool outside temperatures caused vapor in the storage tanks to contract. The introduction of air provided the needed oxygen to trigger a fire.

Calgon Carbon Corporation, the manufacture of the activated carbon, recommended a procedure of wetting the carbon in the drums with water and of re-wetting it periodically thereafter. The evaporation of the water in the drums would prevent the activated carbon from becoming too hot. PDTI reportedly followed this procedure during initial installation. The VC system had been in place for over a month before the accident. However, it was not functioning as designed during this time, since part of the system was open to the atmosphere. During this time, the carbon in the drums could have dried out, even if it had been wetted initially. It is not known if the carbon was rewetted at anytime after initial installation.

- Facilities using activated carbon systems, in conjunction with vendors or recognized experts, should conduct tests to determine the potential for formation of hot spots, runaway reactions, or other consequences associated with adsorption of vapors on activated carbon and ensure that the hazards associated with the heat of adsorption are identified, well understood, and addressed through safeguards, procedures, or other controls. An evaluation of the potential for, and the consequences associated with, air being drawn into a carbon adsorption system (for example, associated with normal tank breathing) must also be addressed as necessary through safeguards or other controls.

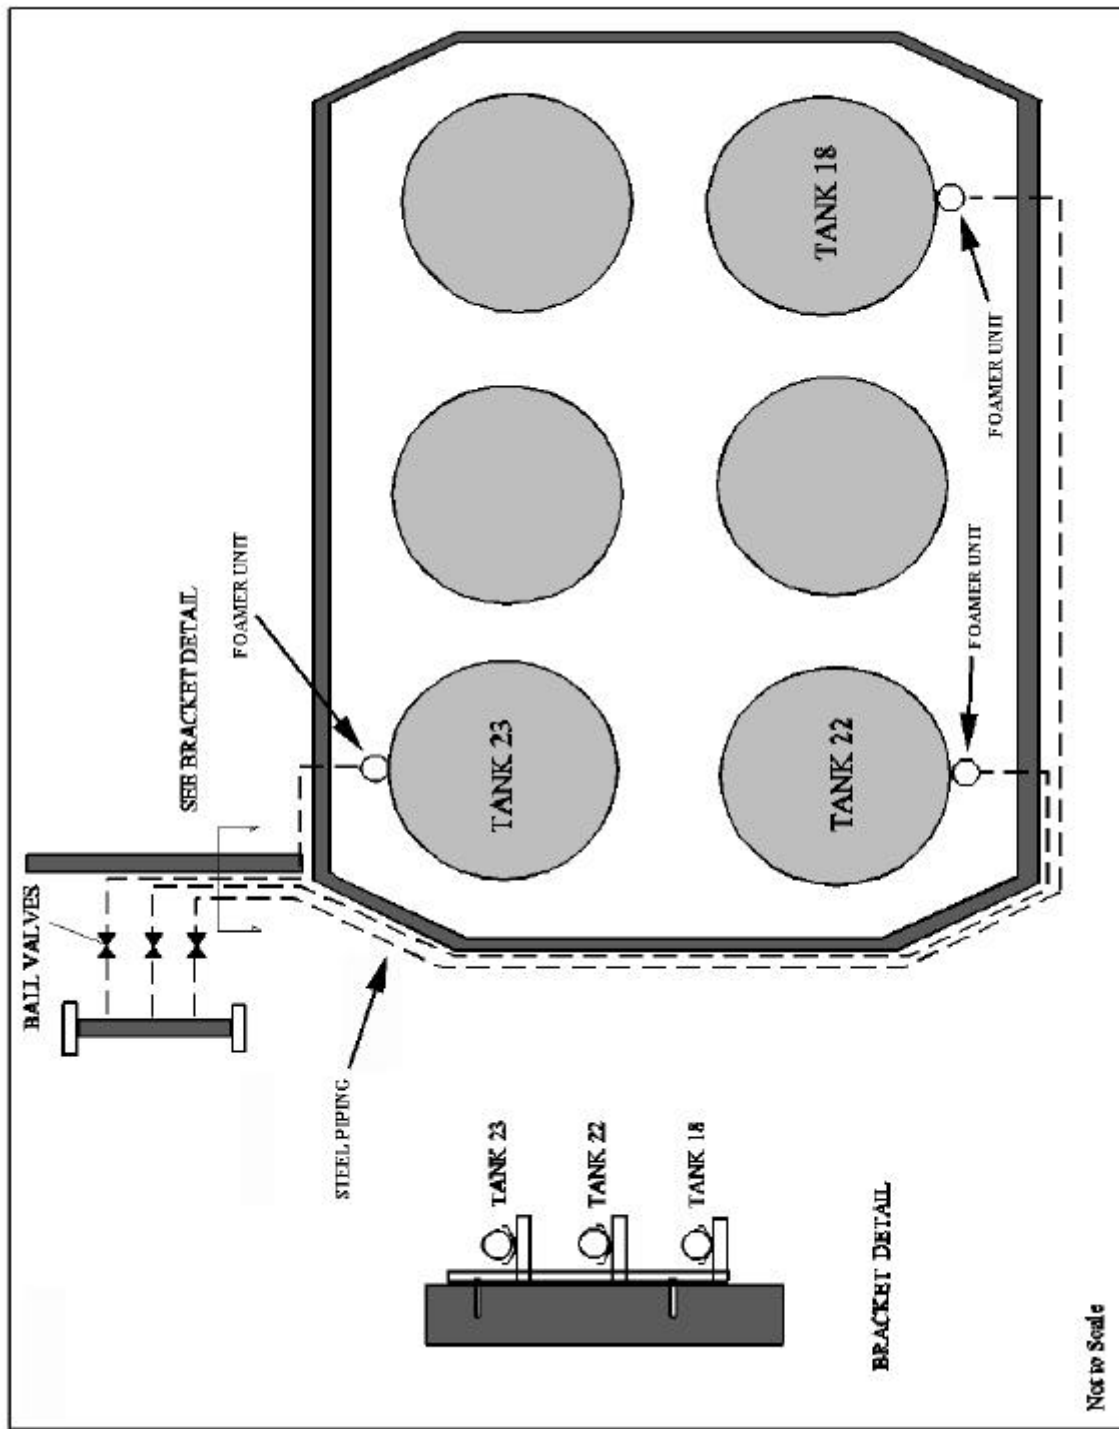
Exhibit 5. Fixed Piping Foam Fire Protection System

- The facility had been broken into and vandalized on two occasions -- two months prior to the fire and two weeks prior to the fire.⁴
- On March 3, 1995, PDTI's contractor began installing the foam fire protection system. The installation of the foam fire protection system had not been completed, and the system was not operational at the time of the fire.^{41, 44}

- Facilities must ensure that equipment for use in handling hazardous substances is equipped with the proper safety devices, and in compliance with national, state, and local fire and hazardous material safety codes and standards before hazardous materials are handled in such equipment. The safeguards, safety devices, or emergency systems designed to prevent or protect the equipment must be in place and fully operational as intended prior to startup of the equipment.

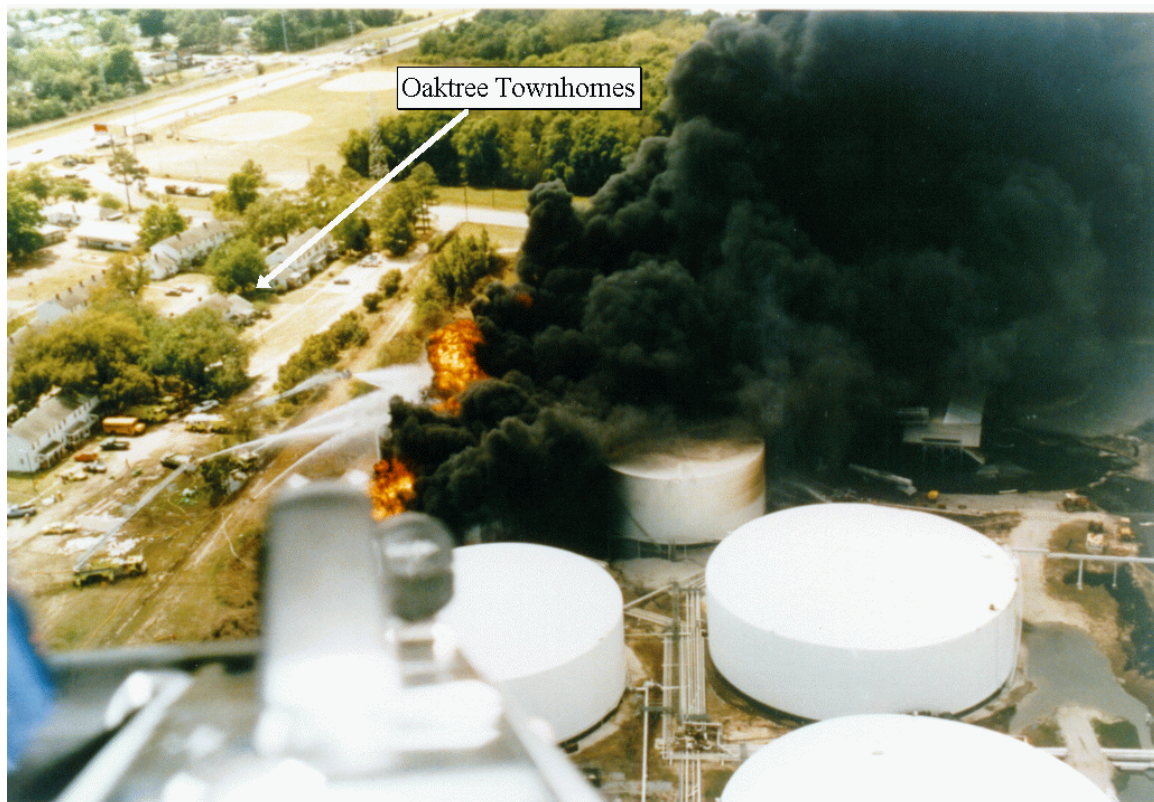
Exhibit 7
Area of Fire and Oaktree Townhomes ²⁹

The intense fire forced the nearby residents of the Oaktree Townhomes complex to immediately evacuate. The fire was sufficiently intense to cause damage to some trees and buildings in the Oaktree complex. The location of the Oaktree Townhomes in relation to the fire can be seen in the photograph in Exhibit 6.^{3, 7, 30, 31}

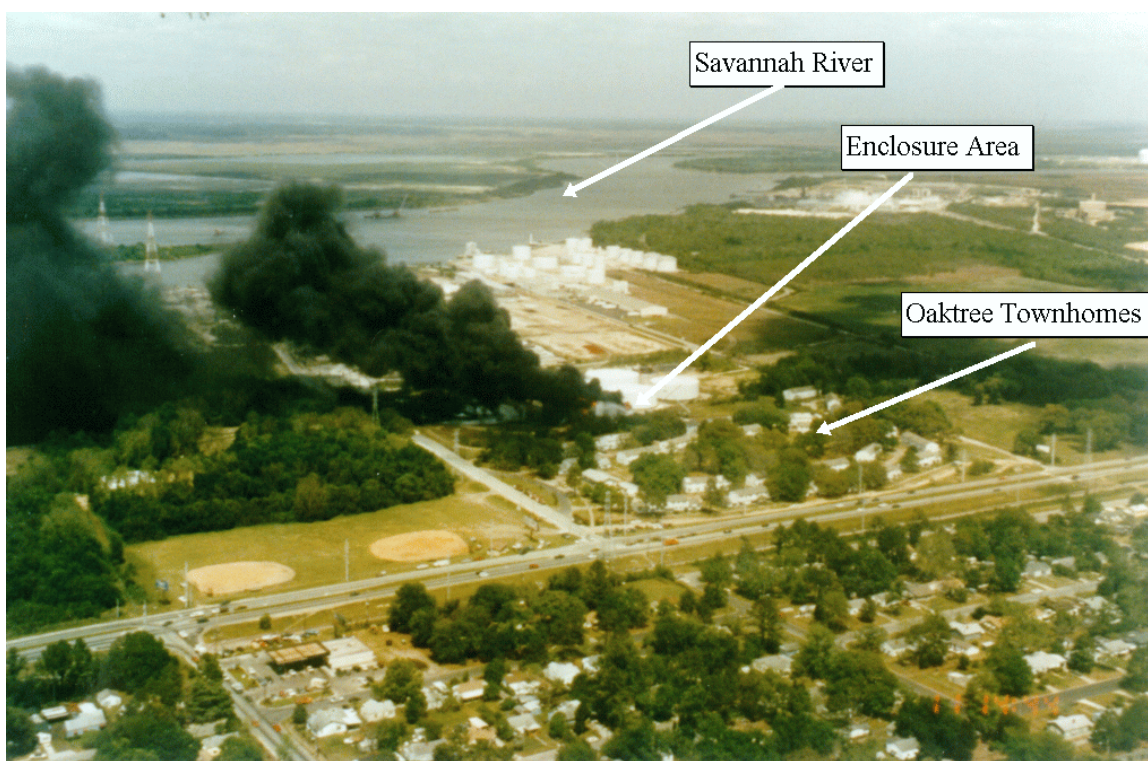
Exhibit 8
Area of Fire and Savannah River ²⁹

River in relation to the fire in the six-tank enclosure area can be seen in the photograph in Exhibit 8. The fire burned on and off for approximately three days before being extinguished late on April 12, 1995.^{3, 30, 31, 32} The three tanks containing CST (18, 22, and 23) were destroyed, and the other three tanks in the six-tank enclosure were damaged. The company's office building, located about 100 yards north of the enclosure, was also destroyed in the fire. Some of the large tanks to the north and east of the enclosure area suffered some degree of radiant heat and smoke damage, but none of them leaked as a result of the damage.⁷ Some of these large tanks are shown in Exhibit 9.

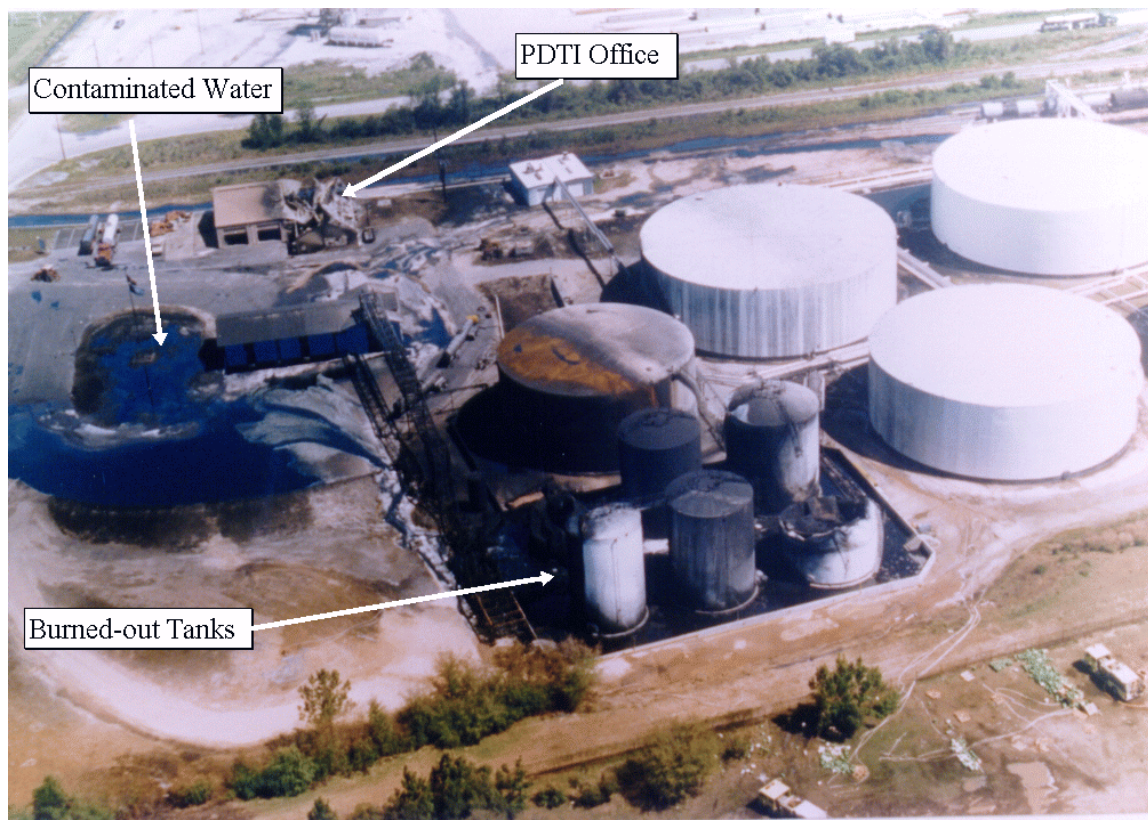
Exhibit 9
Burned-out Tanks and Pool of Contaminated Water ²⁹

The damaged tanks and firefighting effort left approximately 12 million gallons of contaminated water covering an area of about 25 to 40 acres of marsh. The photograph in Exhibit 9 shows the area after the fire was extinguished. A large pool of water that overflowed from the enclosure area can be seen. The contaminated water was determined to be hazardous

because of the high pH and the presence of reactive sulfides that produced hydrogen sulfide. Hydrogen sulfide is toxic, with an Immediately Dangerous to Life and Health (IDLH) level of 100 parts per million (ppm). (IDLH levels are developed for worker protection by the National Institute for Occupational Safety and Health (NIOSH).) Hydrogen sulfide is also flammable, with a flammability range between 4.0 and 44.0 percent. An extensive cleanup of the area was required.⁹

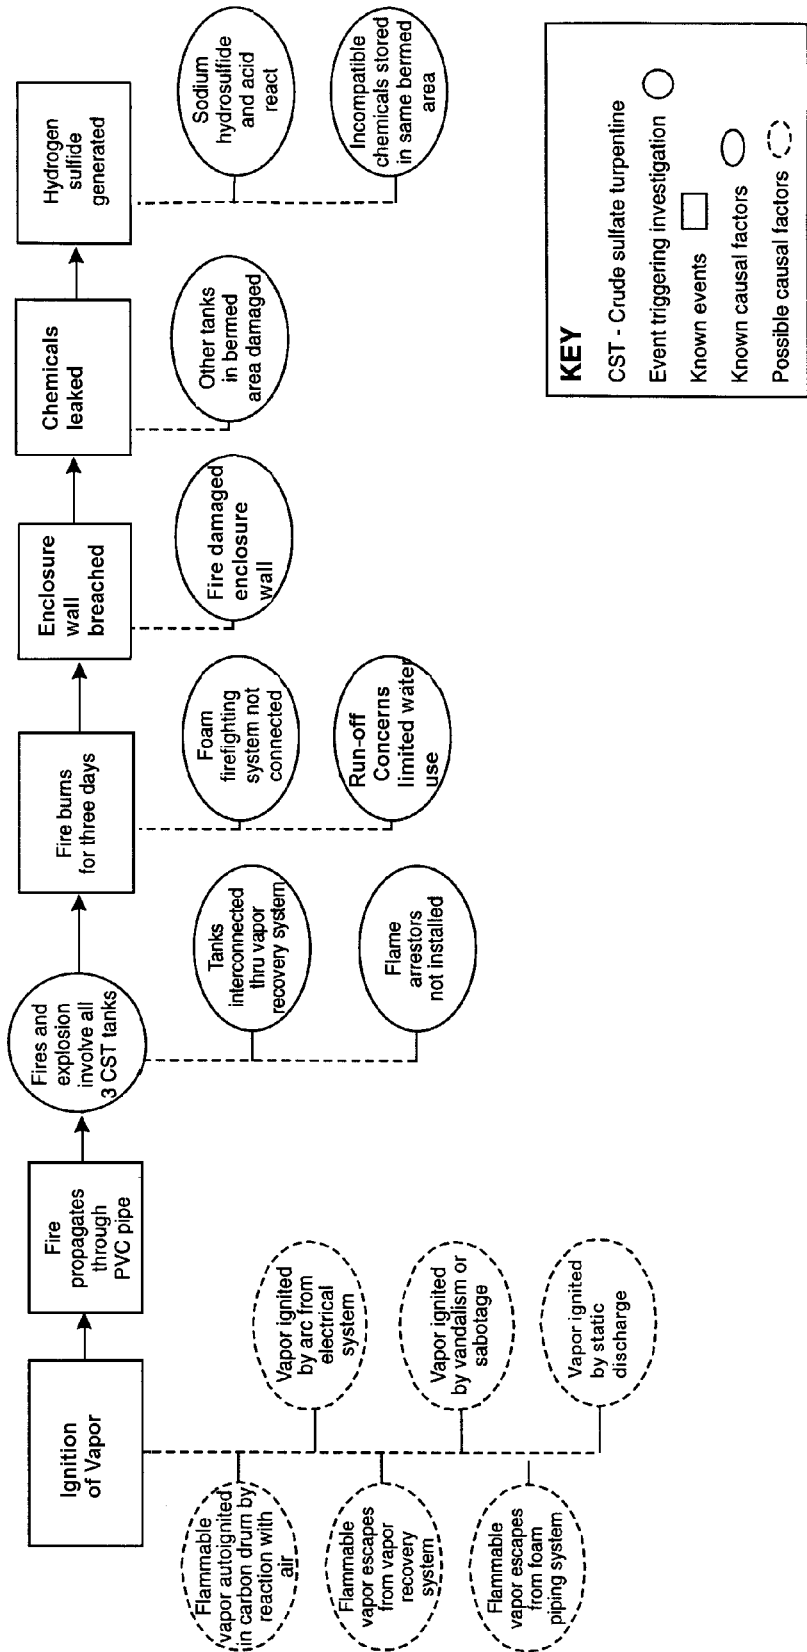
An Event and Causal Factors Diagram for the PDTI accident is presented in Exhibit 10. This diagram presents the sequence of events and causal factors that may have contributed to the occurrence of each of the events. Possible scenarios for immediate cause of the accident, and contributing factors are discussed below. They are included in the Events and Causal Factors Diagram.

- * CST stored for three months.
- * Vapor recovery system, including drums of activated carbon, in place for one month.
- * Fixed foam fire protection system partially installed on day of accident.
- * Seals installed on foamers on day of accident.
