# **EPA CHEMICAL ACCIDENT INVESTIGATION REPORT**

**Pennzoil Product  
Company Refinery  
Rouseville, Pennsylvania**

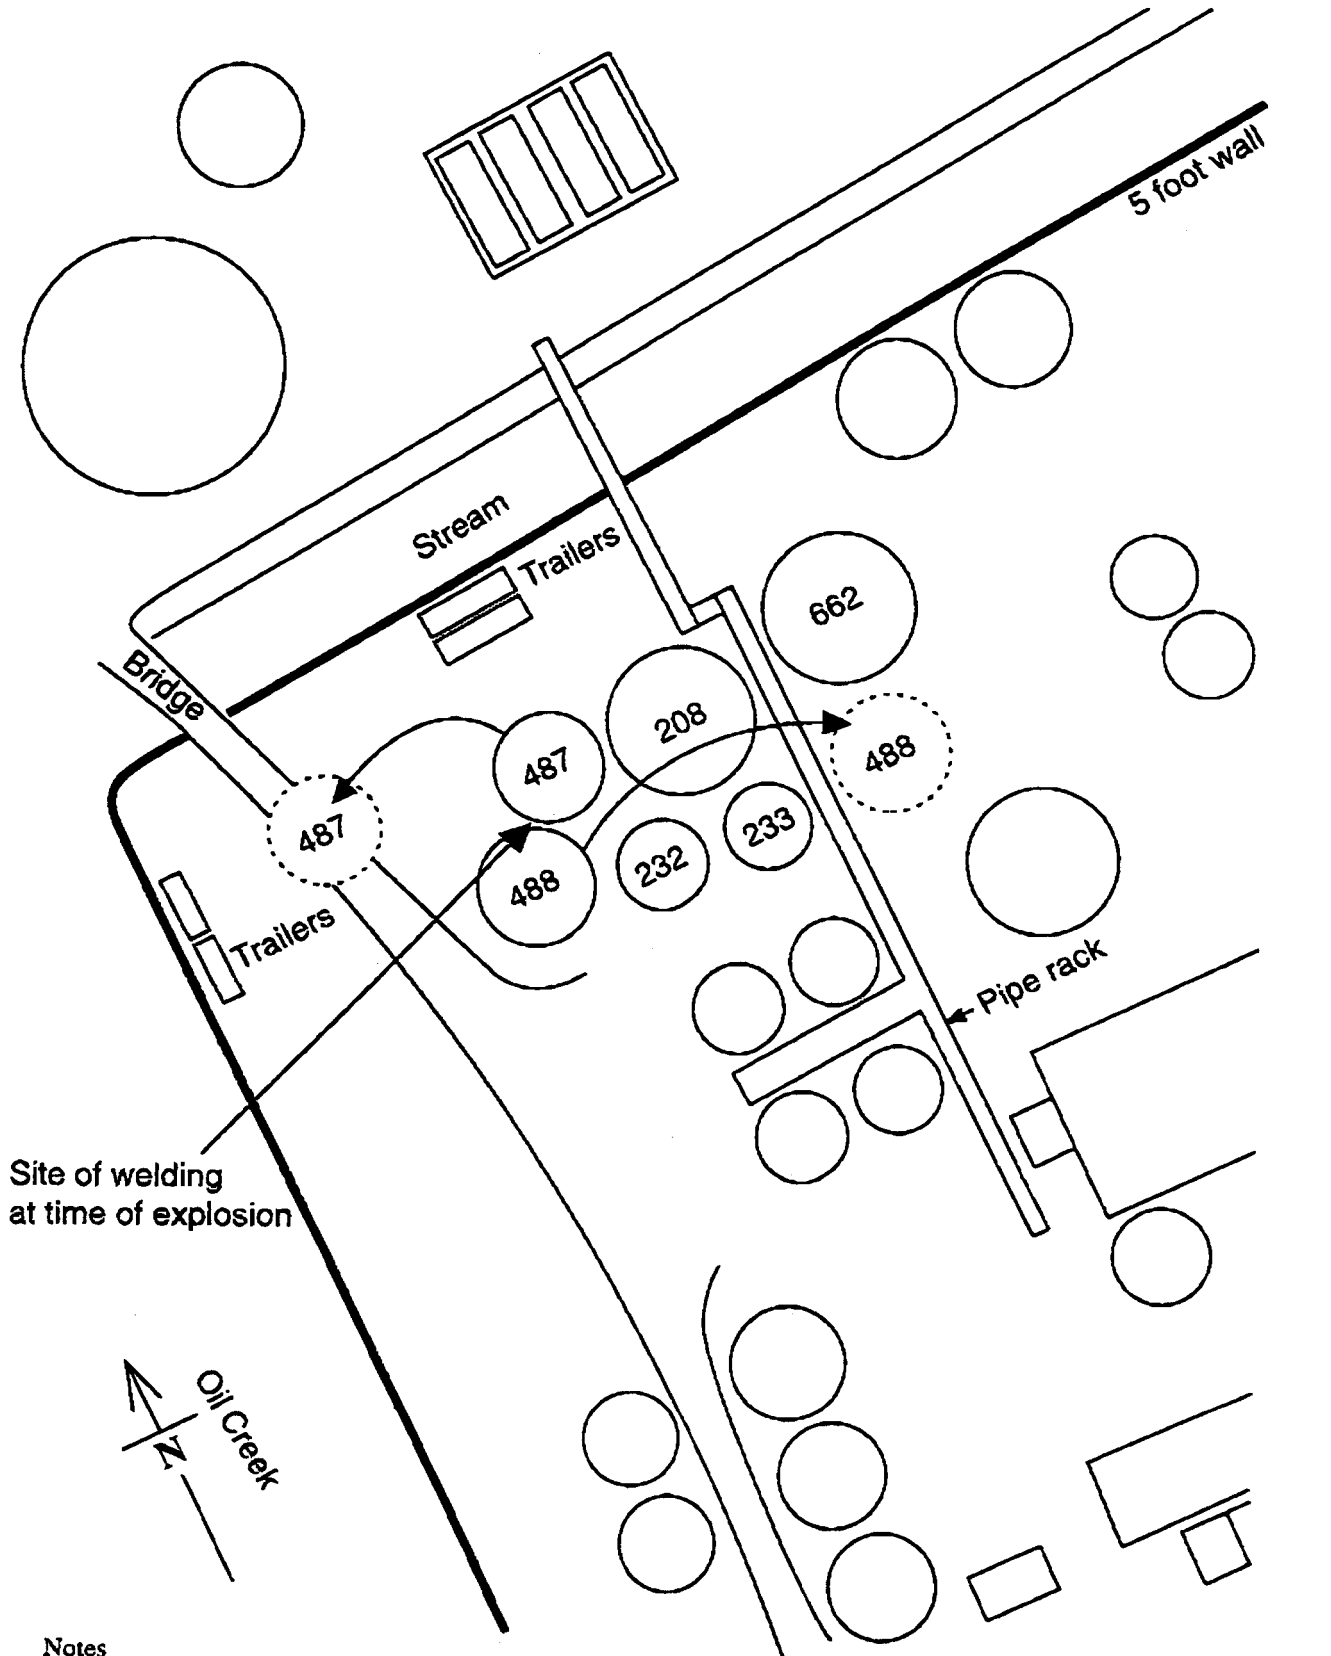
Exhibit 3  
Area of Explosion and Fire at Pennzoil Refinery

Curved lines indicate trajectory of tanks 487 and 488

Tank 208: Naptha; burned in place

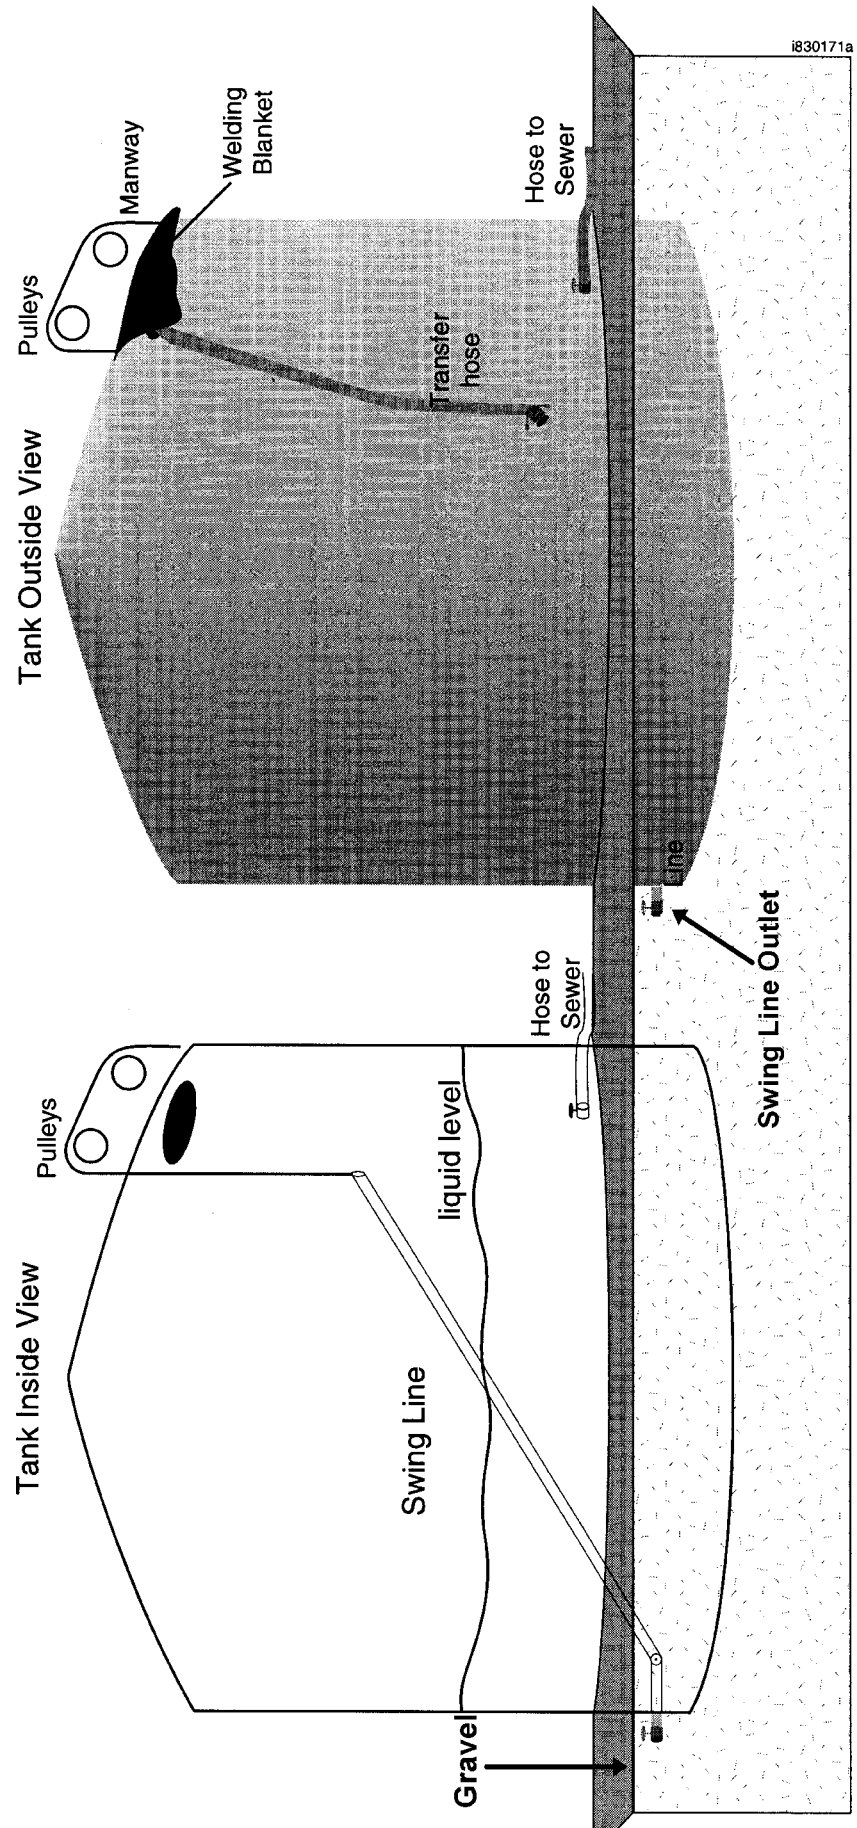
Exhibit 4  
Inside and Outside Views of Tank 487

Tanks 487 and 488, which were similar in size and design, were 30 feet in diameter with 25-foot high sidewalls and five-foot high domes. The tanks, built in 1937, were constructed of steel plates riveted together. The riveted "umbrella" domes were replaced in 1950. The tanks were about four feet apart and shared a common set of stairs leading to the top for employee activities such as gauging the volume of liquid in the tank or inspections. These tanks were not individually diked; i.e., they did not have a secondary containment wall around them. However, they were located in a general tank farm area that had walls and berms to prevent any spilled materials from reaching the Oil Creek.

2. Tanks 487 and 488 failed along their bottom seams, releasing their entire contents. There was evidence of corrosion along the bottom seam. The roofs of these tanks had been replaced since initial construction but the CAIT has no other information about whether these tanks were properly inspected or maintained on a routine basis.

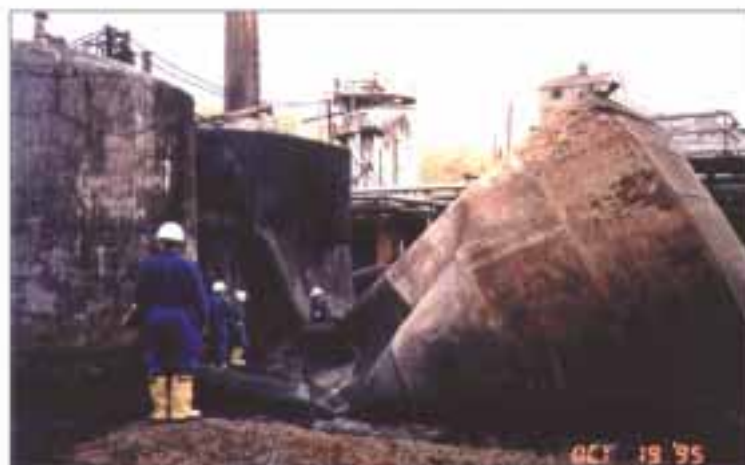
As a result of the explosions, each tank failed catastrophically at the bottom seam where the vertical sidewall of the tank was connected to the bottom horizontal floor plate, lifting the tanks up in opposite directions. Tank 487 lifted off its base and landed about 20 feet to the west. Tank 488 landed about 50 feet to the east after clearing a storage tank and a pipe rack. The burning contents of the tanks, released when the tanks failed, created a wave of burning hydrocarbon that engulfed the entire area.

C. Tank 488, after explosion.

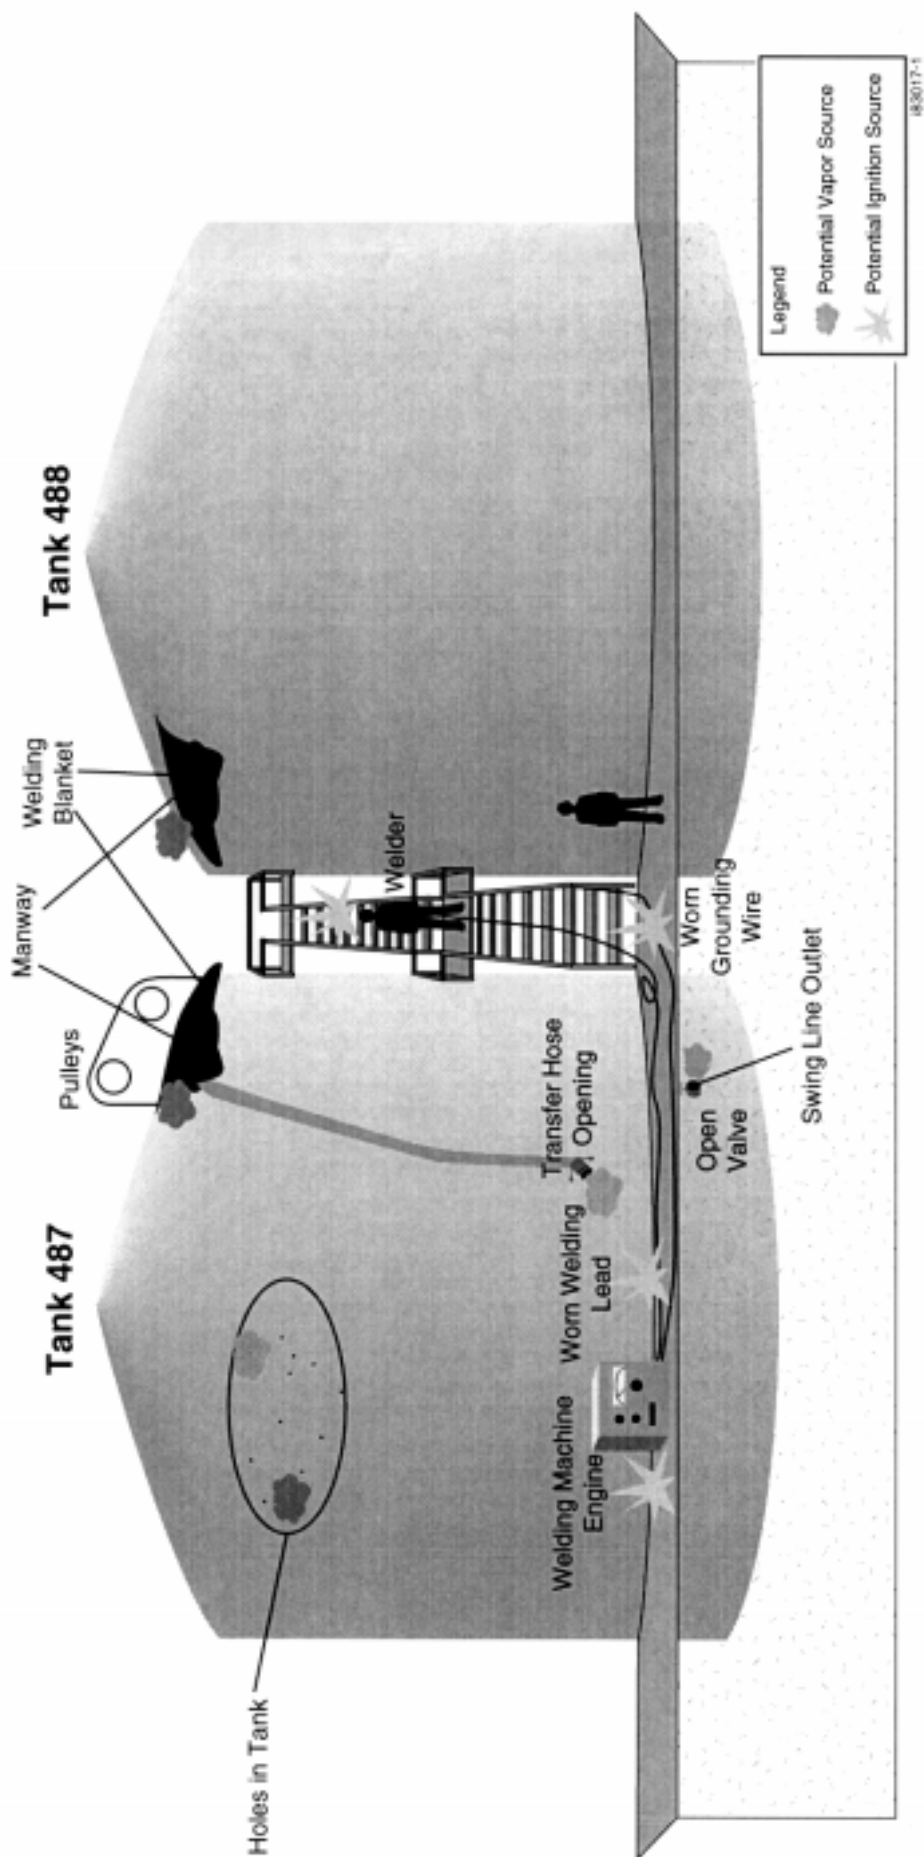
Exhibit 7  
Pennzoil Tank Explosion:  
Potential Vapor and Ignition Sources at Tanks 487 & 488

**Vapor Escaping from Swingline.** The swingline could have provided a route for vapor release (see Exhibit 7). The swingline portion inside the tank was raised above the liquid level in the tank vapor space. Investigators found after the accident that the outside valve near the base of the tank connected to the swingline inside the tank was open. As above, as the tank warmed, if sufficient driving force was present, undiluted heavier-than-air flammable vapors could have been pushed out through the swingline and open valve. If there was little or no wind, these dense vapors could have collected at grade level near ignition sources (see below). After ignition, the flame front could have flashed back through the swingline, igniting vapors in the tank. However, the end fitting on the swingline valve outside the tank was buried under the soil. Further, inspection of the inside of the swingline, after the accident, revealed no evidence of burn or scorch marks.

- The welding rod or sparks from hot slag or spatter possibly could have caused ignition of vapors present, if welding had been started (see Exhibit 7 for employee accounts of the position of the welder). During welding, flux coating the welding rod burns off. The welding rod being used by the welder was found after the accident and inspection revealed that flux on the tip was not burned off; however, there could have been an instantaneous arc, which could have caused ignition, but could have been of such short duration that the flux was not burned off. Or, the welding gun may have been dropped or kicked against the stairway causing an arc. However no evidence was discovered (e.g. arc marks) to support this scenario. Flammable and combustible materials are often ignited during hot work; generally, the material ignited is in the equipment being worked on. It is relatively rare for hot work to ignite a vapor cloud (Lees, 1996).
