# **EPA/OSHA JOINT CHEMICAL ACCIDENT INVESTIGATION REPORT**

**Surpass Chemical Co., Inc.  
Albany, NY**

**Accident Investigation Report**  
**Surpass Chemical Company, Inc., Albany, New York, April 8, 1997**

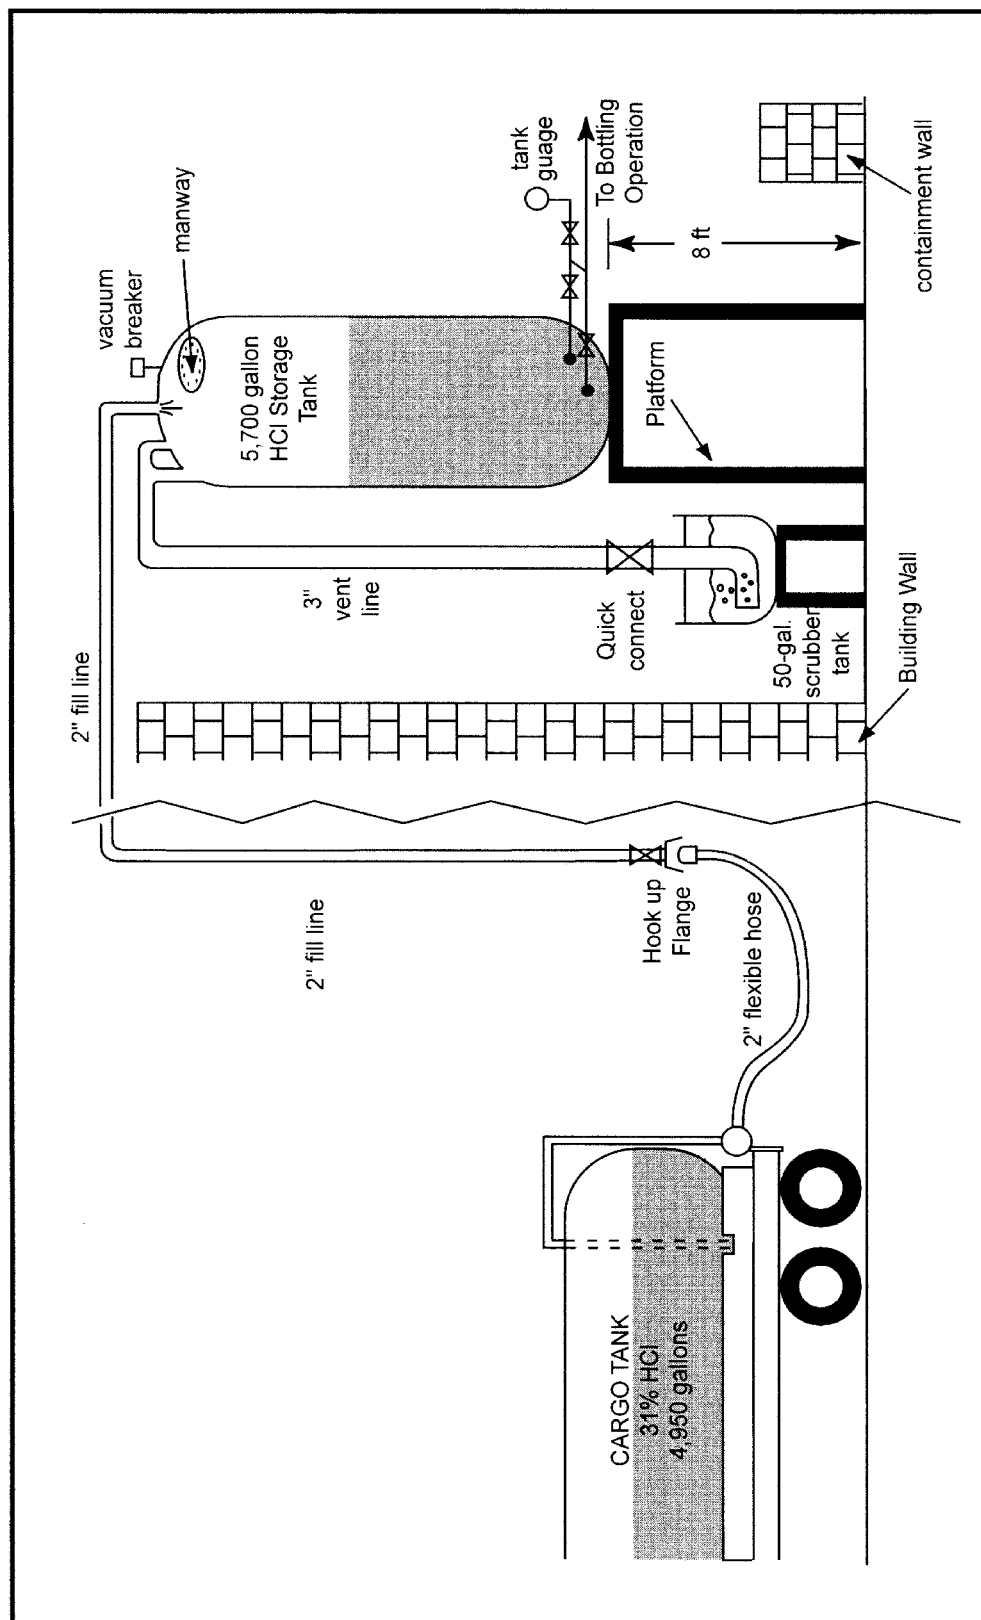
Figure 2: Representation of Offloading Operation  
(not to scale)

The diffuser sat in a 50-gallon, loosely-covered plastic drum referred to as the scrubber tank. (The scrubber system is shown in **Figure 2**.) Initially, the tank was filled with sodium

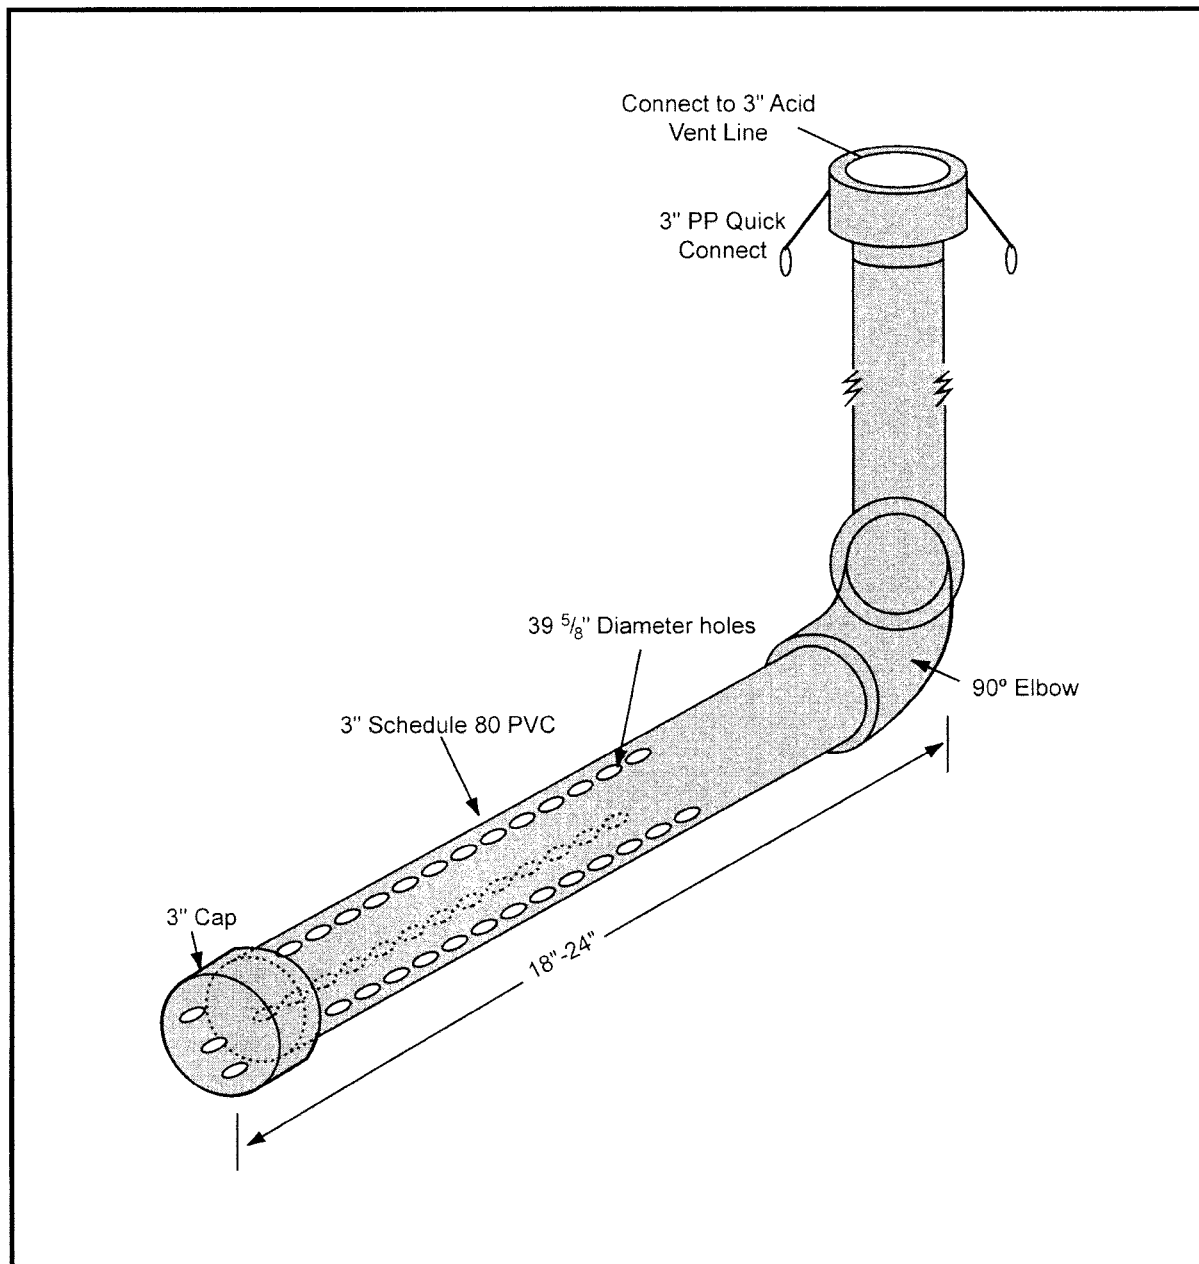
Figure 3: Diffuser Section of Vent System  
(not to scale)

Inadequate maintenance permitted the diffuser section to become clogged with solids, further reducing the scrubber's capacity to vent the pressure buildup in the HCl tank. Surpass had no written procedure for maintaining or inspecting the scrubber system. Maintenance procedures would have been improved by developing detailed procedures for testing and adjusting the scrubber solution--including the frequency of tests, the parameters (pH, specific gravity, etc.) to be measured, and the acceptable range of those parameters. Maintenance results should be documented in order to provide a historical basis for revising the procedures.

***Surpass and other facilities should maintain environmental control systems to ensure continuous reliability and effective operation.*** Based on the system design, the known failure history, and engineering judgement, Surpass and similar facilities should evaluate how long the scrubber solution can be used before it needs to be replaced; develop detailed procedures for inspecting, testing, and adjusting the scrubber solution-- including the frequency of tests, the parameters (pH, specific gravity, etc.) to be measured, and the acceptable range of those parameters; and establish control mechanisms to ensure that preventive maintenance is performed correctly. Maintenance procedures should be written. Maintenance results should be documented in order to provide a historical basis for revising the procedures.

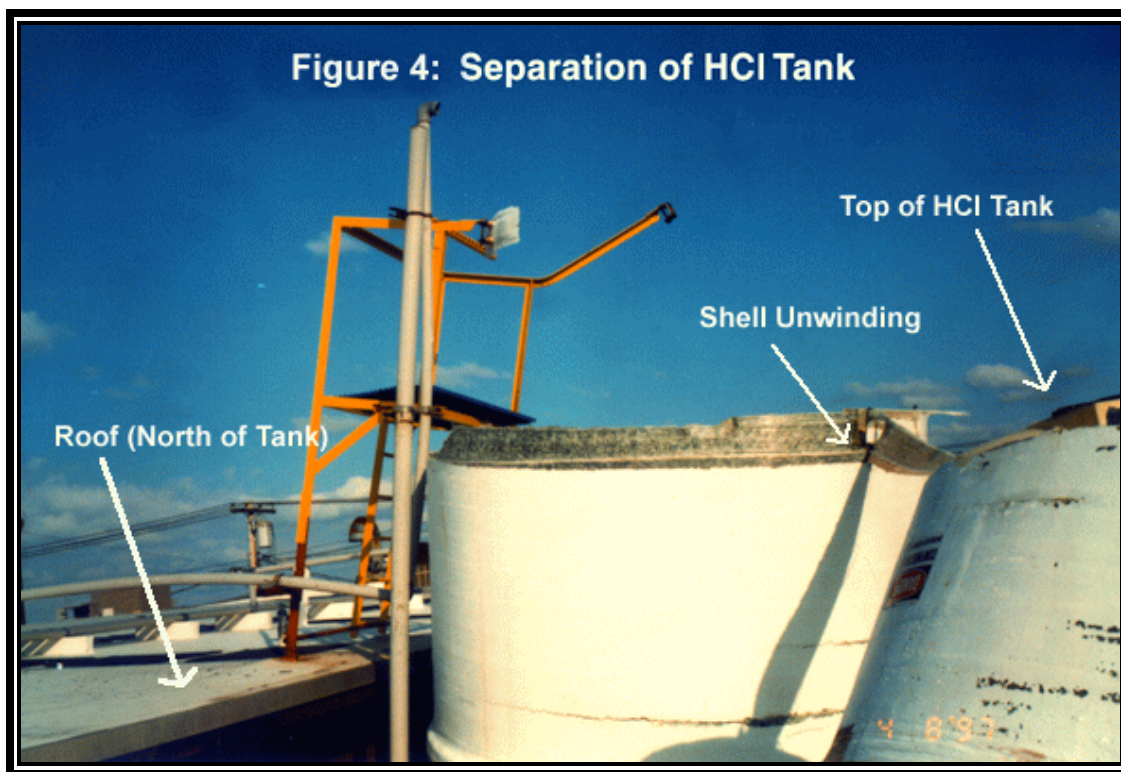
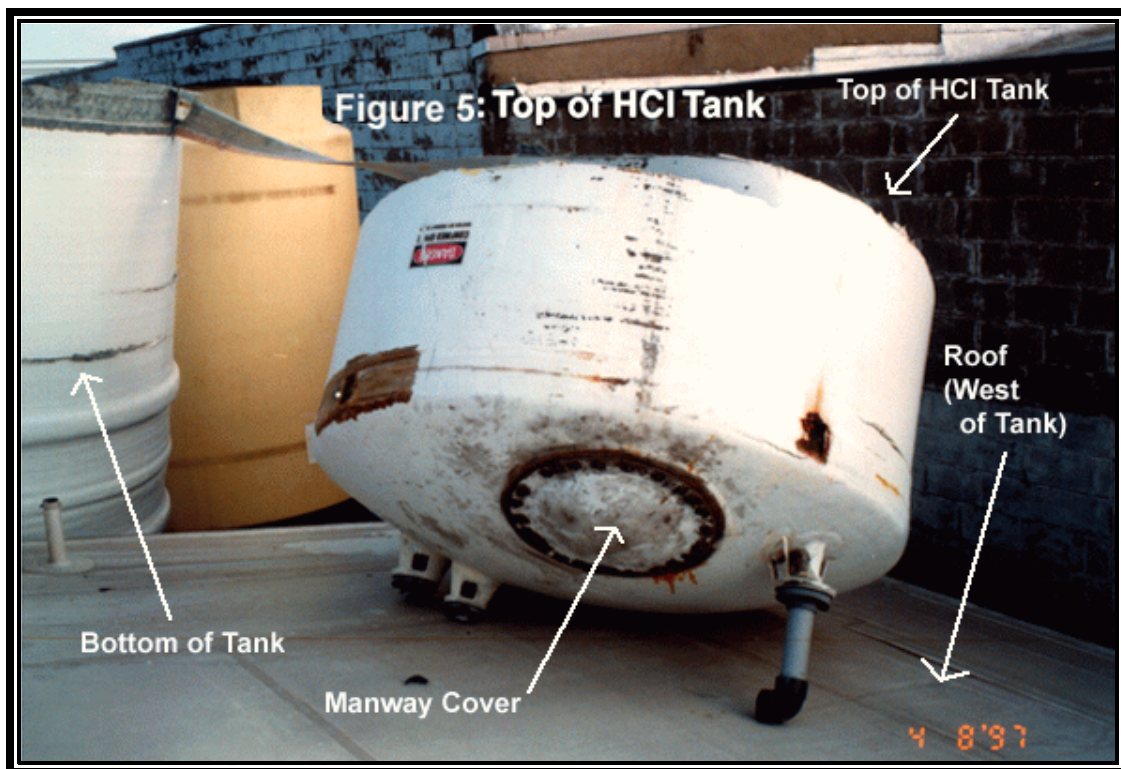
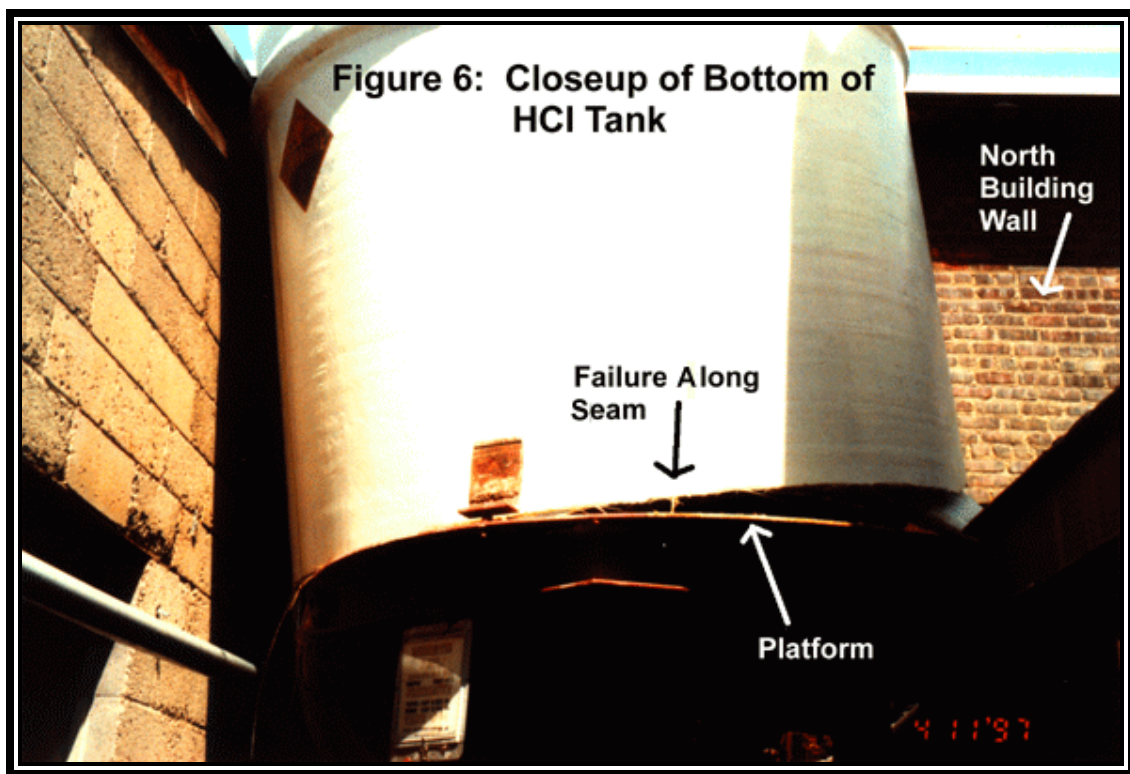
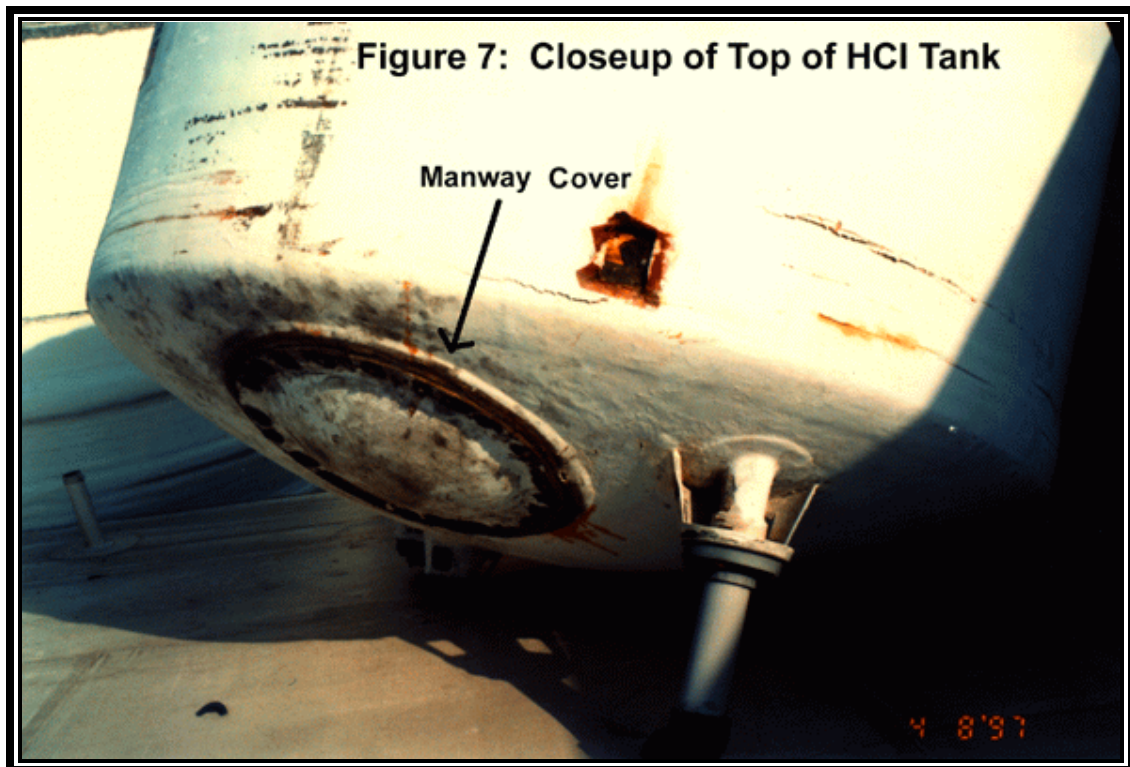
The HCl tank head separated at a point about 5 feet from the top of the tank and flew about 15 feet west to the roof of an adjacent building. **Figure 4** shows the separated tank after the incident, and **Figure 5** shows the top of the tank. The bottom of tank failed in the knuckle area where the cylindrical part of the HCl tank meets the flat bottom, as shown in **Figure 6**. The tank bottom remained on the platform. The cylindrical part of the fiberglass shell began to unwind itself at the top edge (see **Figures 4 and 5**). The shell also remained on the platform but collapsed, leaning toward the west building wall (see **Figure 6**). The scrubber tank was not affected by the tank failure; it was found intact in its original position after the incident, as shown in **Figure 7**.

At the time of rupture, the HCl tank contained about 4,800 gallons of material. The failure of the HCl tank caused a sudden surge of liquid over the secondary containment wall. The force of the liquid also caused a break in the masonry of the secondary containment wall. Surpass has estimated that as a result of this release, about 150 gallons were absorbed by soil within the property boundary and about 2,300 gallons entered storm drains located on Broadway. The storm drains emptied into an underground stream, the Patroon Creek, a tributary of the Hudson River. Surpass also estimated that 1,900 gallons were contained within the secondary containment dike and that 400 gallons entered a nearby building through a window in the north wall and through an exhaust fan in the west wall.

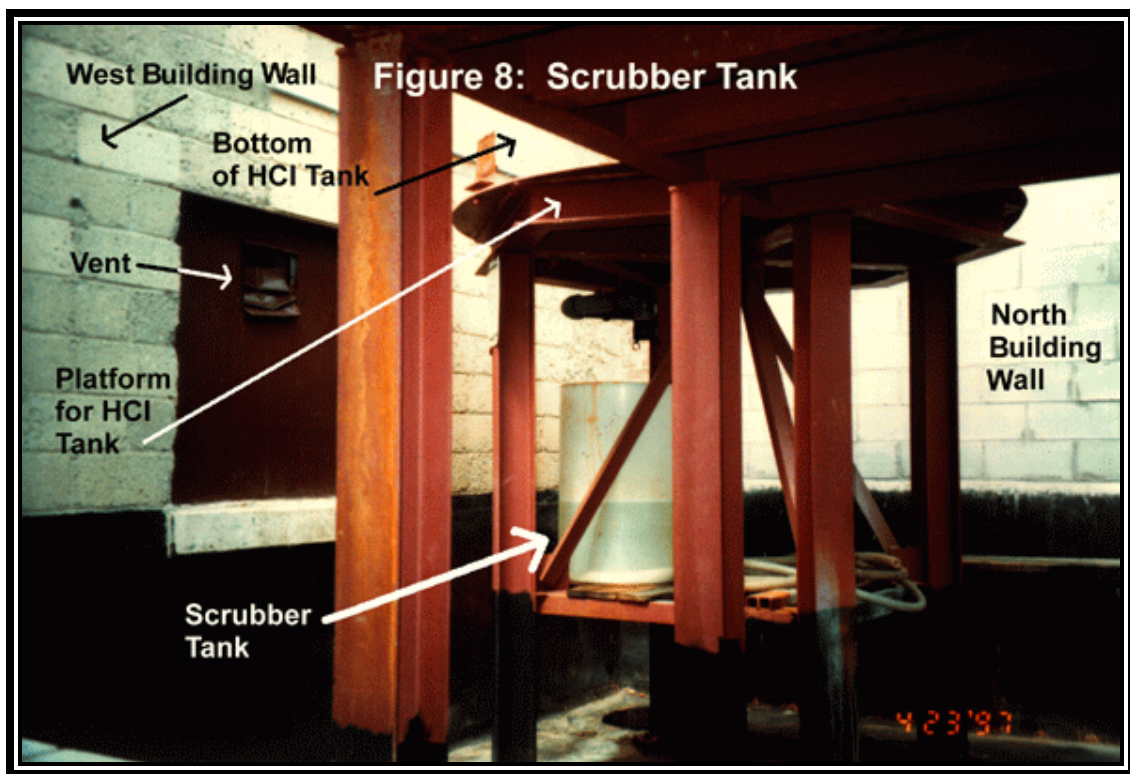
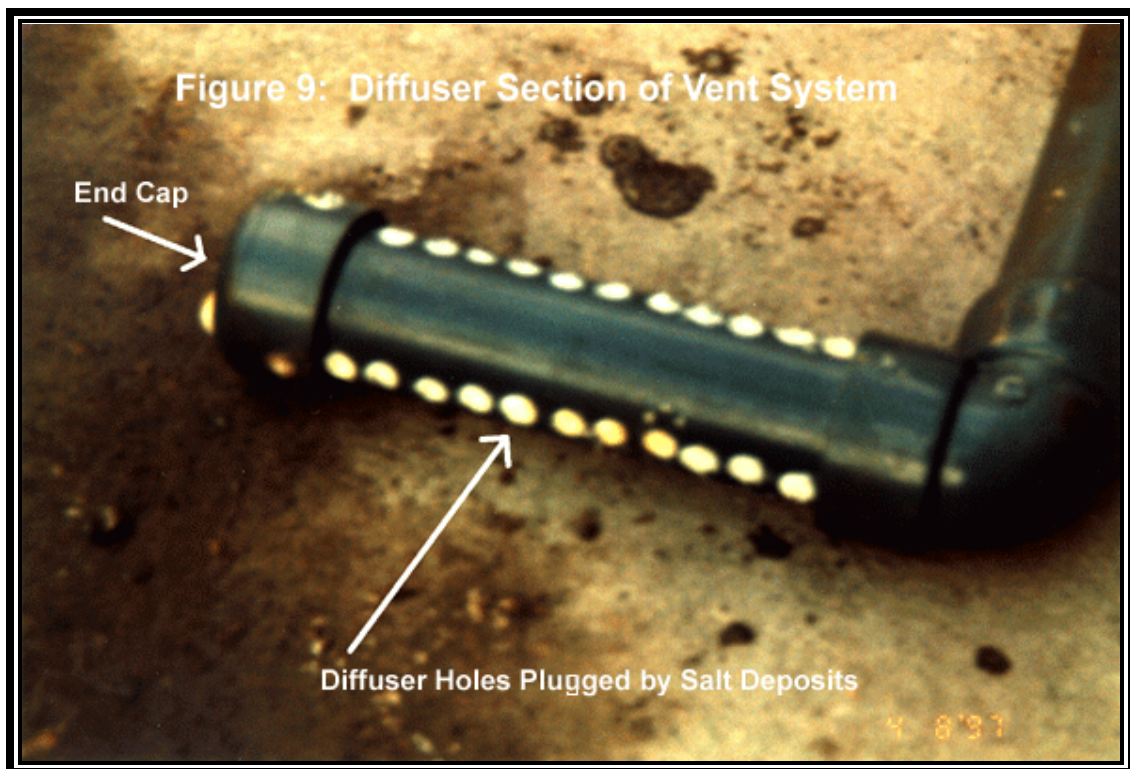
- The HCl tank ruptured into three pieces, as described in Section 3.2.
- The manway on the tank top was sealed shut, and the only way for vapor to escape from the tank was through the vent line. (See **Figure 7**.)

- The scrubber tank was not affected by the tank failure; it was found intact in its original position after the incident. (See **Figure 8**.)
- After the incident, the diffuser in the scrubbing tank was removed by disconnecting the vent line quick connect and removing the lid from the scrubber tank. The holes in the diffuser were found to be clogged with a white crystalline substance, as shown in **Figure 9**. This substance was sodium chloride, according to laboratory analysis.

- A layer of white crystalline material was also found in the bottom of the scrubber tank. This substance also was sodium chloride, according to laboratory analysis.

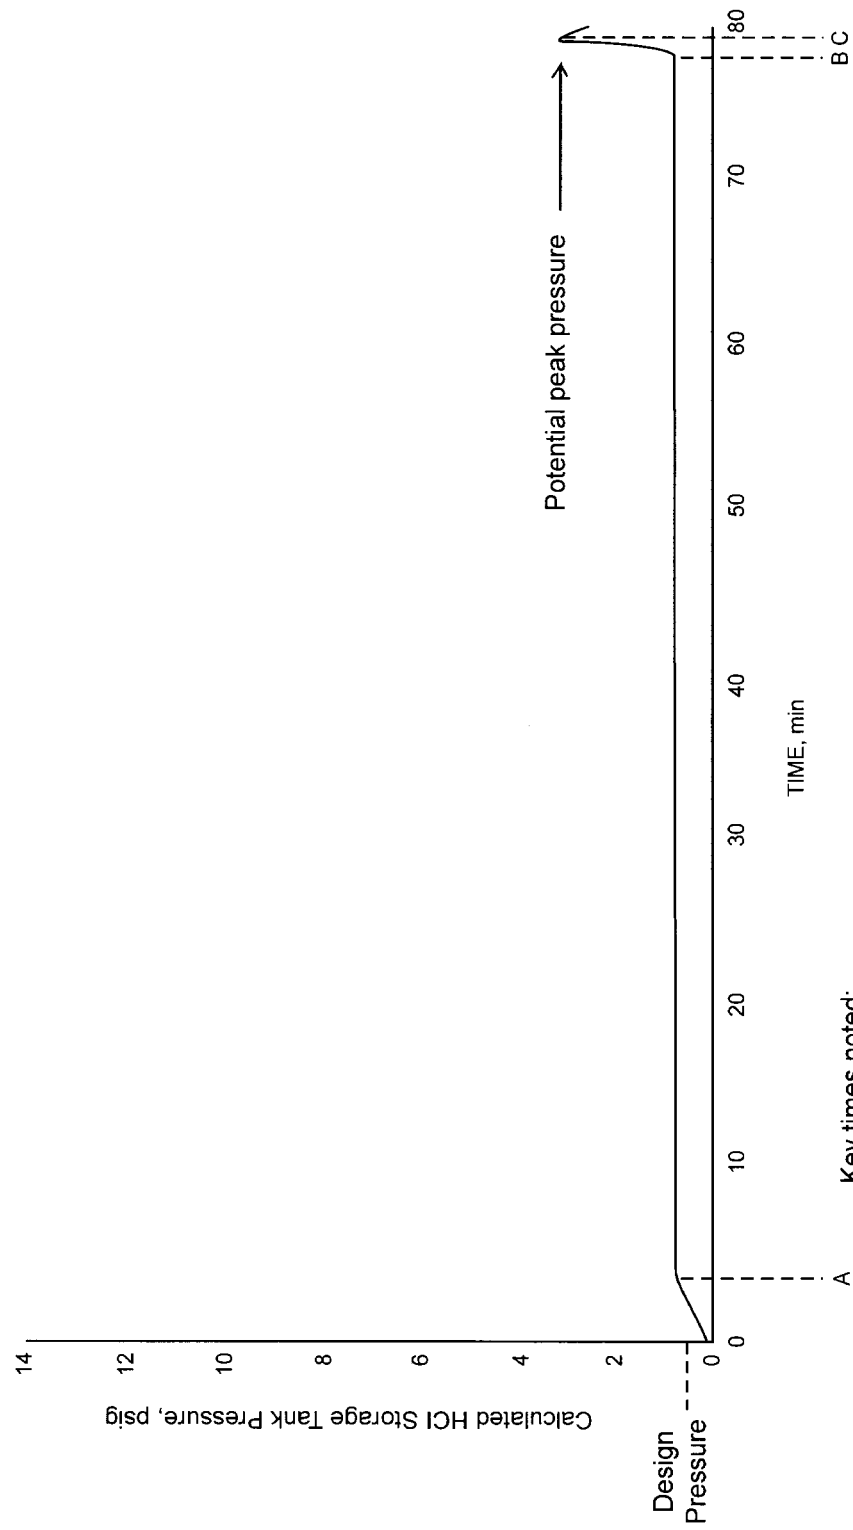
Figure 10  
 Modeled HCl Storage Tank Pressure  
 Scenario: No Fouling of Diffuser Openings

A - HCl storage tank pressure exceeds hydrostatic pressure of solution in scrubber tank.

C - Potential peak pressure as modeled for scenario.

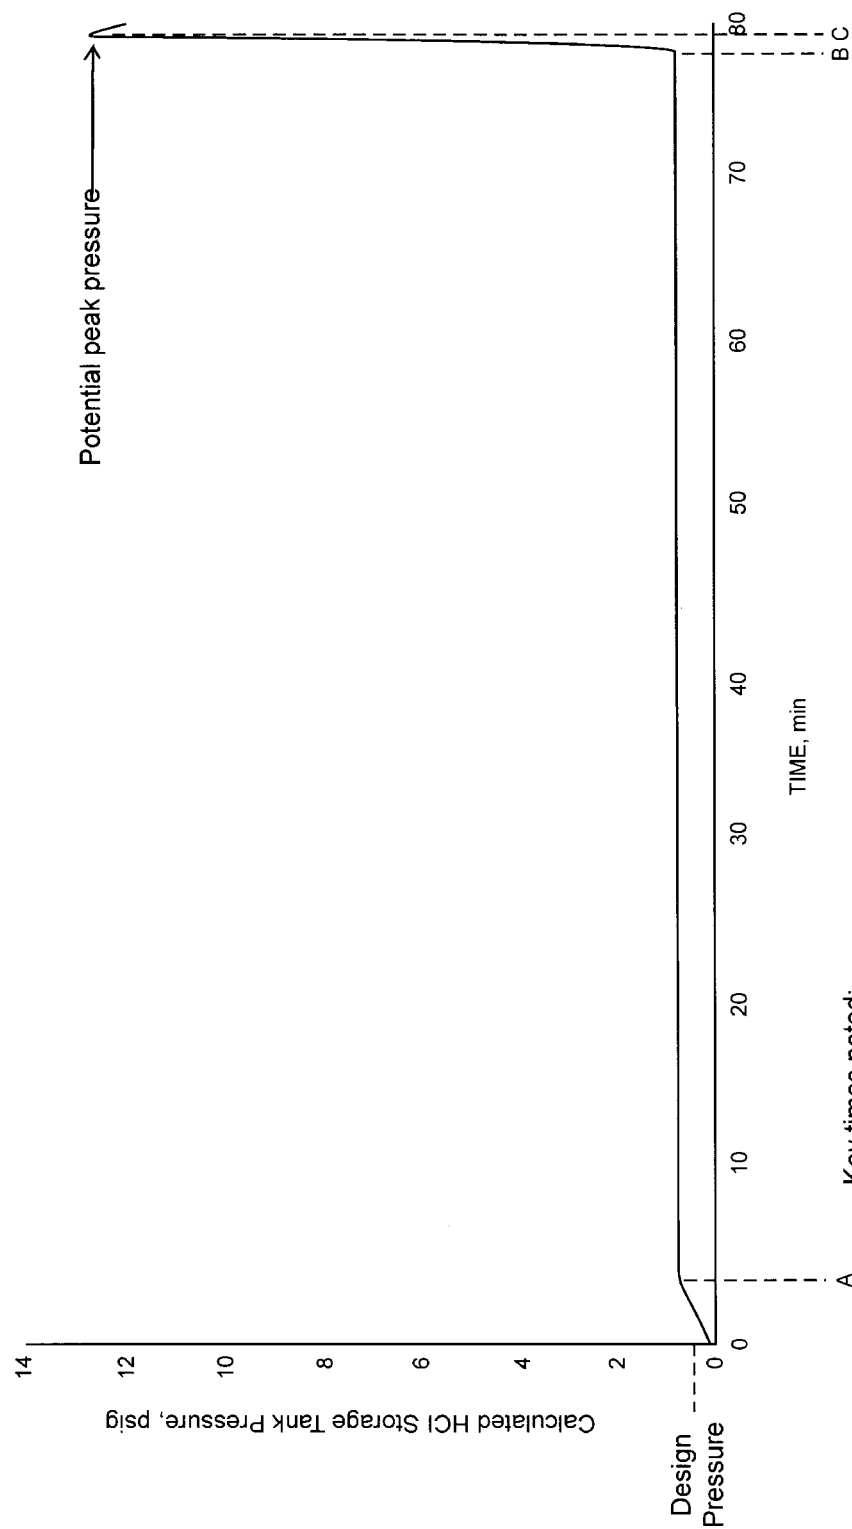
Figure 11  
 Modeled HCl Storage Tank Pressure  
 Scenario: 84% Fouling of Diffuser Openings

Key times noted:  
 A - HCl storage tank pressure exceeds hydrostatic pressure of solution in scrubber tank.  
 B - Pressurized air from truck's cargo tank flows into HCl tank.  
 C - Potential peak pressure as modeled for scenario.
