**Worker Injured During
Fireworks Explosion
Date of Incident: 99 06 30
Type of Incident: Fatal**

SUMMARY

1.1 373899

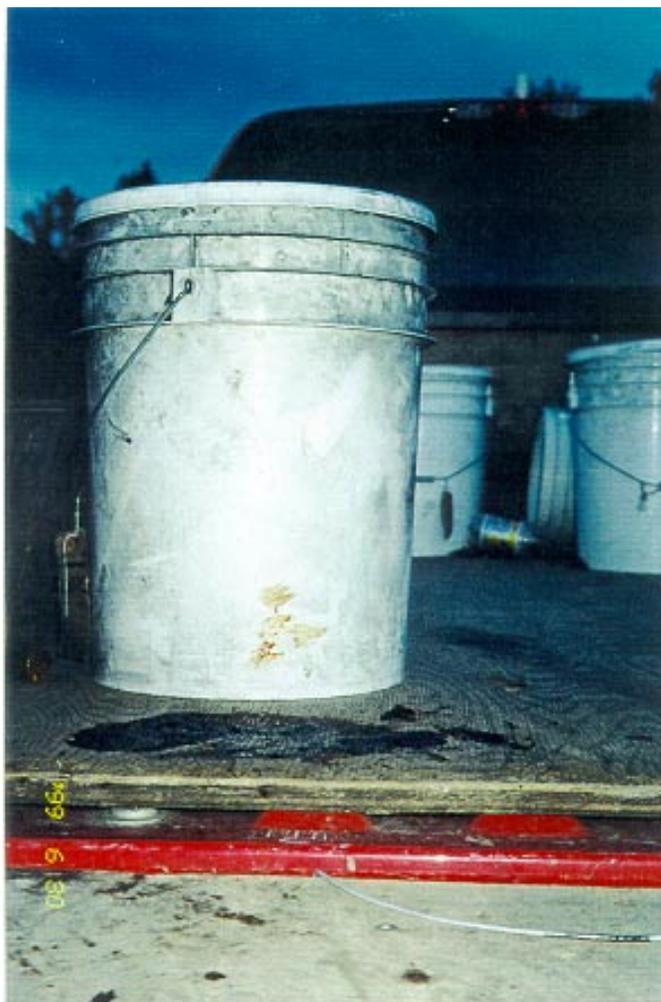
Photograph #1

- 10.5 In the pick-up truck box, were four white, plastic, five gallon (19L) pails. Two were empty, one full and one half-full. The contents of the full and half-full pails consisted of unspecified mixtures of explosive materials (a pyrotechnic mixture) used in the manufacturing of firework products. (See Attachment A-1)

View of the contents inside the worker's company truck. The Pictured four white plastic pails contained the explosive waste materials. Two were empty (emptied during the prior burns) and two still contained explosive waste material.

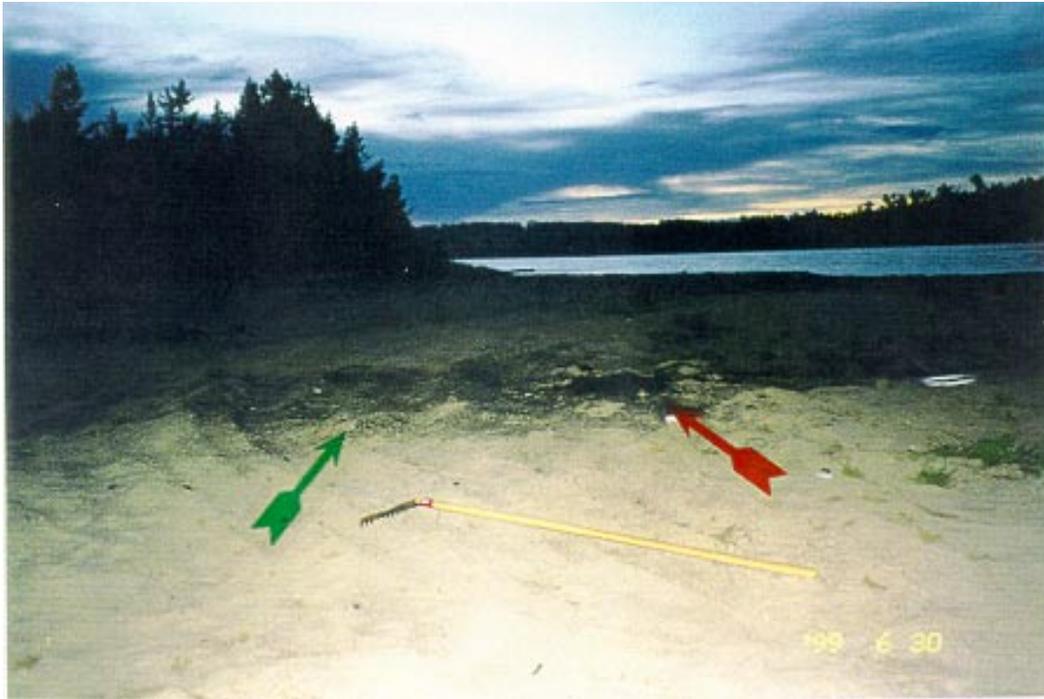
Photograph #2

- 10.7 Approximately 20m north, behind the truck, was a blackened area believed to be the "blast/explosion" site. (See Attachment A-2)
- 10.7.1 There were some other blackened sites in the sand that represented prior burn areas. Conditions of the burn sites suggest they were a result of burns from days prior to the day of the incident (they appeared to be lighter in colour). (See Attachment A-2)

- 12.10.2.2 Site conditions suggest that all burn piles were done on the same spot, or on different spots within a few metres of each other in a pre-determined rotation. It was most likely that the worker used the same spot for each burn and the other burn piles would represent burns from the previous weeks. (See 10.6.1 and Attachment A-2)

View of where the explosion occurred. The red arrow [centre, right] points to a darker burn site. The spot where the explosion occurred. The green arrow [centre, left] points to a number of lighter burn sites believed to be a result of past burns.

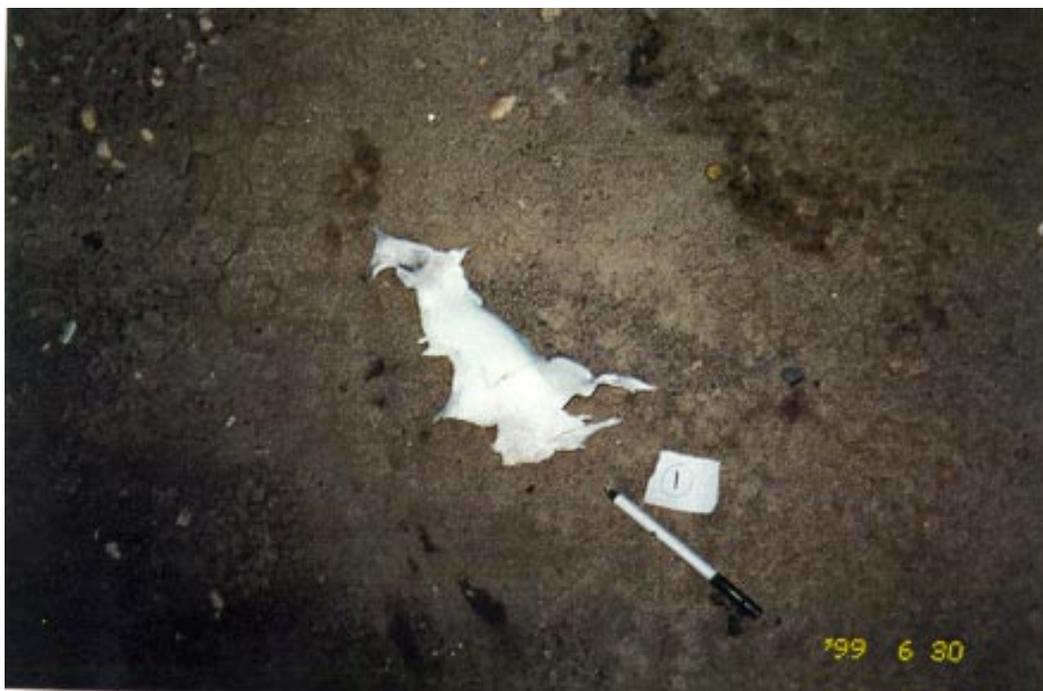
Photograph #3

- 10.8 From the blast location, plastic shrapnel from the exploded pail was observed to be strewn in numerous locations in every direction. Parts of the pail were observed directly on the blast site (a fragment from the bottom of the pail), and also away from the actual blast site at approximately 5m between the truck and the blast site, approximately 20m at the river's edge, and approximately 50m in the west wooded area. (See Attachment A-3)

An example picture of a piece of the five gallon plastic pail that was involved in the explosion.

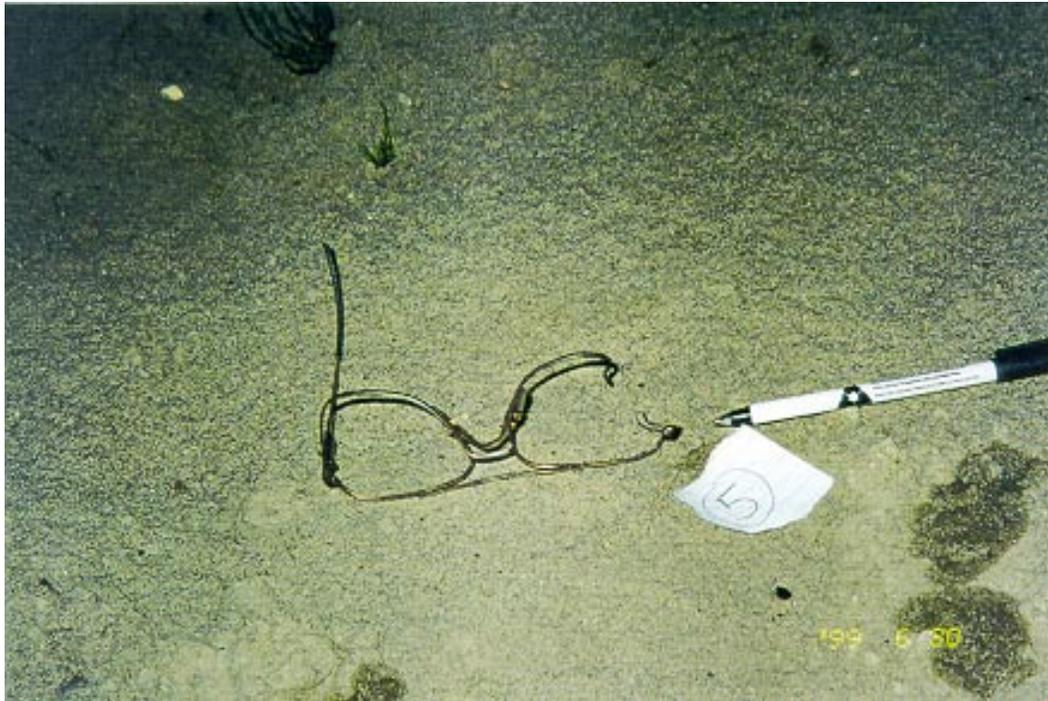
Photograph #4

- Paper Products: Used as casings for the explosive mixtures.
- 10.9 The severity of the explosion was also demonstrated by the worker's destroyed prescription eyewear found approximately 8.5m west of the blast site, and a blue baseball cap in two pieces (the brim portion found approximately 11.5m west of the blast and the cap portion found approximately 14m northwest of the blast area). (See Attachments A-4, A-5 and A-6)

The worker's prescription glasses the worker wore at the time of the explosion. The destruction of the glasses was a result of the explosion. (See Sketch – Attachment "B")

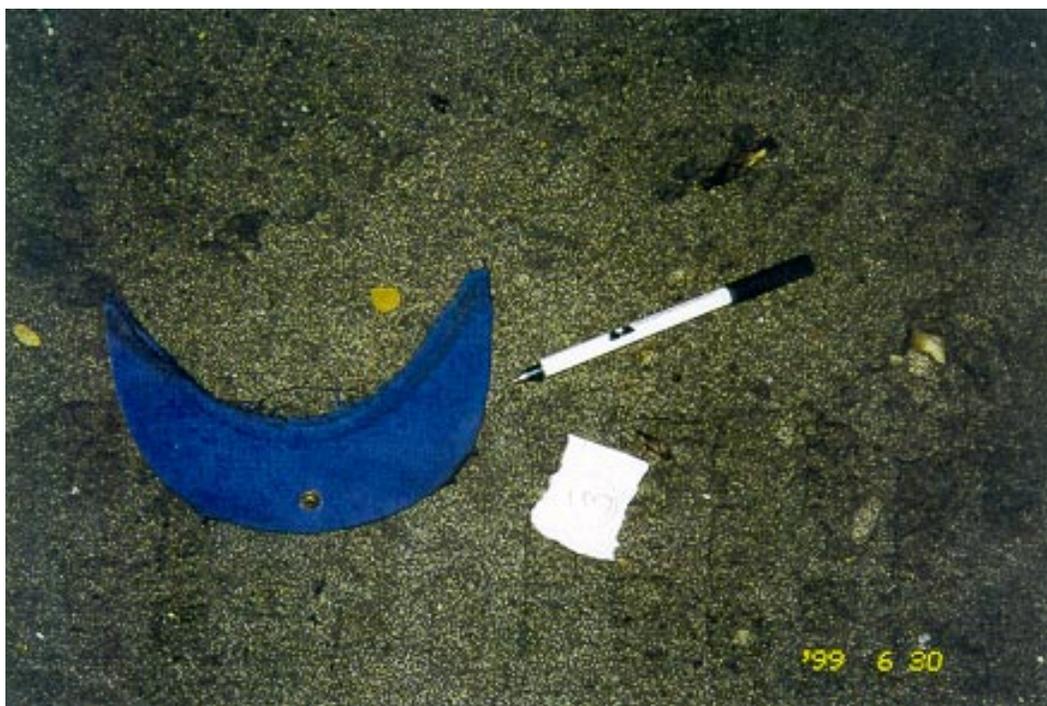
Photograph #5

The worker's brim portion of his blue baseball cap. The baseball cap was torn into two pieces as a result of the explosion. (See Sketch – Attachment "B").

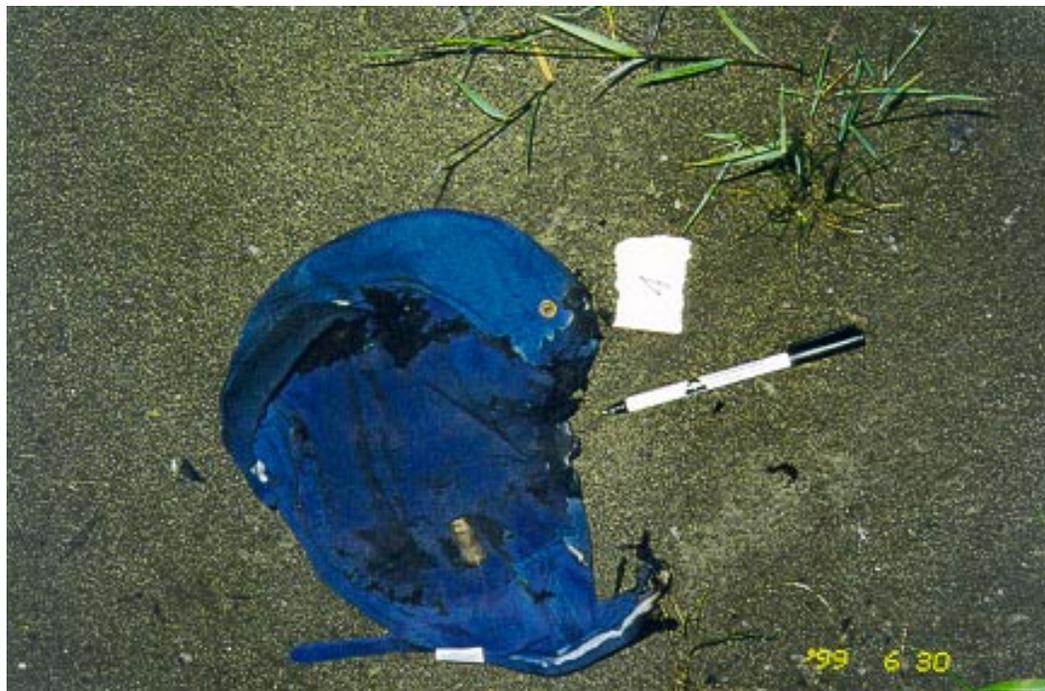
Picture #6

The worker's cap portion of his blue baseball cap. The baseball cap was torn in two as a result of the explosion. (See Sketch – Attachment "B").
Note: inside the cap is firework component called a mach.

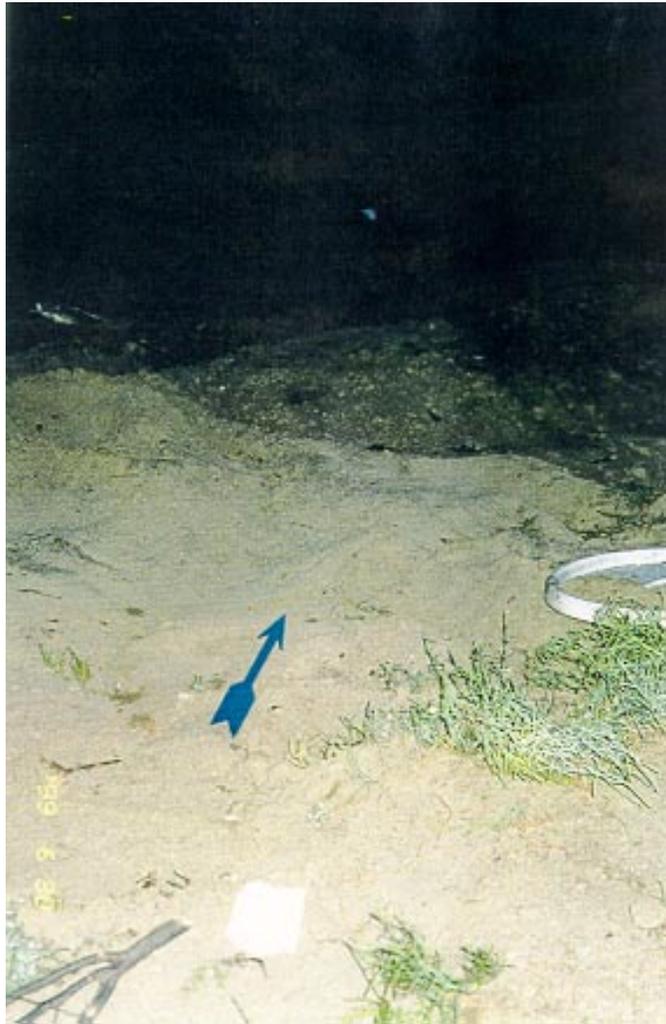
Photograph #7

The blue arrow (centre) points to the imprint in the sand left by the worker after the explosion occurred.

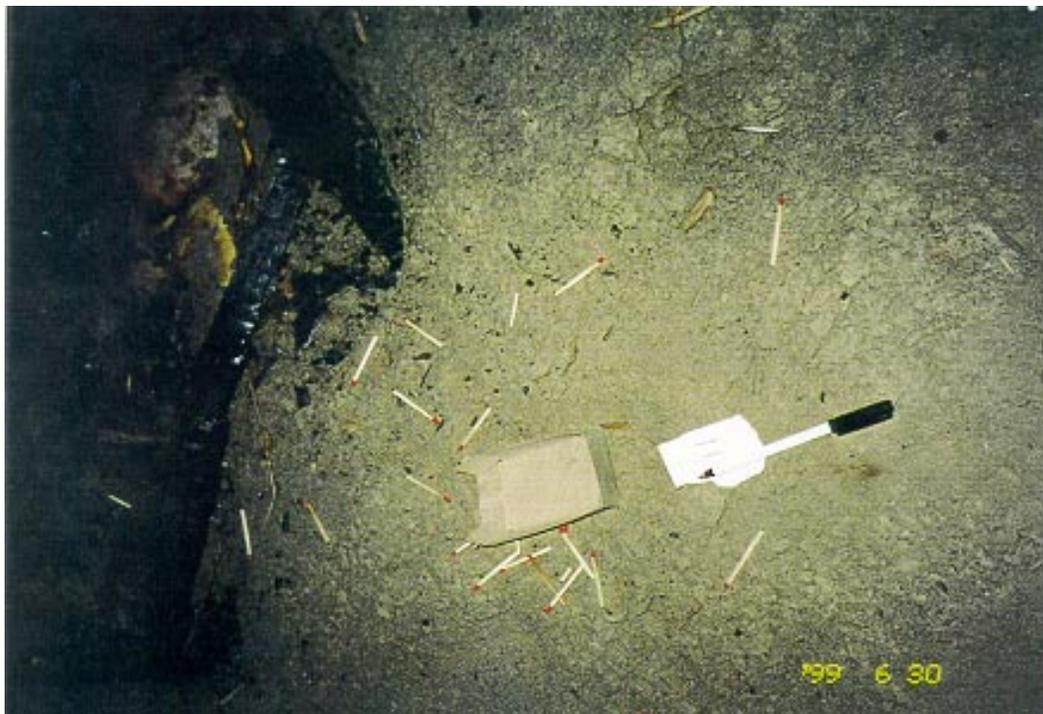
Photograph #8

- The site specific procedures itemized matches to be used. The use of matches is inherently dangerous and is not recommended. National Resource Canada's pamphlet states no matches are to be used.

Wooden matches the worker would have used to ignite the fuse.
As a result of the explosion, the matches were scattered outside and
around their container.

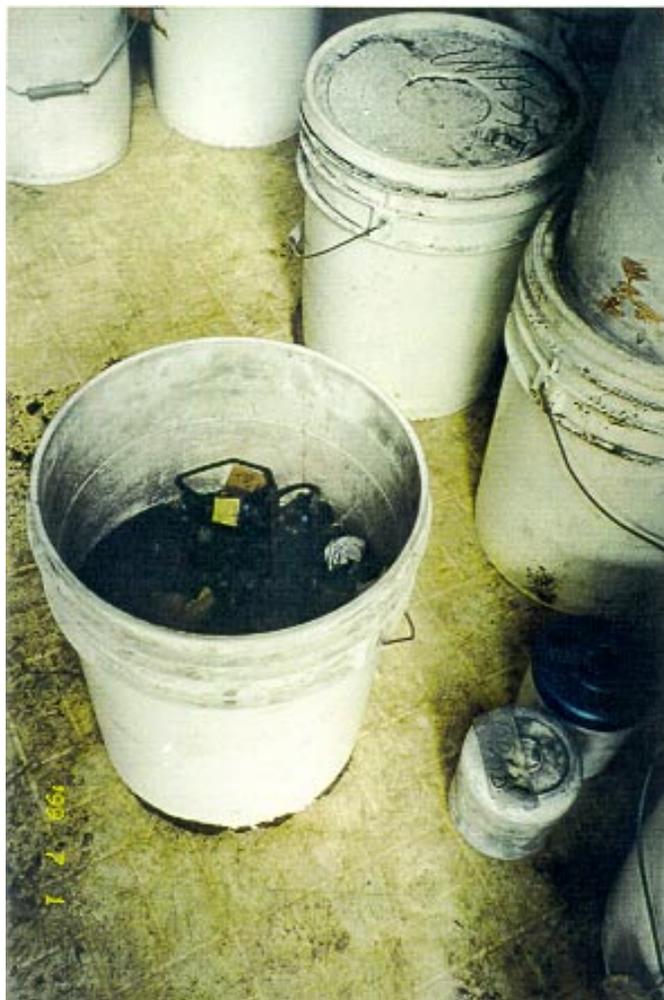
Photograph #9

An example of the various explosive waste materials contained in one of the two containers at the incident scene.

Note: compare A-9 to A-10

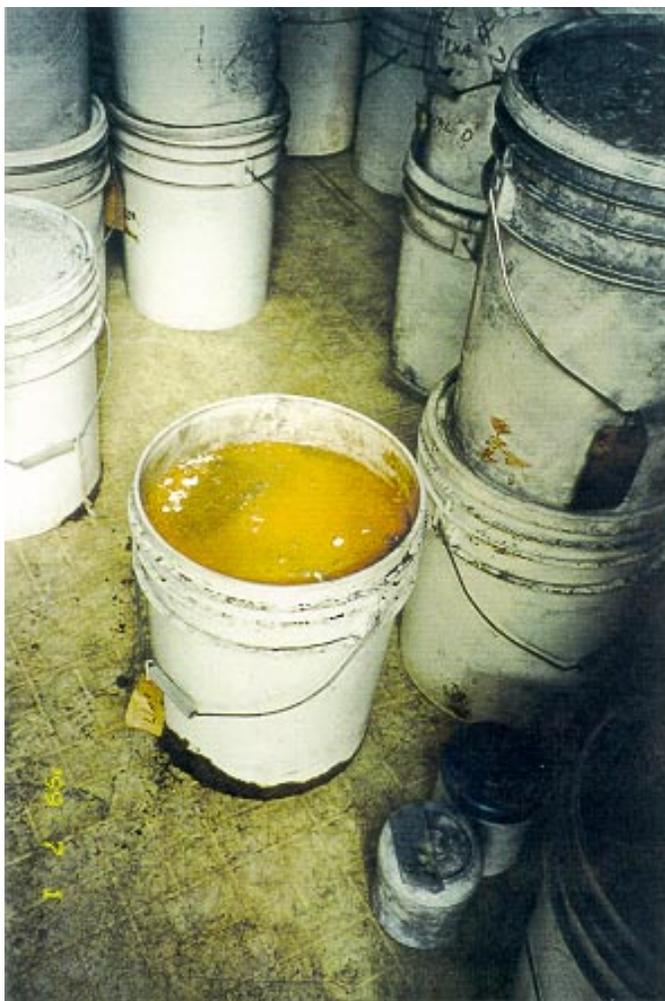
Photograph #10

An example of the various explosive waste materials contained in one of the two containers at the incident scene.

Note: compare A-10 to A-9

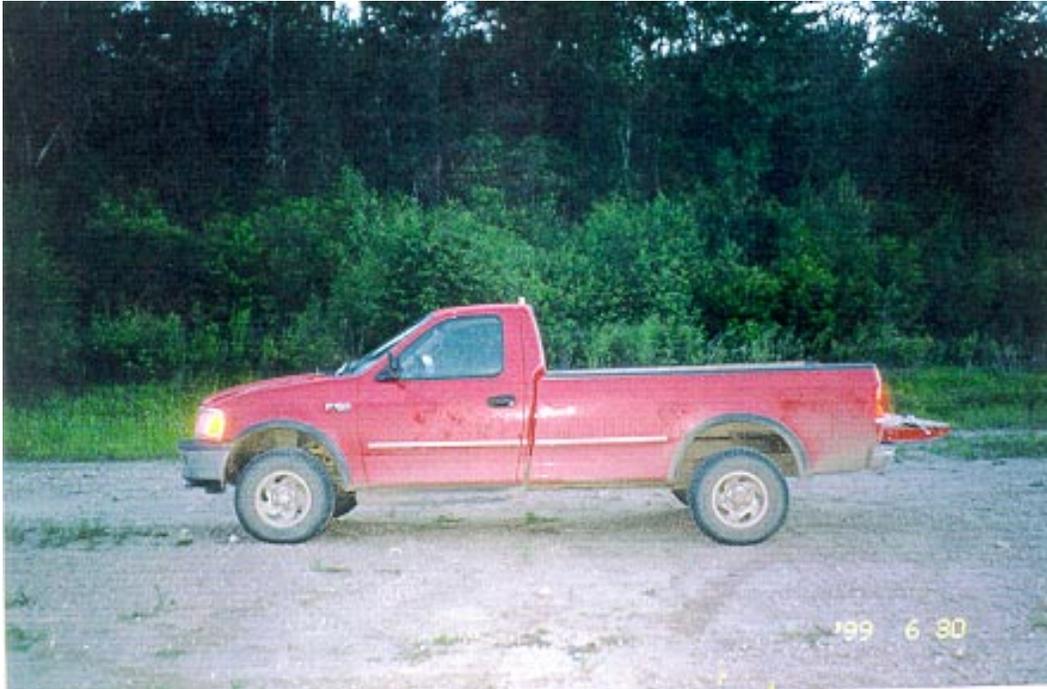
Photograph #11

- 12.13 At some point after the explosion the worker got up and struggled to get assistance/help.
- 12.13.1 It appeared the worker travelled to the pick up truck and attempted to access the unlocked cab. After some failed attempts to enter the truck, the worker travelled 850m up the road where he later collapsed. (See Attachment A-11)
- 12.14 At approximately 15:30 the RCMP received a call from a member of the public that a body was found approximately seven kilometres east on township road 494.
- 12.15 RCMP and Ambulance arrived on the scene. The worker was pronounced dead at the scene and removed from the location.
- 12.16 At approximately 17:30 the worker's manager was notified that a workplace fatality had occurred.

The employer's pick up truck still parked at the scene of the incident.
The vehicle was used to transport the material to the incident scene.

Note: obvious signs of the worker's attempts to access the cab of the truck.

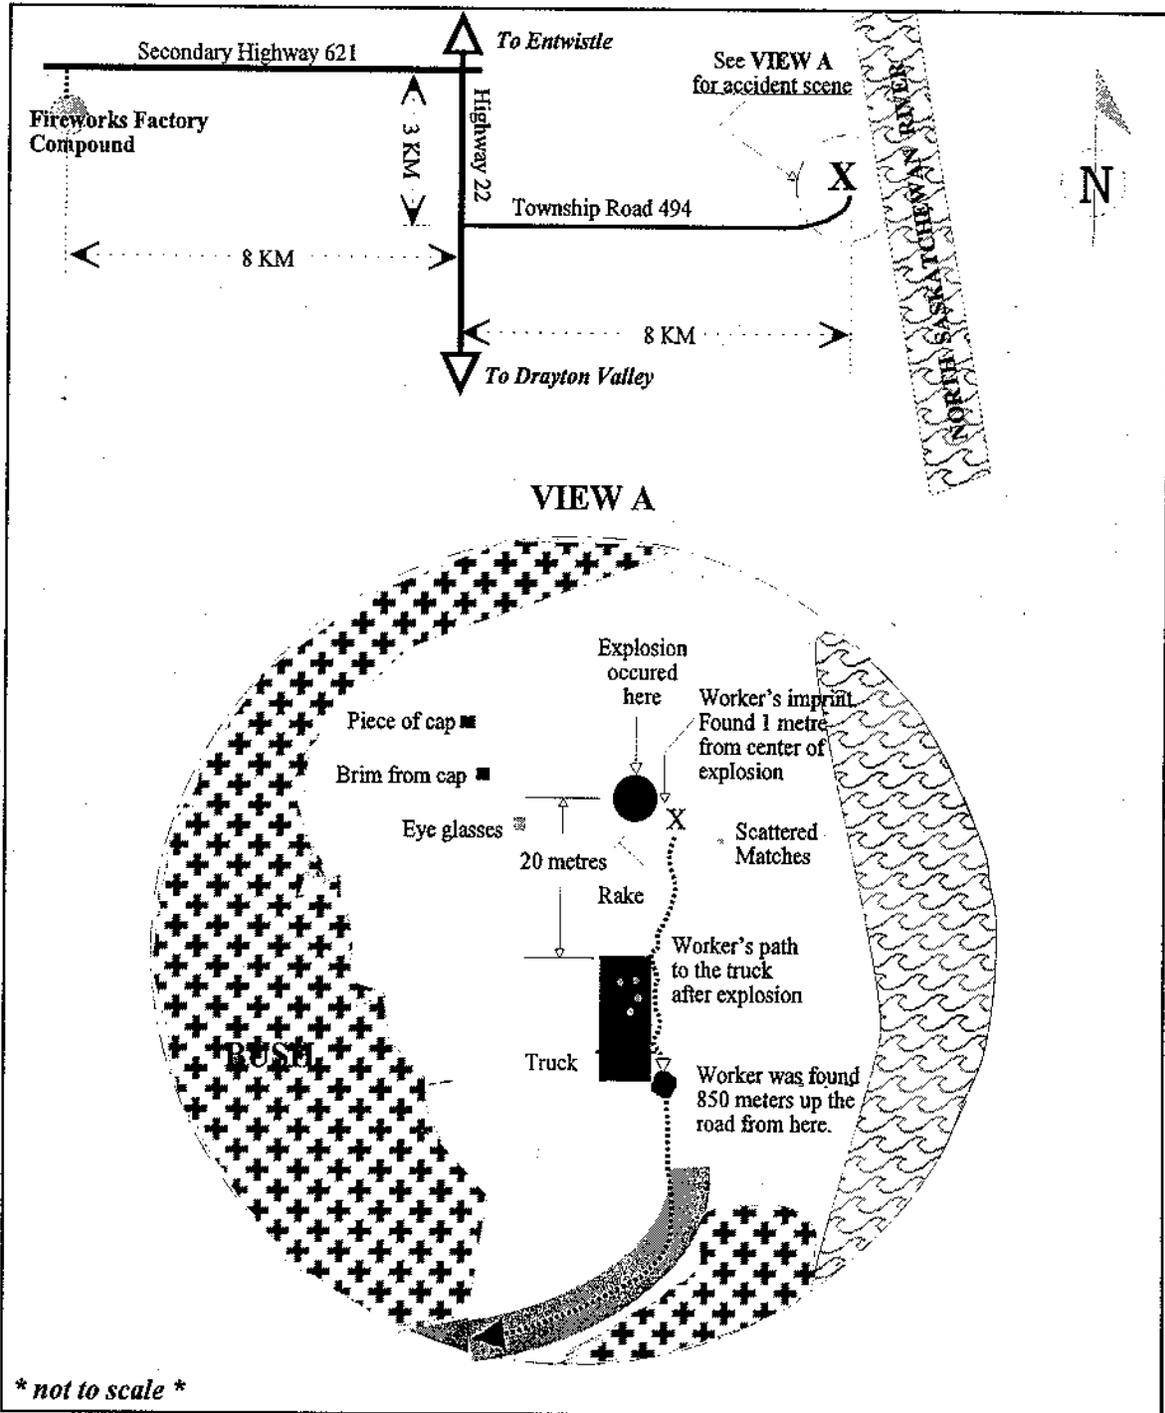
ATTACHMENT "B"

- 10.14 Refer to Sketch in Attachment B.
- 10.15 At the time of the incident, weather conditions were inconclusive. Environment Canada's Monthly Meteorological Summary establishes mean temperature at 13C, relative humidity ranging from 46% to 85% and no rain or thunder showers. Local weather forecast for that day were projected to be periods of rain, with the chance of thunder showers, and temperatures ranging from lows of 7°C to highs of 16°C. The employer's daily log indicated periods of thunder showers were present that day.
