**WORKER INJURED DURING A  
FLAMMABLE LIQUID  
EXPLOSION**

**Date of Incident: April 17, 2000**

1.1 247329

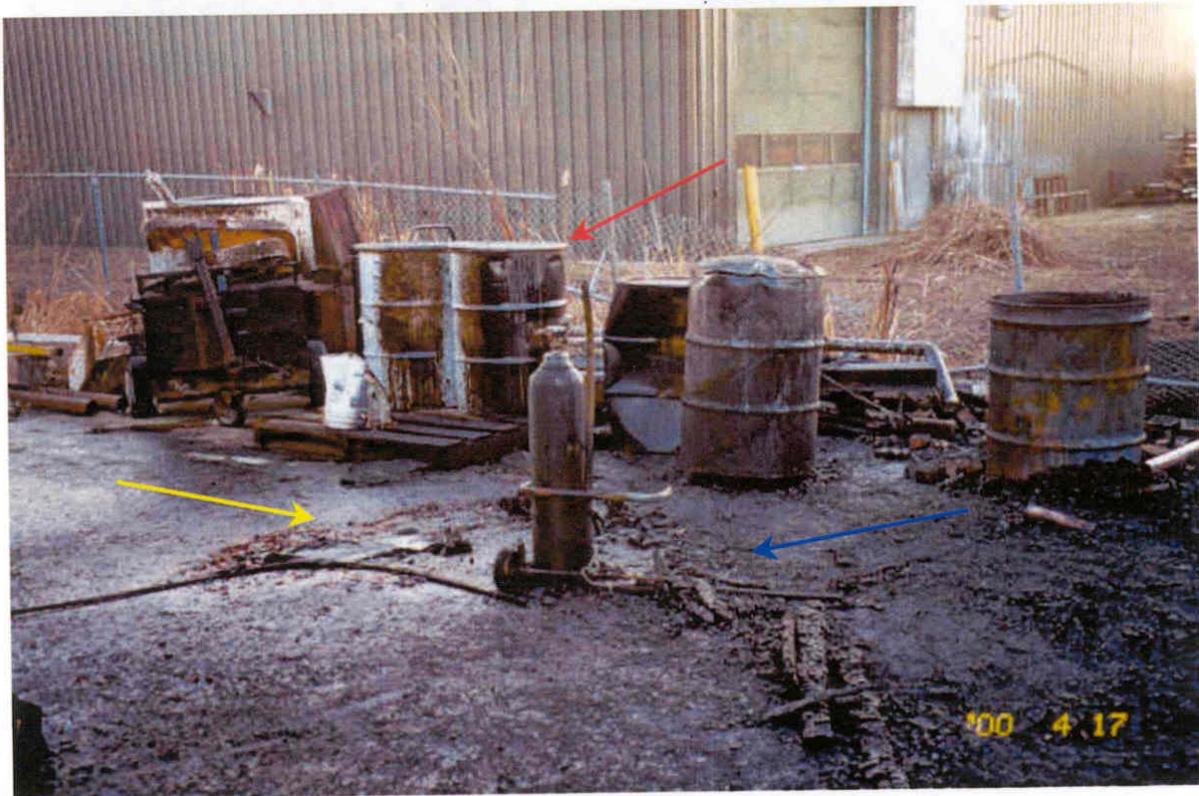
Photograph #1

Example of spray from contents of drum.  
Worker was found here.  
Barrel was located here.

View of the location where the worker was performing the cut on the 2051 drum.

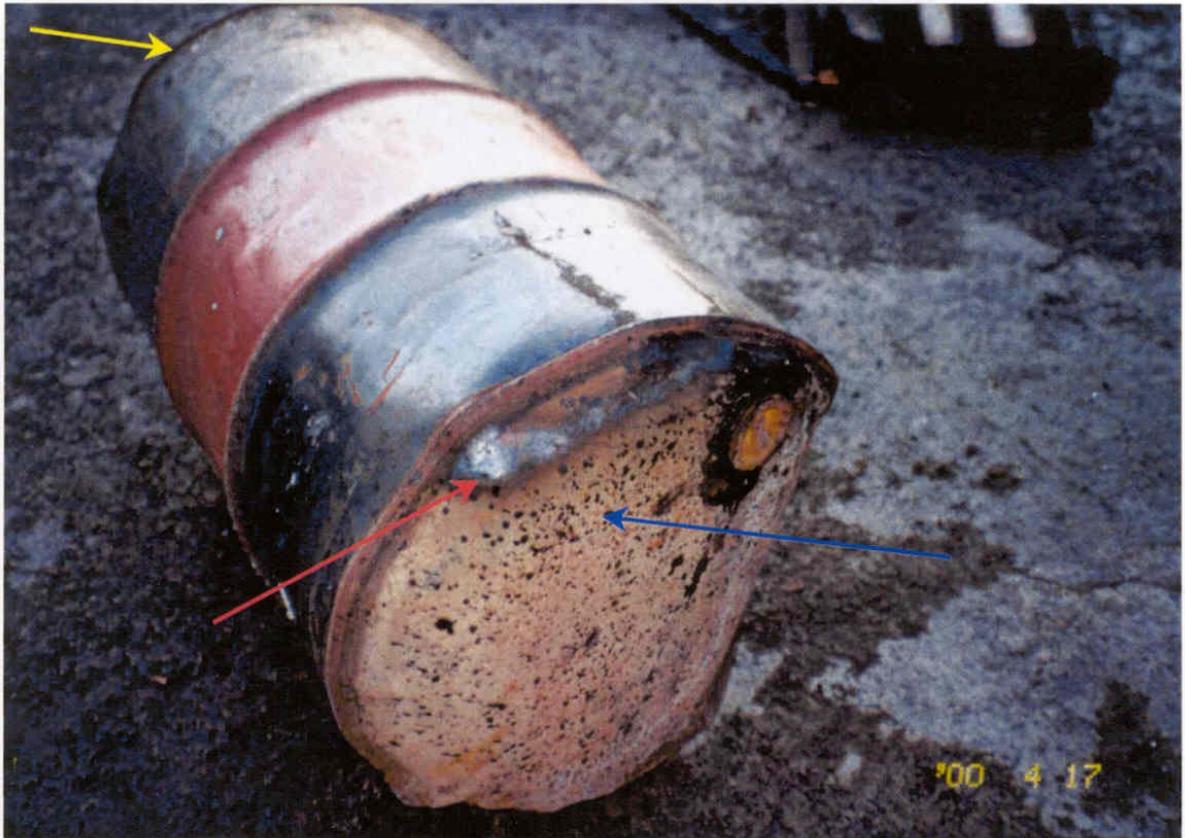
10.1.1 An examination of the drum revealed a small puncture hole in the top outer edge of the drum. The puncture hole was approximately 5.1 mm from the outer edge of the drum, which appeared to be concurrent with the work activity of utilizing a cutting torch. (See Attachment "A", Photograph #2 and Photograph #3)

Puncture  
Bottom section  
Top

The 2051 drum of Asphalt Primer the worker utilized as a worktable. (See Photograph #3)

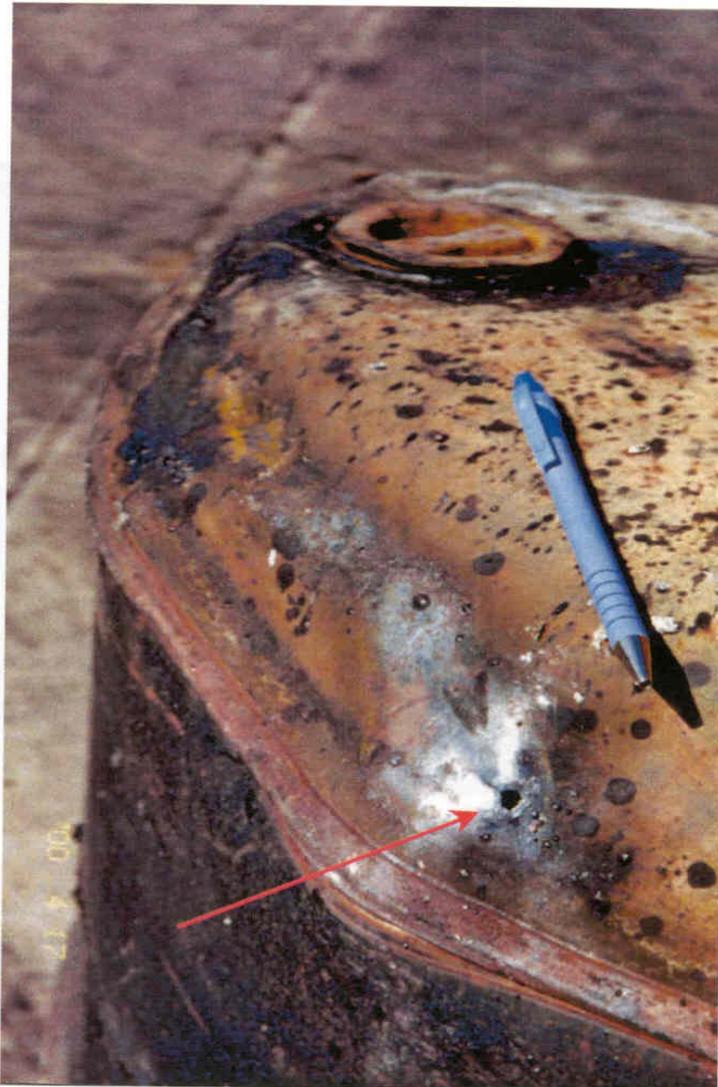
- 12.14.1 The worker's cut into the steel plate began to arc and cut into the barrel.
- 12.15 The introduction of an ignition source caused the vapours inside the drum to ignite. The vapours expanded causing the drum to rupture.

Photograph #3 Close up view of the puncture hole left in the 2051 drum from the cutting torch activity (See Photograph #2).

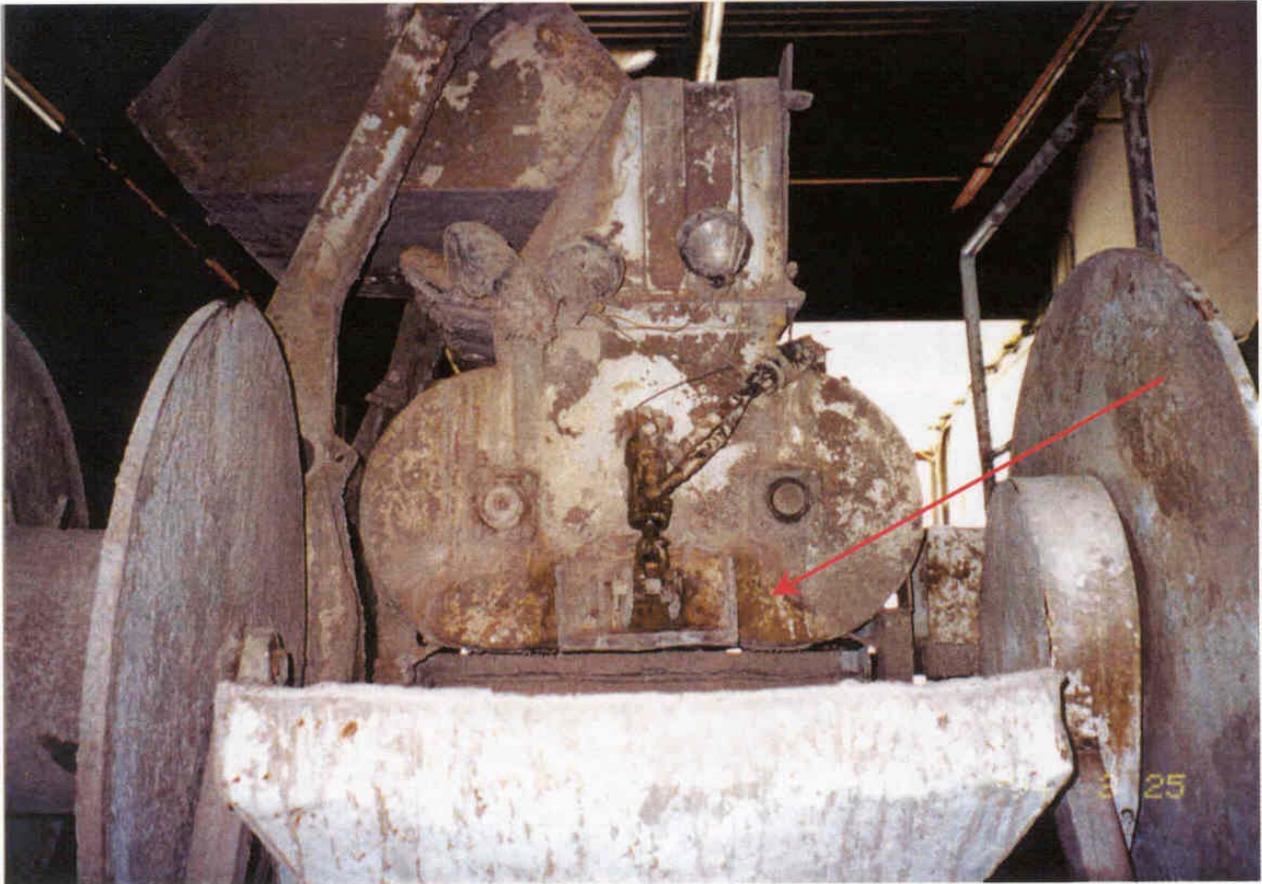
the hopper and pump. The gate is made from a 15.9 mm plain carbon steel plate and measures approximately 266.7 mm wide and 127.0 mm high. (See Attachment “A”, Photograph #4)

Photograph #4 Rear view of the GYP-Circle Pump

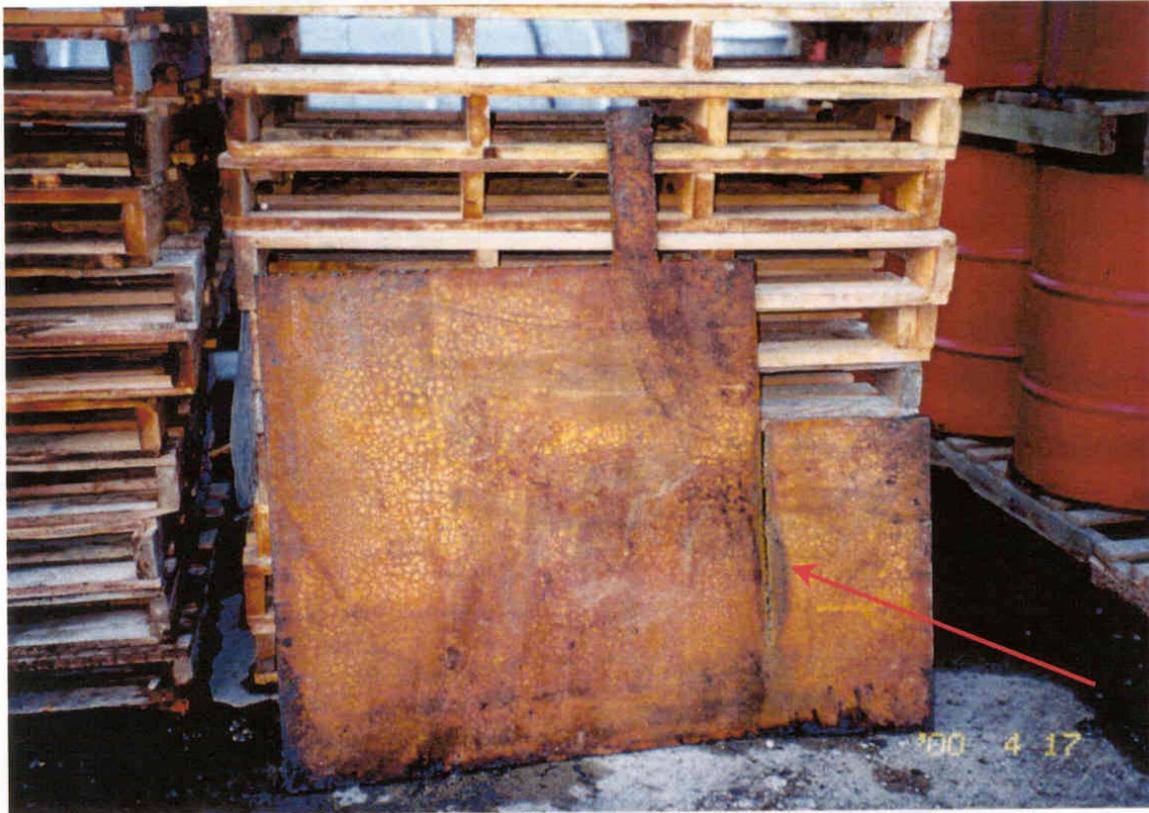
- 12.13 The steel plate was still located atop the 205 l drum of Asphalt Primer when the cutting activity commenced.
- 12.14 The worker had completed a cut of approximately 432 mm into the steel plate when the cutting torch's flame intersected and punctured a hole in the drum. (See Attachment "A", Photograph #5 and Photograph 6)

Red arrow [bottom, right]      Cut made by the torch

The 15.9 mm x 0.9 m x 0.9 m plain carbon steel plate.  
(See Photograph #6)

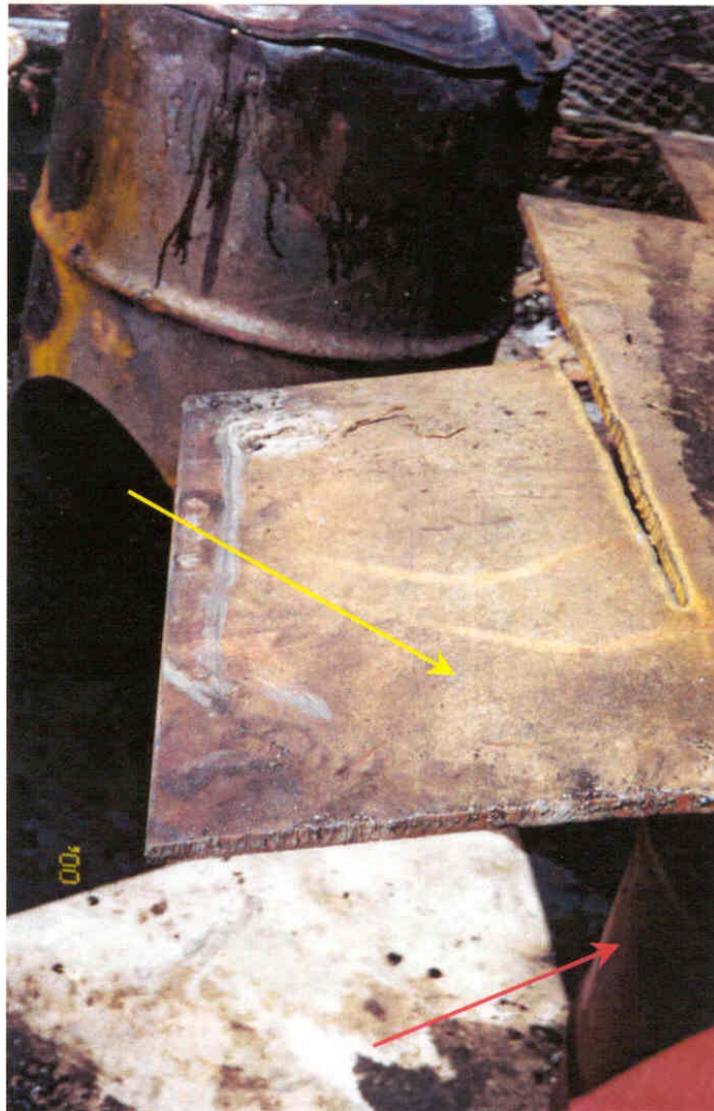
Photograph #6	Example of the position of the steel plate during the cut. (See Photograph #5)
---------------	---

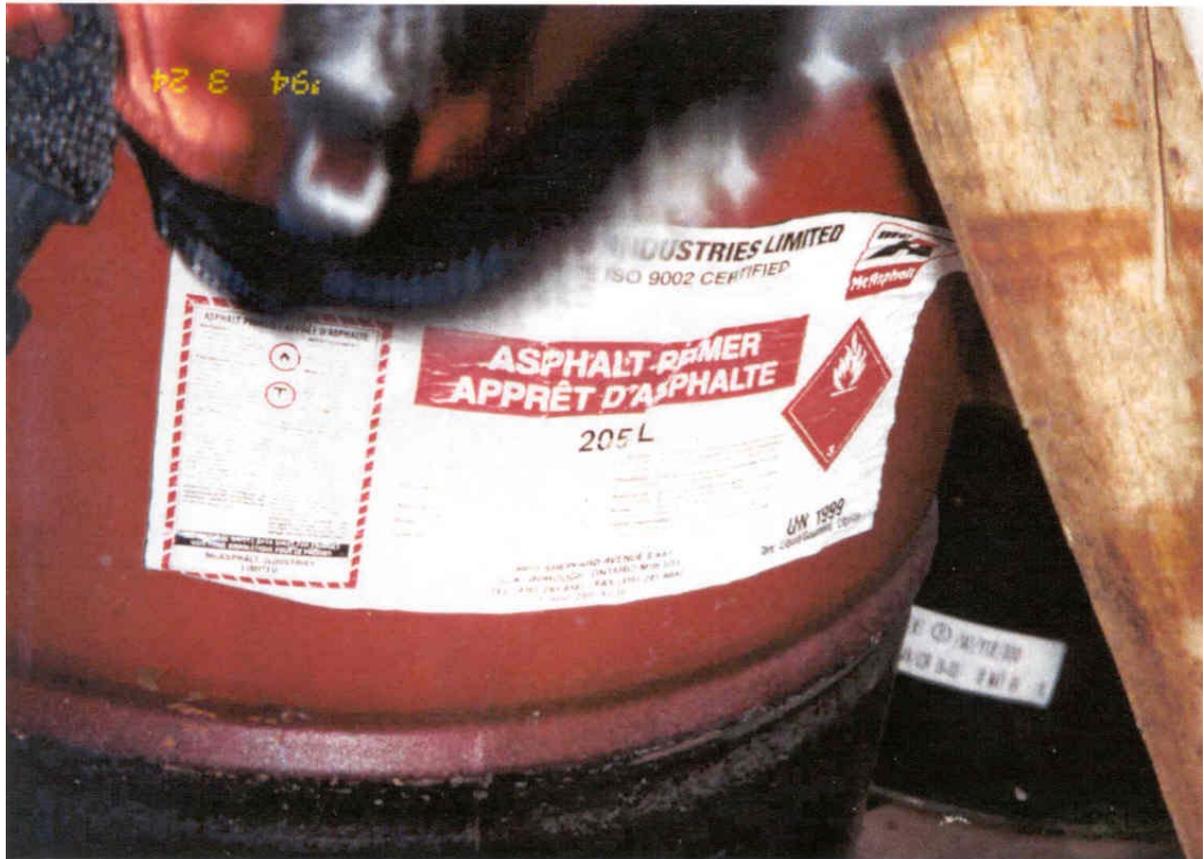
13.3.2 It was observed that supplier labels were either removed or damaged on various Asphalt Primer containers located on the work site. (see Attachment "A", Photograph #7 and Photograph #8). It could not be determined who removed these labels.

View of a supplier label attached to a container of Asphalt Primer (See Photograph #8).

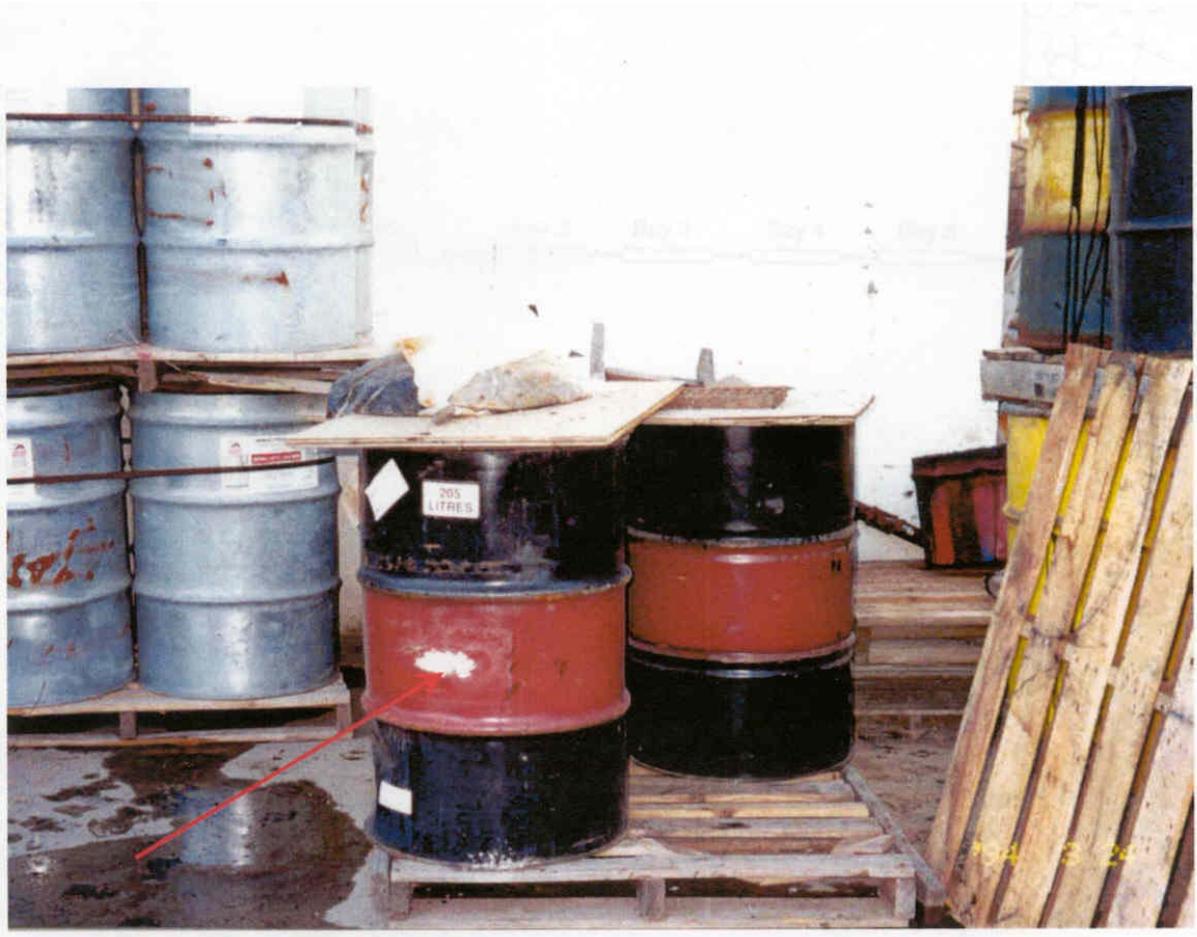
Photograph #8

Red arrow [centre] No label

View of an Asphalt Primer container without an appropriate supplier label (See Photograph #7).
