Tank Truck Explosion

Date of Incident: 99 10 27

Type of Incident: Double Fatality

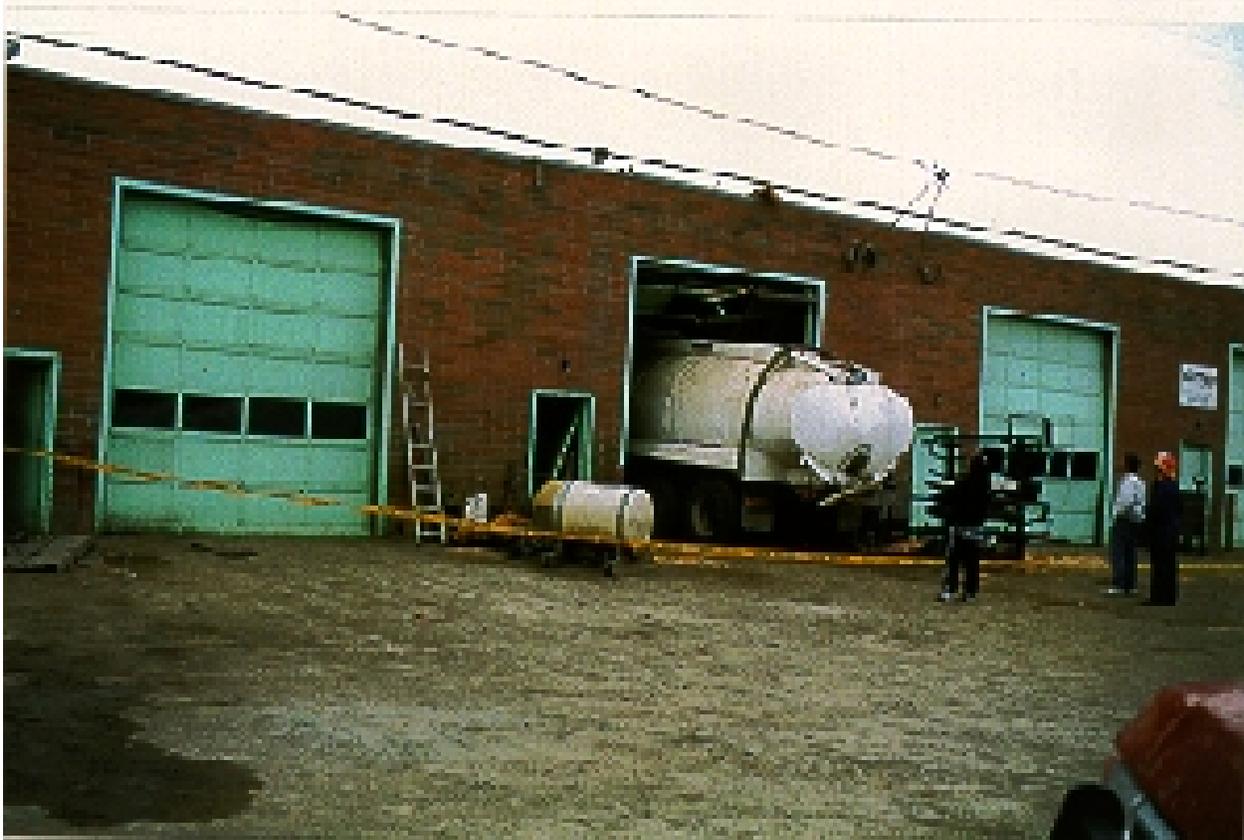
10.1 The maintenance shop measured 24 metres long x 7 metres wide x 5 metres high. The building and roof of the shop were damaged during the explosion (Refer Attachment A, Diagram; Attachment B, Photos #1 and #2).

Photograph #1 – Shows damaged building and location of the exploded tank truck extended past the shop door.

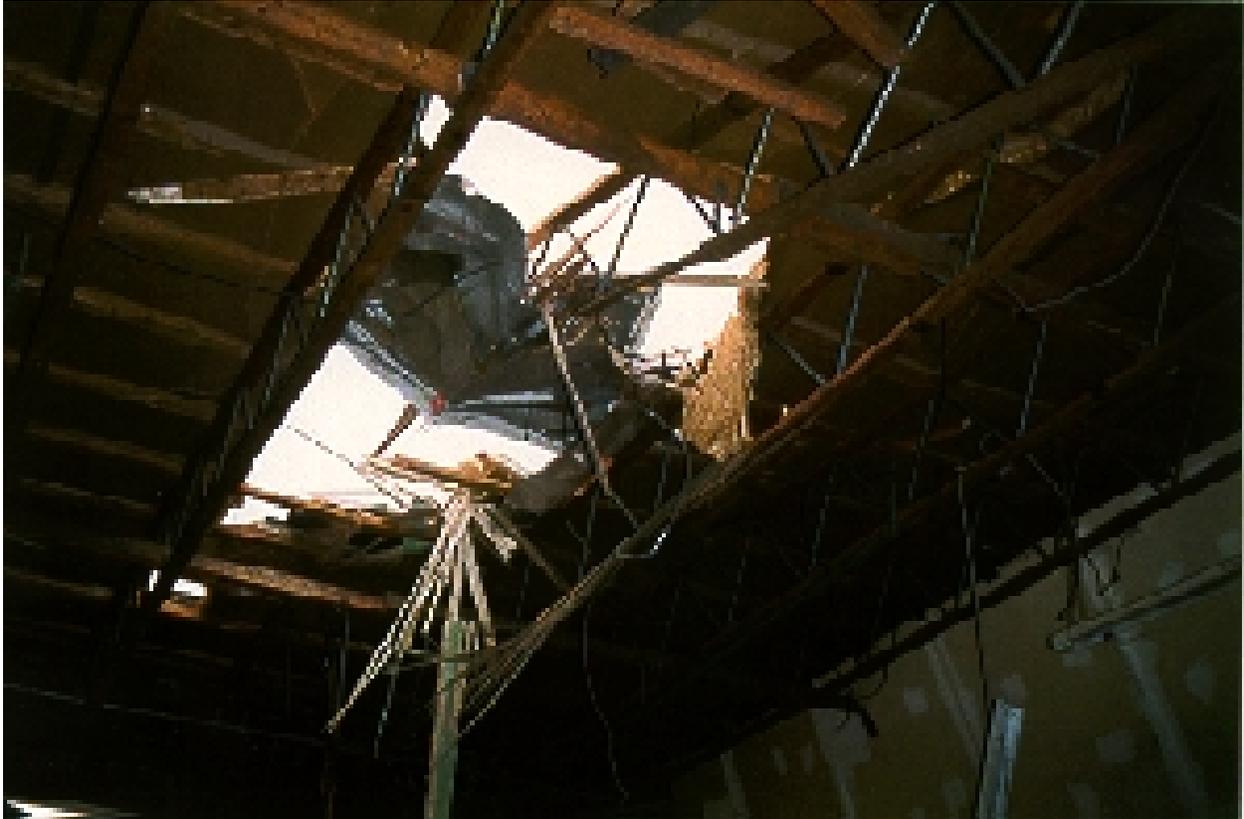
Photograph #2 – Shows damaged roof and cab of tank truck lodged in the ceiling.

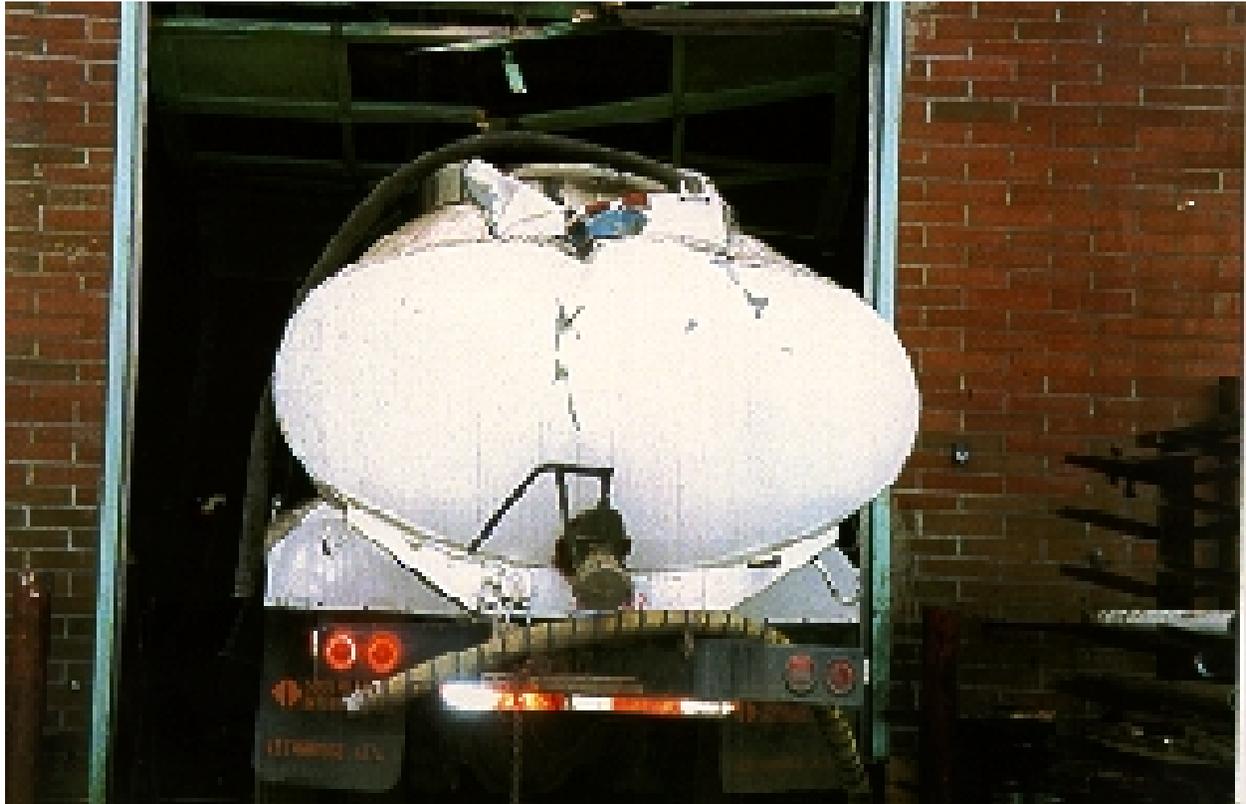
10.2 The tank truck unit consisted of a 110-barrel capacity tank installed on a 1980 International Tandem truck chassis. The tank contained approximately 455 litres of flammable residual material (wastewater saturated with methane) at the time of explosion. The wastewater was collected from seven gas wells (Refer Attachment B, Photos # 1 and #3; Attachment C, Laboratory Analysis).

Photograph #3 – Shows the damaged tank truck from the rear.

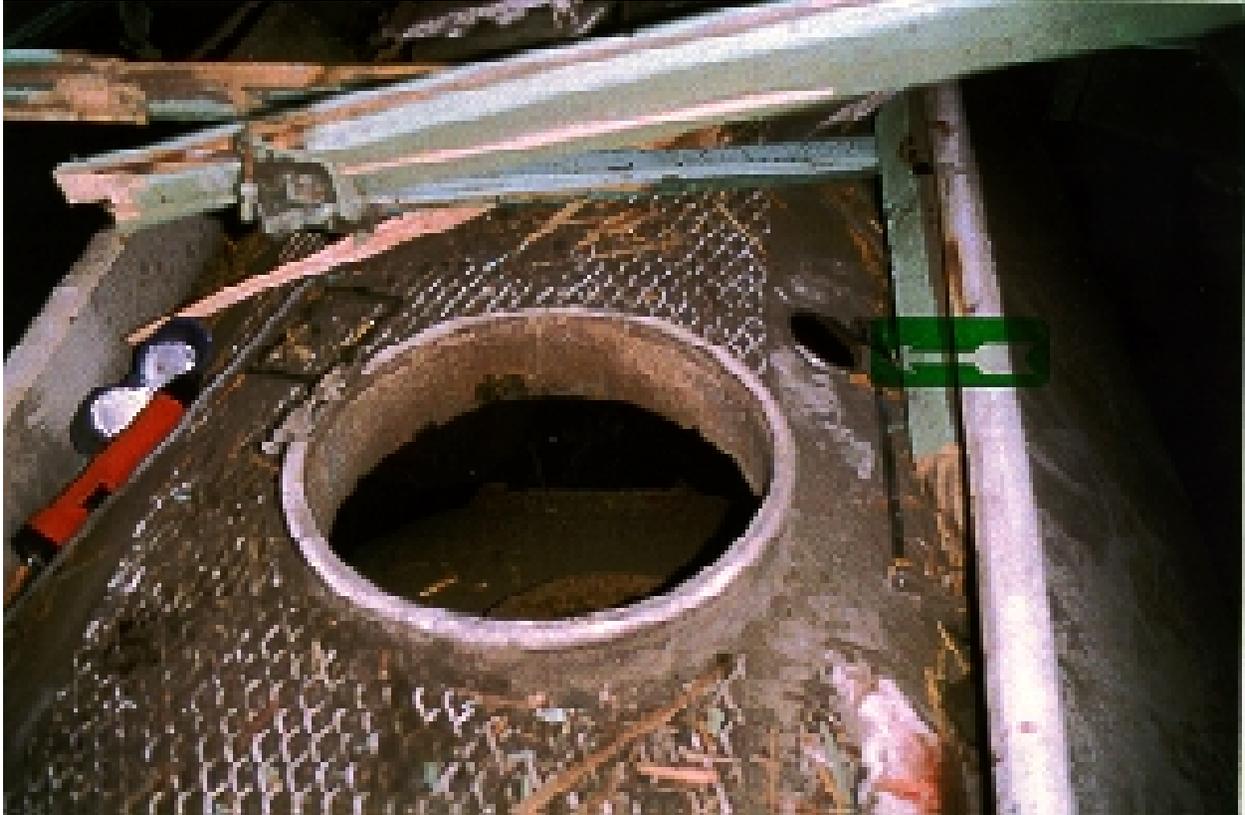
10.3 The overflow pipe was 4 metres long and 8.2 centimetres in diameter with a 90° elbow attached. This elbow was to be welded to the overflow opening on top of the tank. The evidence revealed that a welding arc had been struck on the overflow pipe elbow (Refer Attachment B, Photos #4, #5 and #6).

Photograph #4 – - Arrow shows the opening where the overflow pipe was to be welded.

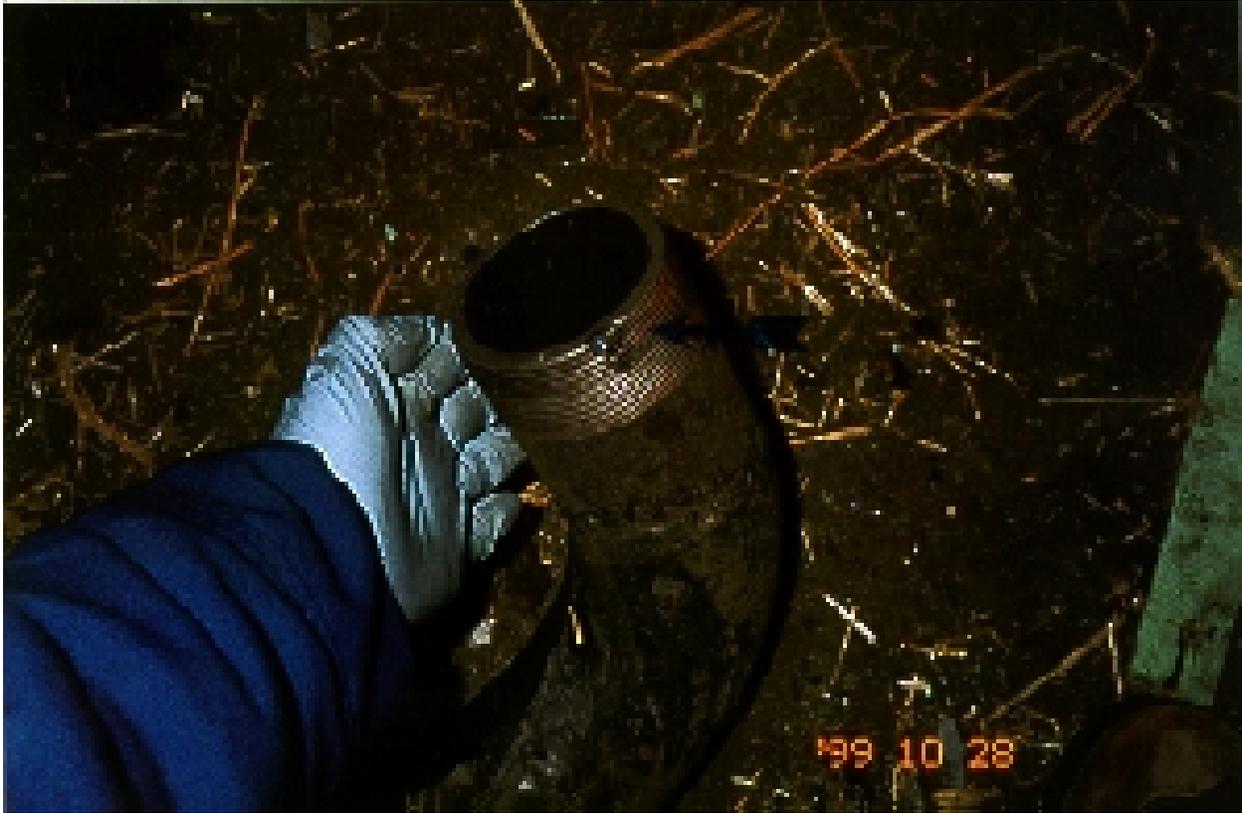
Photograph #5 – Shows overflow pipe elbow. Arrow shows where a welding arc had been struck.

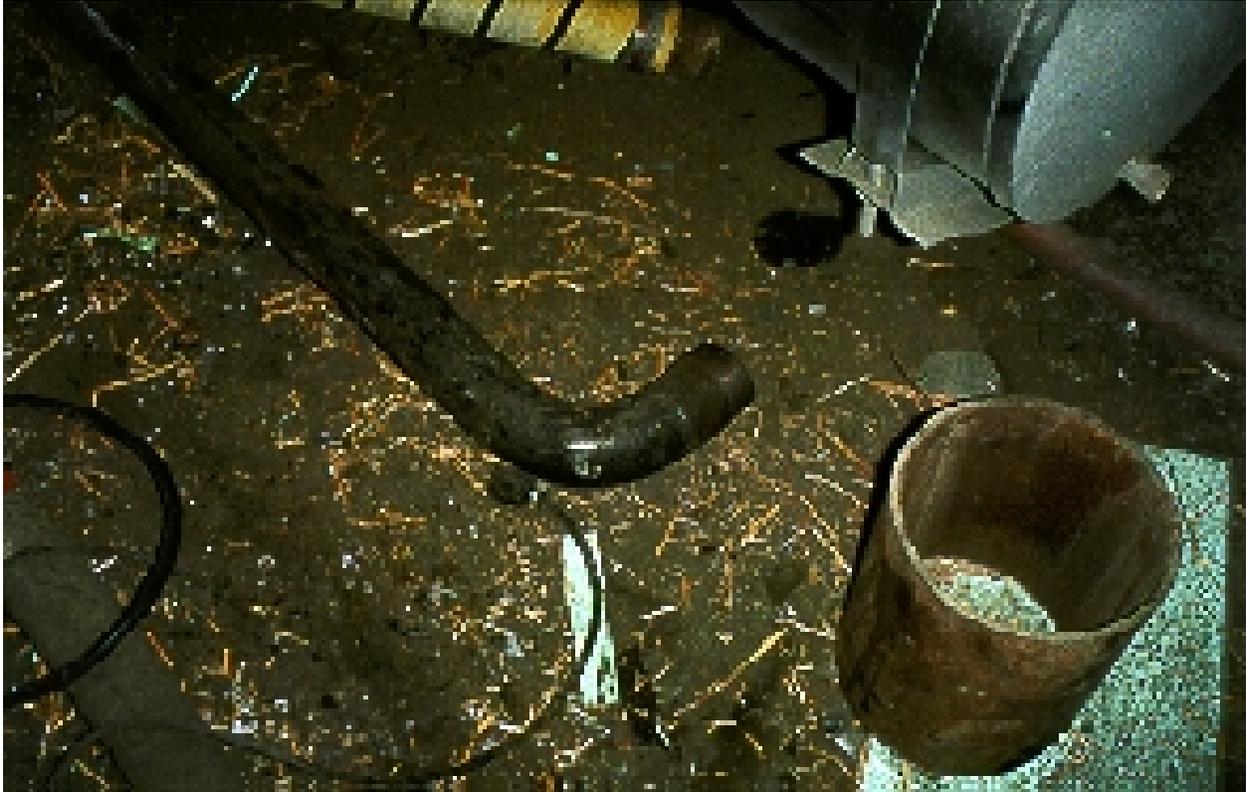
Photograph #6 – Shows the overflow pipe situated on the shop floor.

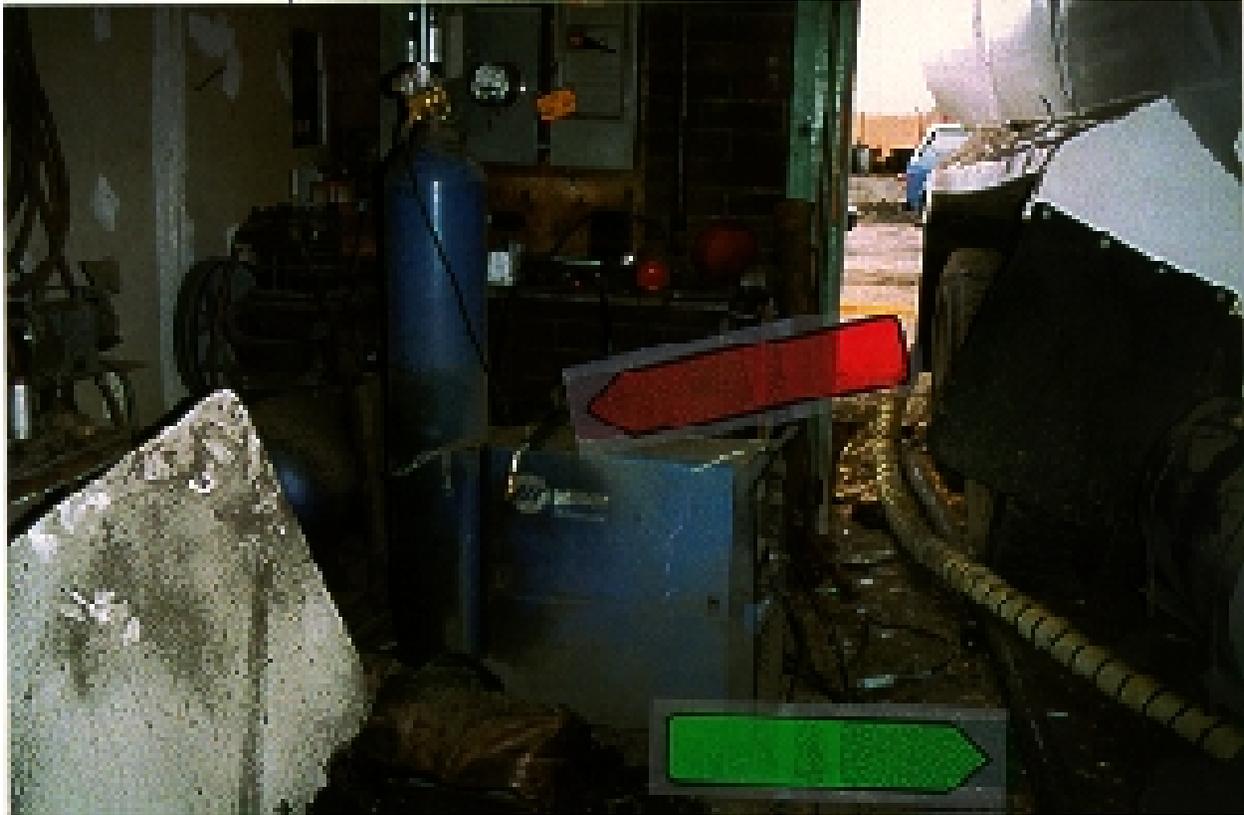
- 10.4 A Miller brand Millermatic 250X wire feed welder was used to weld the overflow pipe (Refer Attachment B, Photo #7).
- 10.5 A Gastec combustible gas meter, model #GP204, was present in the cab of the truck.

Photograph #7 – Shows the wire feed welder’s position with respect to the tank truck. Green arrow [lower arrow] shows the overflow pipe location. Red arrow [upper arrow] shows the welding stinger used to strike the arc.
