Report on the investigation of  
an explosion on board  
***fv Fleur de Lys***  
which then foundered  
18 miles south-east of Portland Bill  
on 16 April 2000

Marine Accident Investigation Branch  
First Floor, Carlton House  
Carlton Place  
Southampton  
United Kingdom  
SO15 2DZ  
**Report No 36/2001**  
**October 2001**

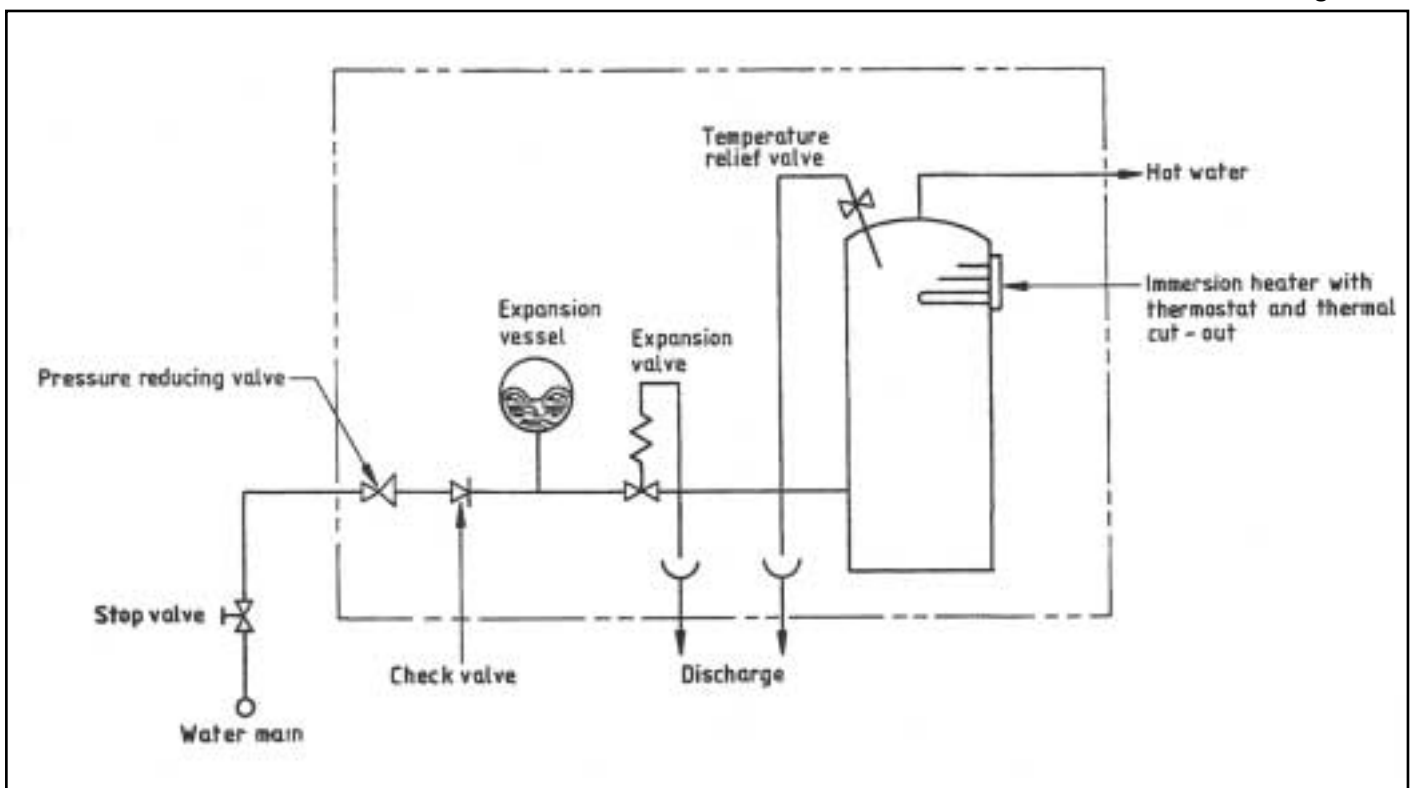
Figure 1

Typical arrangement of an unvented hot water system

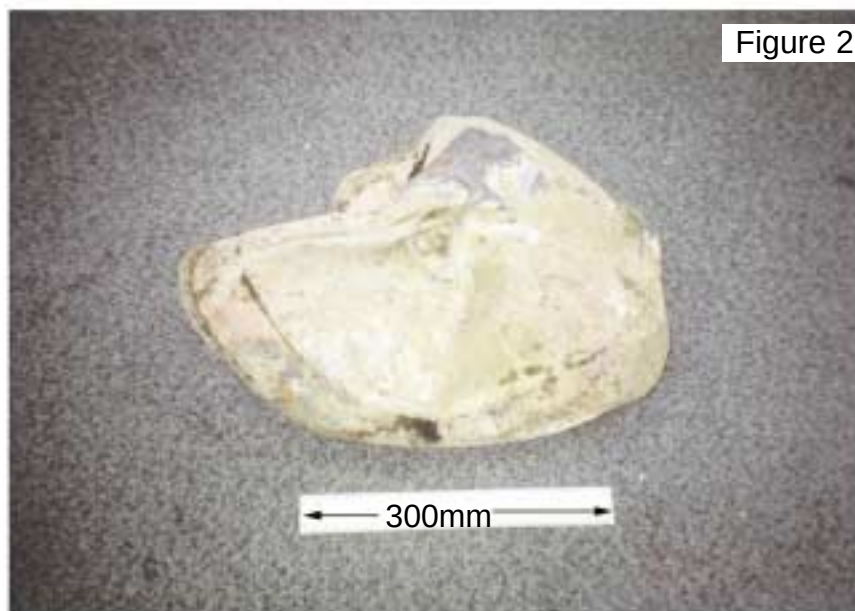
These three items were all seriously distorted, and no thermal insulation remained on their surfaces. The cylinder bottom showed signs of failure of the circumferential brazed joint to the wrapper plate. Many other failure surfaces were of virgin material some distance from any brazed or welded seam.

Base of hot water cylinder

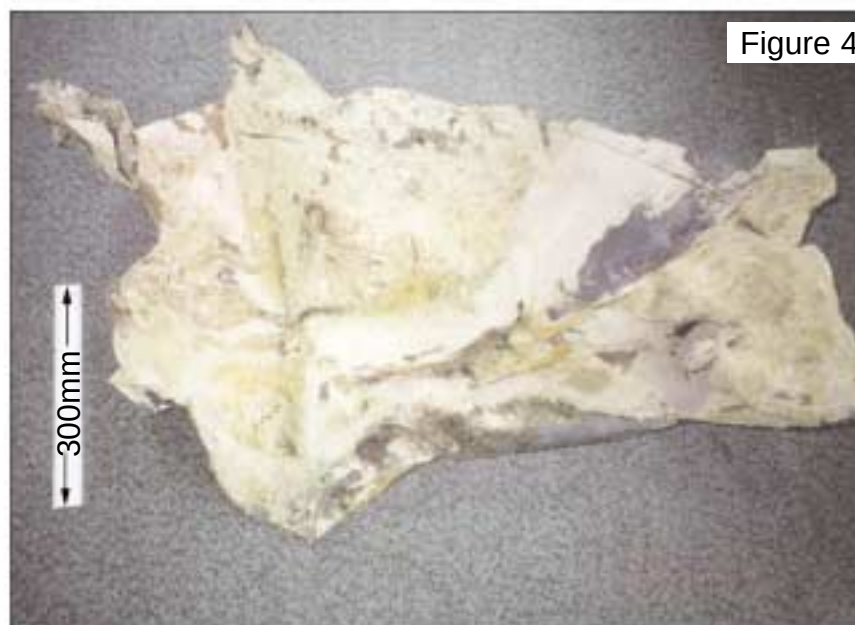
Further searching resulted in the cylinder's cylindrical wrapper plate being found beside the starboard side of the main engine, partially below floor plate level, and about 2m forward of the engine room/cabin division. A smaller piece was close by. The wrapper plate was noted to be embossed with the manufacturer's mark, M4469 (**Figures 2, 3 & 4**).

Wrapper plate of cylinder

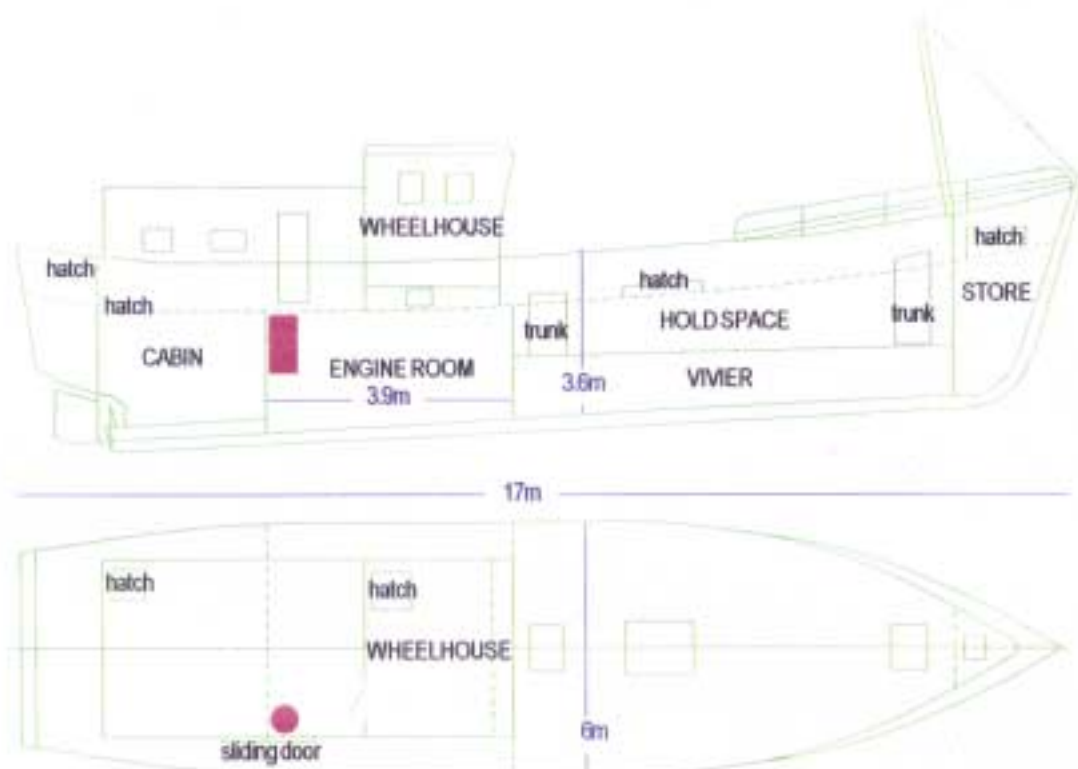
The first of these drawings is redrawn below with the location of the hot water cylinder indicated in red. The location has been identified from the description, "High against the aft bulkhead of the engine room, starboard side, was the hot water storage cylinder".

The drawing is not to scale but some principal dimensions are included (in blue). Using the drawing, the engine room would have the approximate dimensions of 3.9m fore to aft 4.2m width with a height of 2.5m.

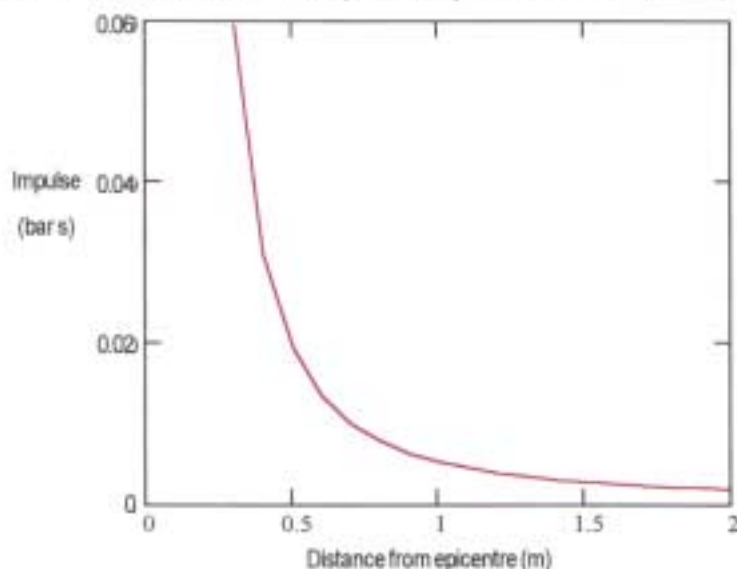
the explosion epicentre for this explosive energy is shown below. The maximum value close to the water cylinder perimeter is 0.06 bar s.

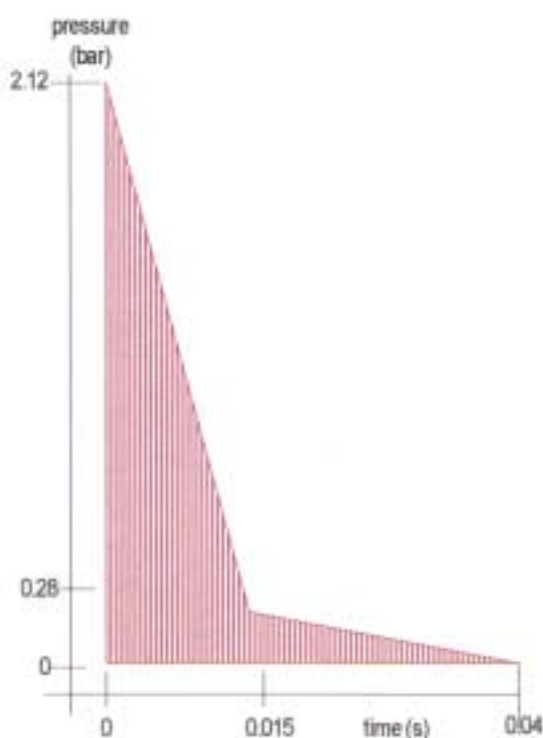
The load applied to the structure consists of a peak blast wave overpressure of 2.12 bar (multiplier of 2) with a duration of 0.015 s (obtained from the blast impulse of 0.06) and a quasi-static over pressure of 0.28 bar applied for 0.04 s. The load transient is shown on the right.

The effective load therefore possesses a peak value of 2.12 bar and an impulse (the shaded area under the transient curve) of 0.0215 bar s.

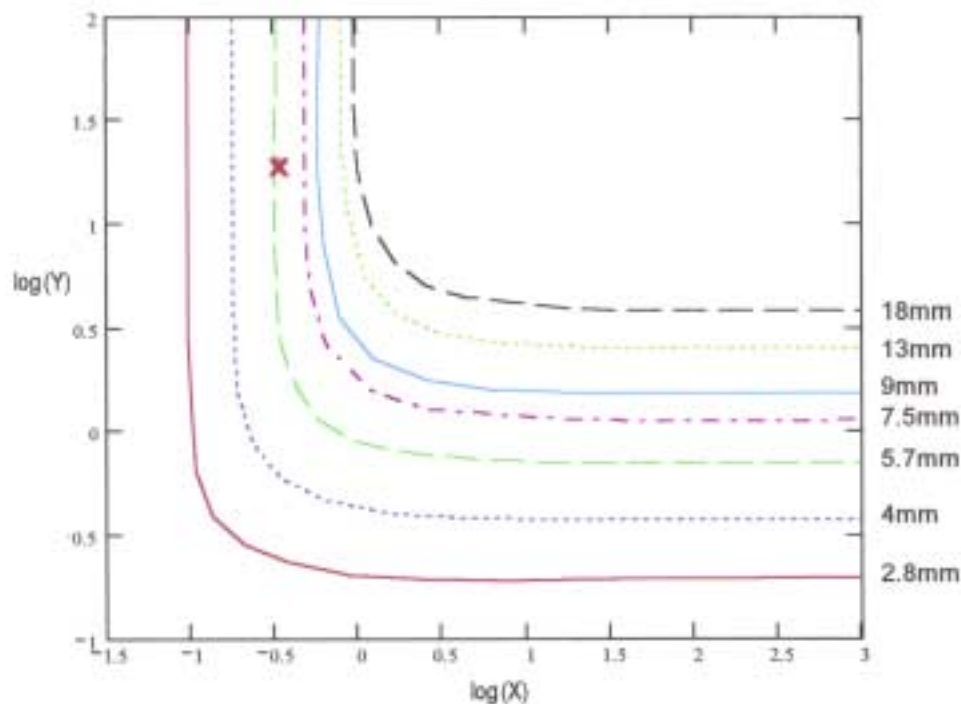
The PI chart for beams has been reproduced from the figure in Ref.2 and is shown below. The X-axis represents the resistance to peak overpressure and the Y-axis represents the resistance to impulse. The X and Y values for the peak overpressure of 2.12 bar and the impulse of 0.0215 bar s and for the hull plank defined earlier are 0.336 and 19.5 respectively and these figures are represented by the point X on the chart.

This result shows that the blast load would expect to deflect a hull plank by up to 6mm between the frames. This would apply to all the planks in similar locations.

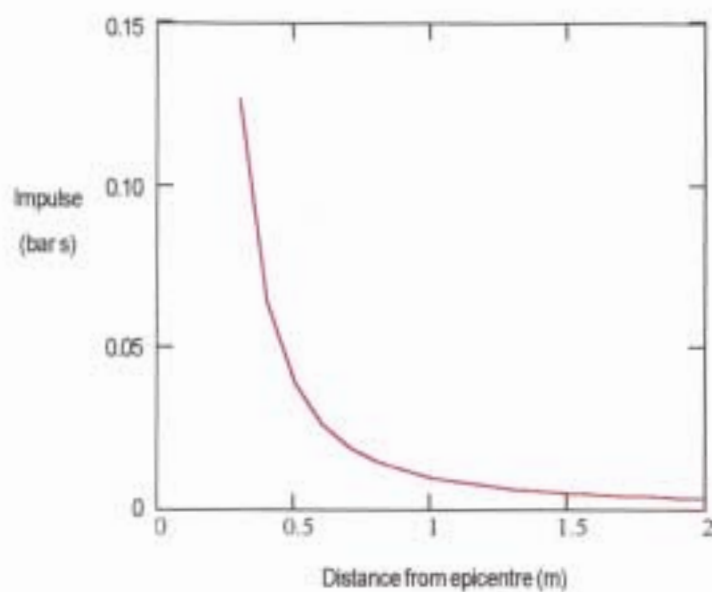
The appropriate graphical result relating blast impulse as a function of distance from the explosion epicentre for this explosive energy is shown below. The maximum value close to the water cylinder perimeter is 0.13 bar s.

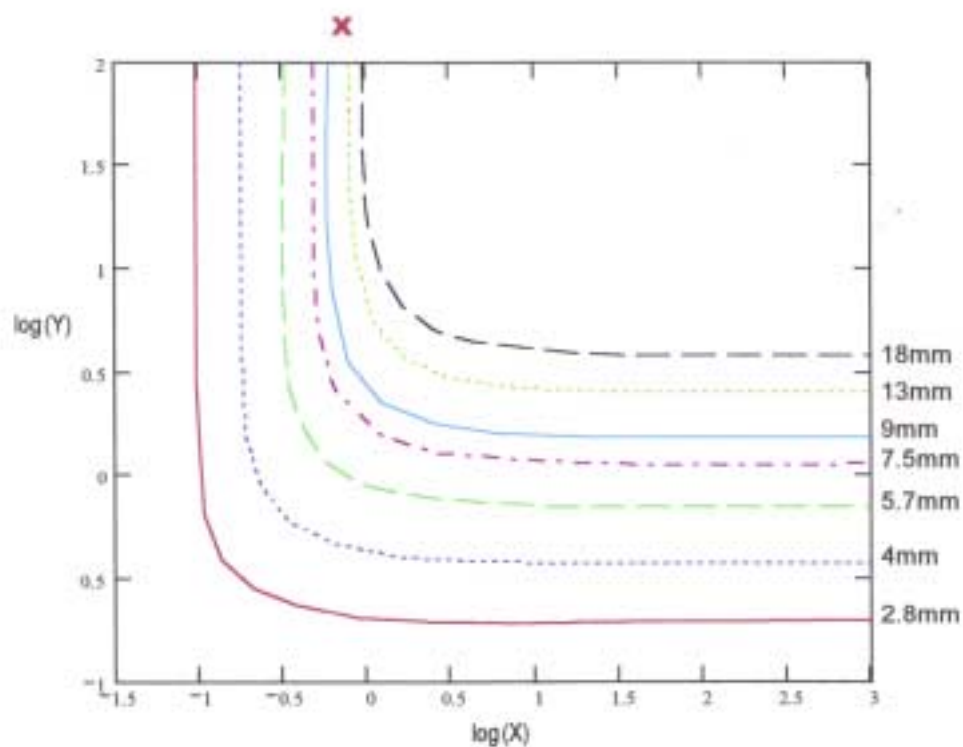
The PI chart for beams has been reproduced from the figure in Ref.2 and is shown below. The Y-axis represents the resistance to peak overpressure and the X-axis represents the resistance to impulse. The X and Y values for the peak overpressure of 4.44 bar and the impulse of 0.155 bar s and for the hull plank defined earlier are 0.705 and 141 respectively and these figures fall outside the chart as shown in the figure on the next page.

This result shows that the blast load would expect to deflect a hull plank by up to 11mm between the frames. This would apply to all the planks in similar locations.
