Report of the investigation  
of a carbon monoxide poisoning on  
**fr *Mariama K* (FR242)**  
in Douarnenez, France  
on 10 June 2000  
One fatality

Marine Accident Investigation Branch  
First Floor, Carlton House  
Carlton Place  
Southampton  
SO15 2DZ

**Report No 12/2001**

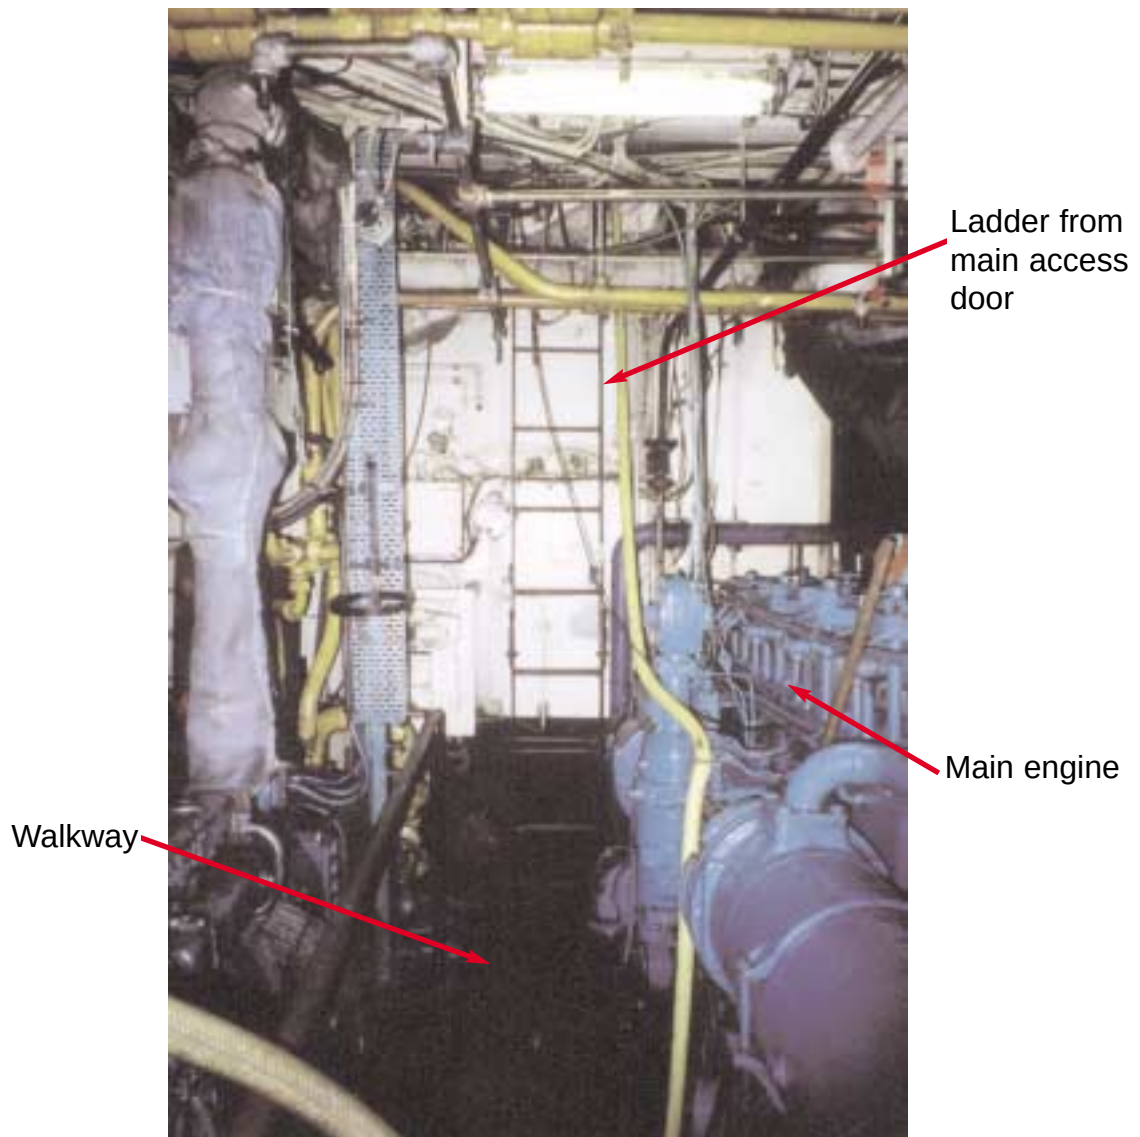
Figure 2

The main engine room door leads into a vertical trunk, with a ladder leading down to a fore and aft walkway to the starboard side of the main engine. On the starboard side of this walkway is an auxiliary engine with another narrow length of walkway at its starboard side (see **Figure 2**).

The portable pump used to pump bilges was positioned at the forward end of this narrow walkway, beneath the emergency escape hatch.

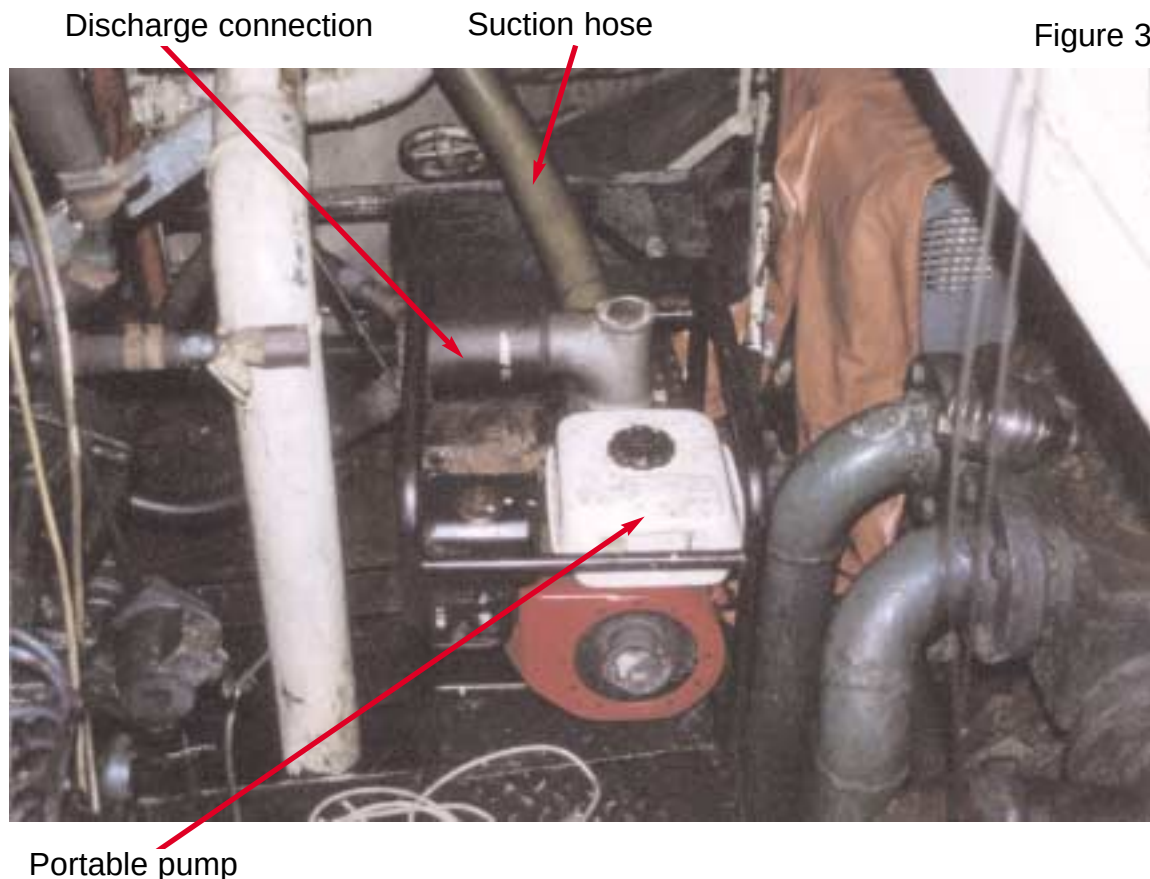
During the voyage to Europe, the engine room bilges were routinely pumped out using the portable pump. Initially this was placed on the working deck, with a suction hose leading into the engine room bilges. The pump did not perform well in this arrangement, so it was decided to reduce the suction lift by lowering the pump into the engine room (**see Figure 3**). This configuration performed satisfactorily.

The portable pump, positioned at the starboard side of the main engine, was used to pump the bilge water into a slush well on the starboard side of the working deck. Two hoses, passing from the pump through the engine room's emergency escape hatch, connected the pump to the slush well. An electric pump, permanently installed in the slush well, then transferred the bilge water overboard.

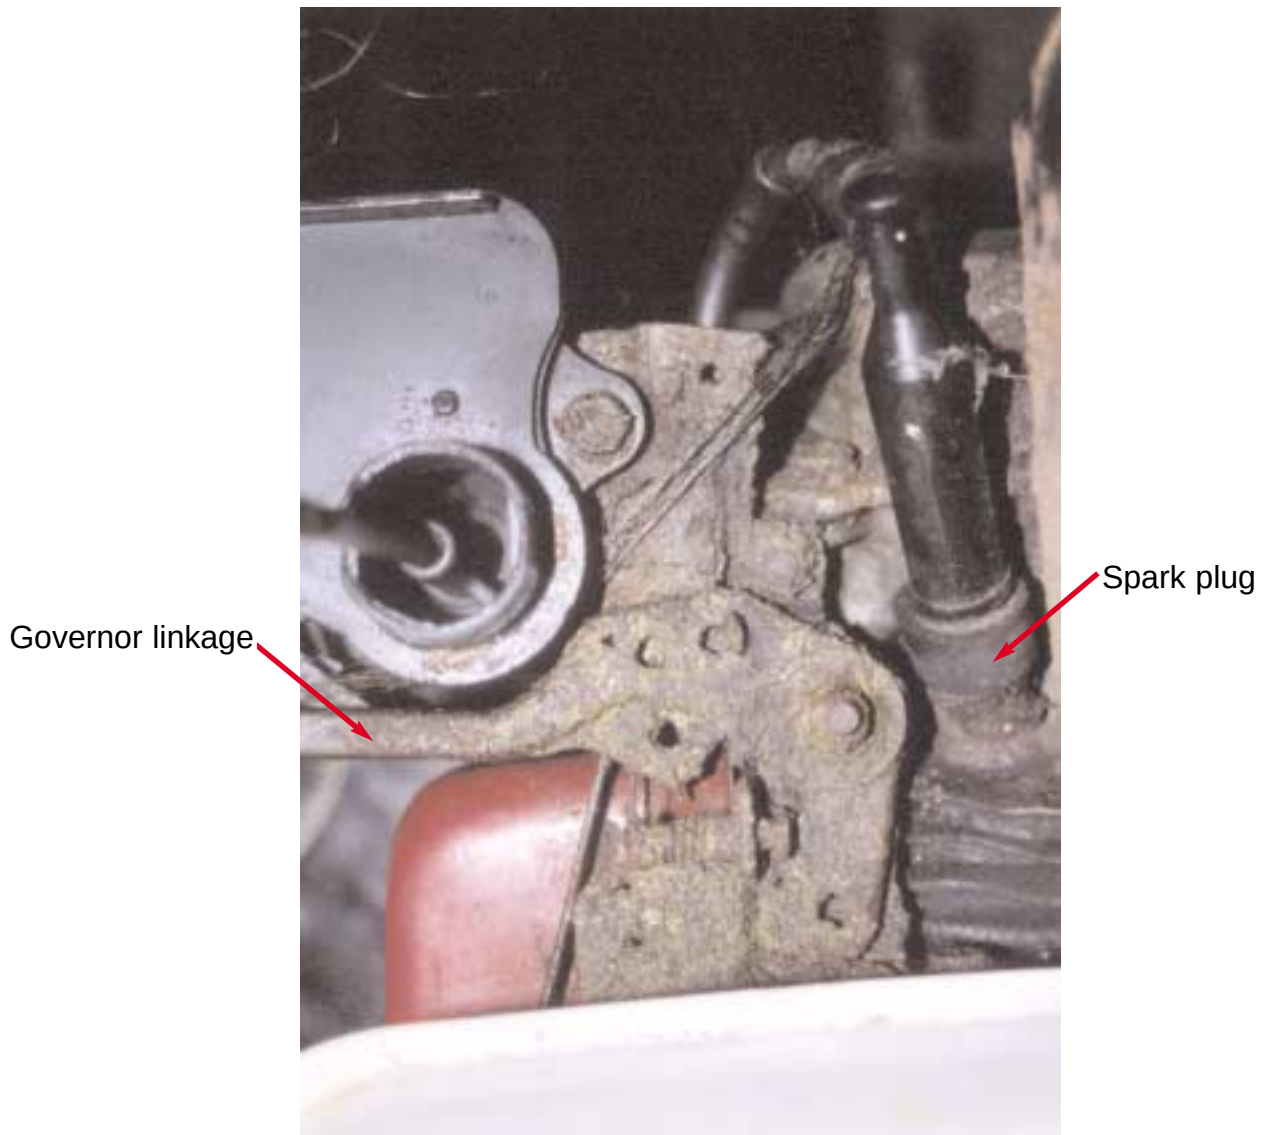
Figure 4

No other substance capable of producing a noxious vapour was found in the engine room. However, the portable petrol-powered pump, at the starboard forward end of the engine room was examined.

Apart from noting that the engine of this pump exhausted into the engine room, details of manufacturer, its type and capacity were recorded. These have been stated in Section 1.6. Also noted was the poor condition of several parts of the engine, in particular the governor linkage and sparking plug were very heavily corroded (**see Figure 4**). Although the governor linkage was free to move by hand, it was not established whether its range of movement was to specification. The engine and pump were not test run as part of this inspection.
