MARINE CASUALTY REPORT

SS SANSINENA (LIBERIAN) EXPLOSION AND FIRE
IN LOS ANGELES HARBOR, CALIFORNIA ON
17 DECEMBER 1976 WITH LOSS OF LIFE

U.S. COAST GUARD
MARINE BOARD OF INVESTIGATION REPORT

REPORT NO USCG 16732 /71895

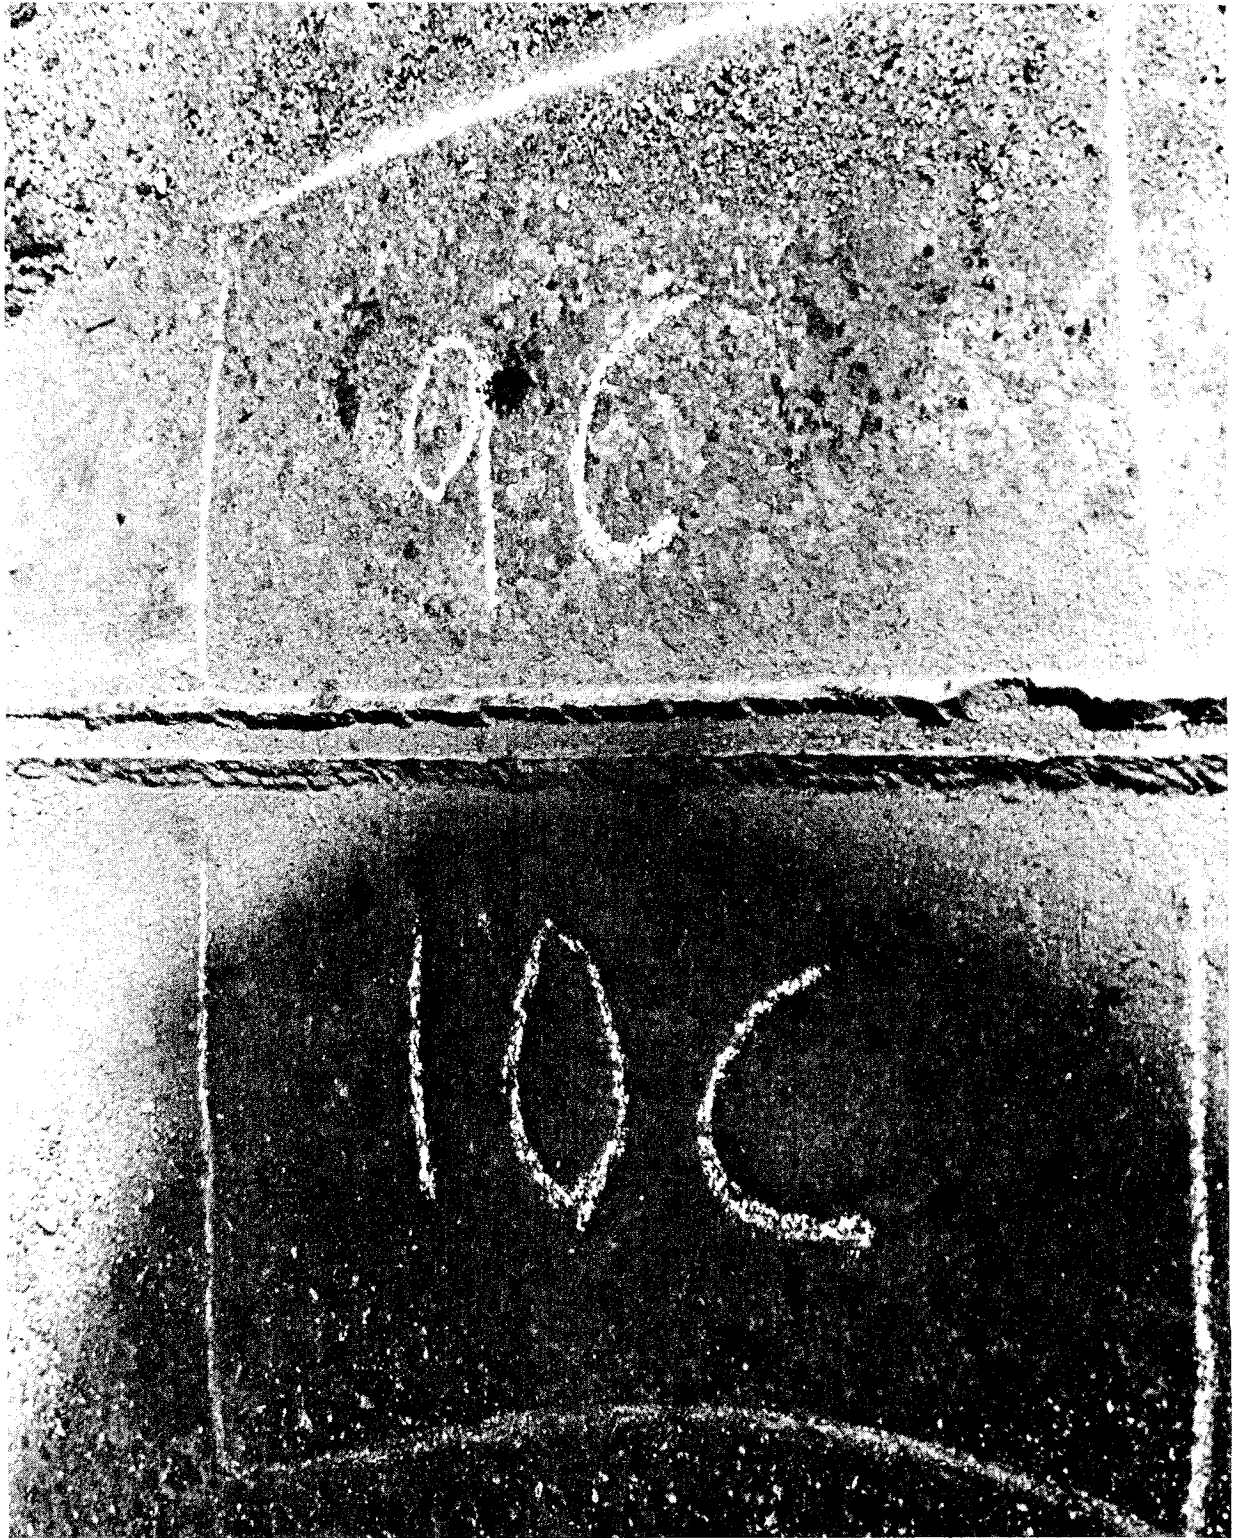
tank were bent forward, all abaft #10 tank were bent aft. (Figure 5.) There were no bits of the #10 longitudinal bulkheads left attached. However, a close examination of the broken continuous fillet welds along those bulkhead lines revealed that on the outboard sides the remaining welds were lower on average and were beveled outward from the bulkhead's former position, while the opposite broken fillets were higher and were slightly "hooked" toward where the bulkhead had been. (Figure 6 typical.) The bulkhead fragments indicated clearly the direction of bulkhead displacement. There were consistent findings that the beveled fillets were on the side toward which the bulkhead fragments were bent, with the slightly "hooked" edge higher on the opposite fillets.

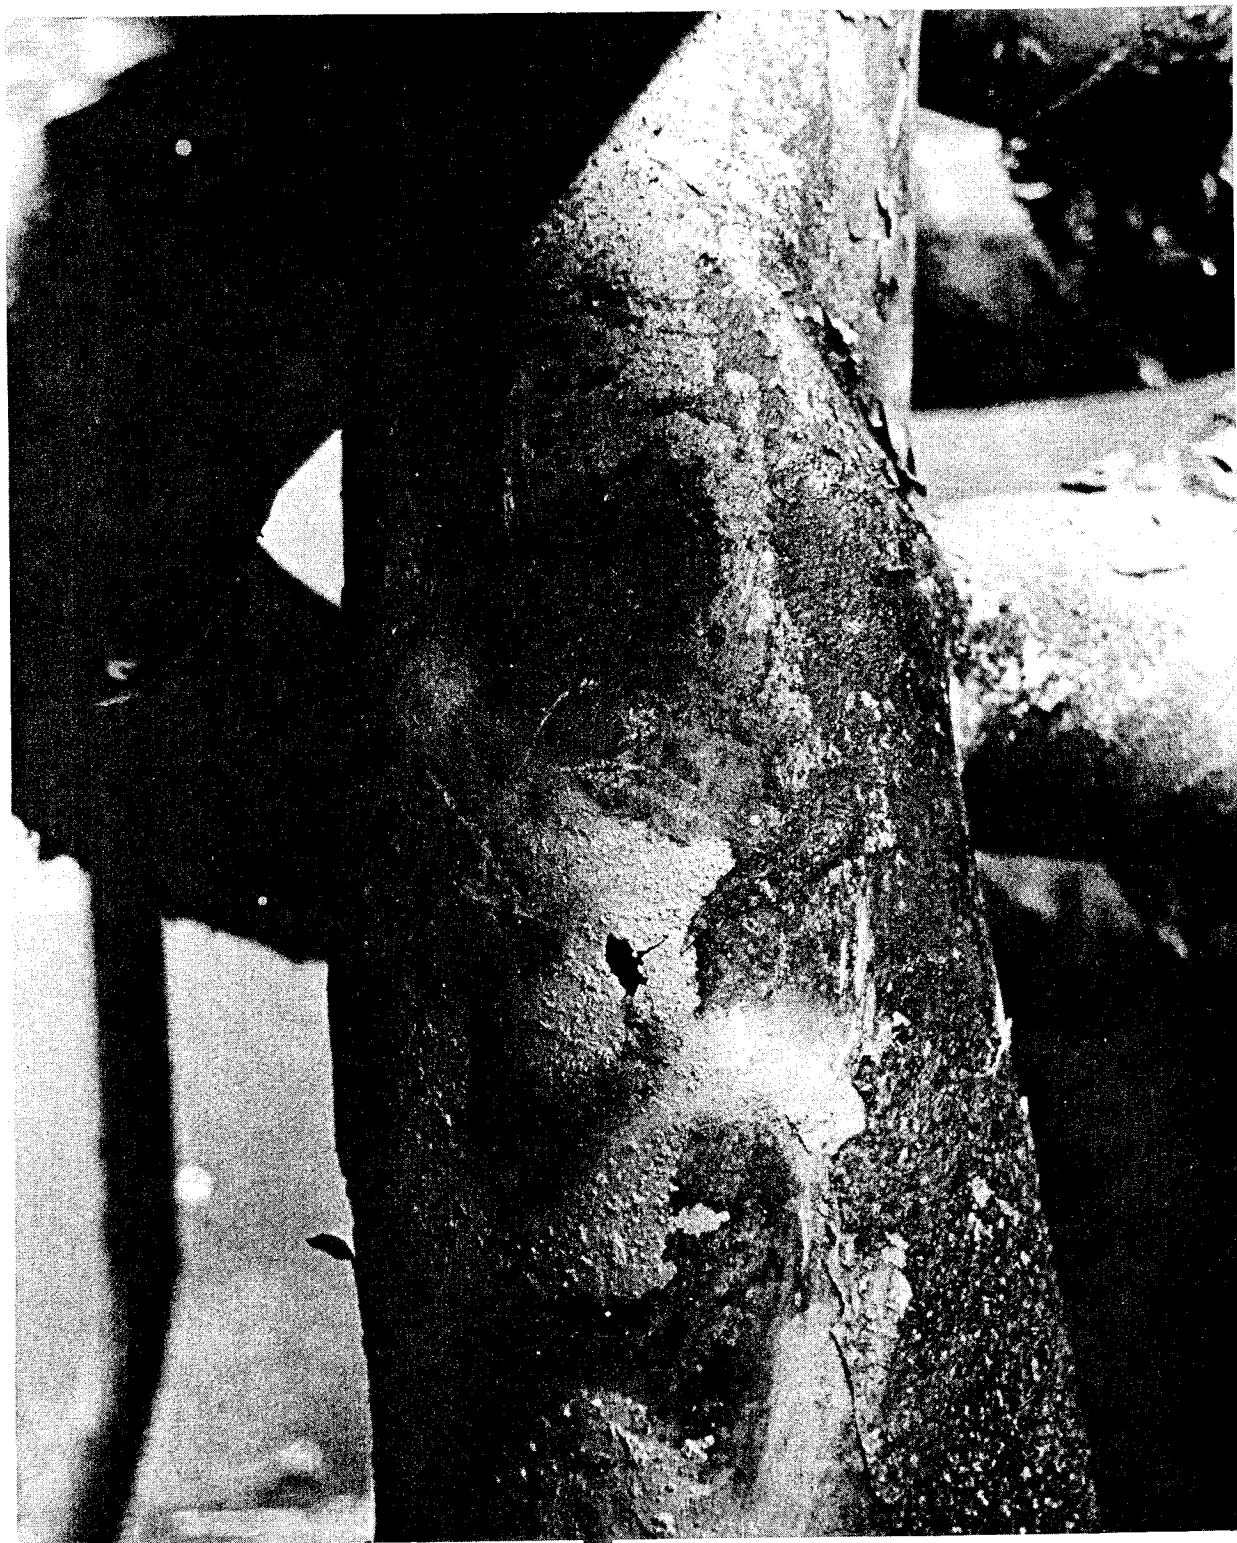
The integrity of the cargo vent system was compromised by numerous wastage holes on the underside of the cargo vent piping, a missing washout nipple cap, and a missing drain plug. The lack of integrity in the cargo vent piping further negated the dissipating effect of the weather head vent stacks at the top of the kingposts and contributed to the accumulation of hydrocarbon vapors on deck in the cargo tank area. The inspection procedures of the cargo vent system by the shipboard personnel, classification society inspectors, inspectors for the Government of Liberia, and company inspectors were inadequate to detect the relatively extensive deterioration that existed on the underside sections of the cargo vent piping. Furthermore, this lack of integrity allowed the vent piping to serve as a path of transmission for a flame to enter the cargo tanks.

d. Examination of pieces of the cargo tank vent piping, including the branch lines and the common header revealed numerous areas of localized wastage. Several pieces were found with holes wasted through on their undersides. (See figures 7 through 8 for examples.) Examination of the area surrounding these holes revealed that the holes were primarily the result of internal corrosion. Much of this piping had a very heavy buildup of exterior paint, as much as 1/8-inch thickness in places. Various samples of the cargo vent piping and a typical P/V valve were analyzed by the Aerospace Corporation in an effort to characterize the corrosion behavior. Generally, uniform corrosion of the bottom portion of the vent piping was noted to be at least twice and at some places up to four times the normally expected corrosion rate for galvanized steel in a marine environment. Further, localized deeper pits and holes in the vent header pipes in the vicinity of P/V valve connections were attributed to either galvanic action between the steel pipes and copper products from the P/V valves or action of a hydrochloric acid solution in areas of initial breakdown of the protective zinc coating. The analysis also concluded that the corrosion holes studied were covered by a thick external paint coating prior to the explosion.

6. The recommendation that every cargo venting system at an age of 10 years be surveyed to determine its material condition, including the removal of all P/V valves and audiogauging of the underside of the piping directly under the P/V valves is concurred with in part. The Merchant Marine Technical Division will conduct a detailed physical and metallurgical examination on a representative number of tank vessels in various trades over the next 5 years to determine needed inspection intervals. In the interim the program of examining tanker venting systems, which was initiated as a result of this casualty, will be continued. Also, the scope and interval of examinations to be conducted aboard tankers is being thoroughly discussed at IMCO and a proposal will be presented at the Plenipotentiary Conference
