Gasoline Tanker Incidents in Chicago, Illinois and Fairfax County, Virginia

Case Studies in Hazardous Materials Planning

Gasoline Tanker Incidents in Chicago, Illinois and Fairfax County, Virginia (March 30, 1989 and May 29, 1989)

**This is Report 032 of the Major Fires Investigation Project conducted
by TriData Corporation under contract EMW-88-C-2849 to the United
States Fire Administration, Federal Emergency Management Agency.**

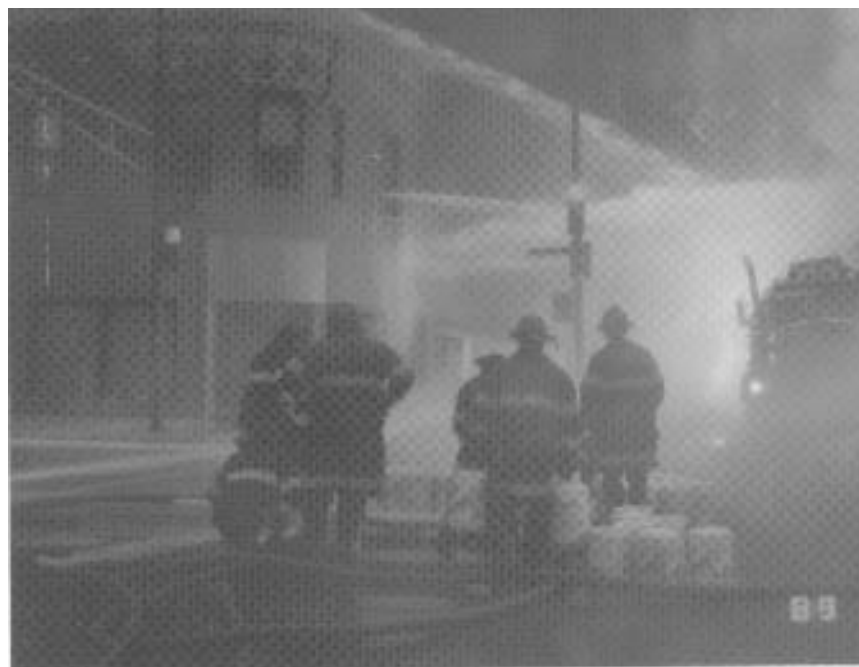
4. Firefighters operate foam handline to control spill fire. Note streams directed at exposure and tanker, including from second floor of exposure.

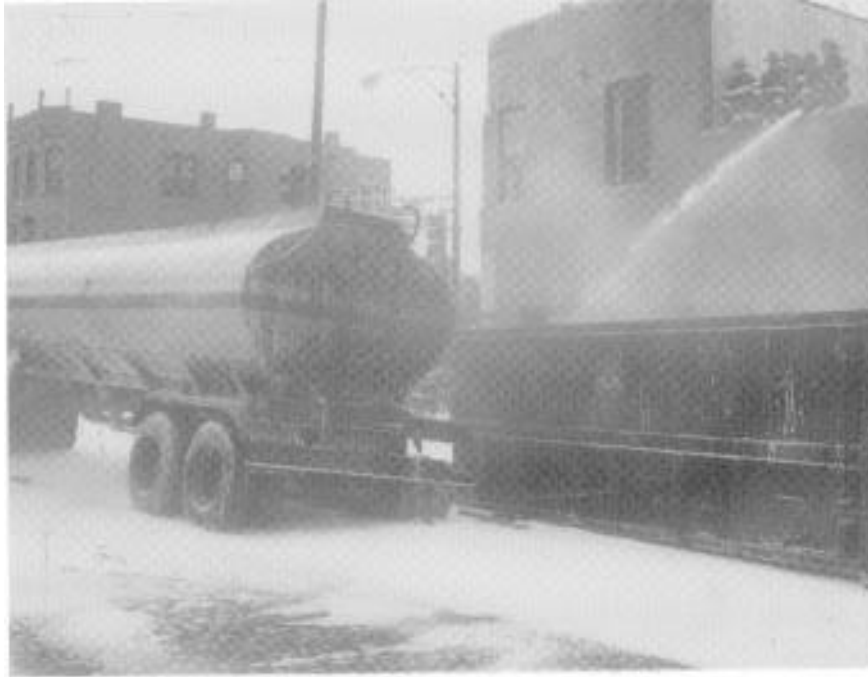
11. Firefighters flood debris in dumpster to prevent reignition of gasoline.

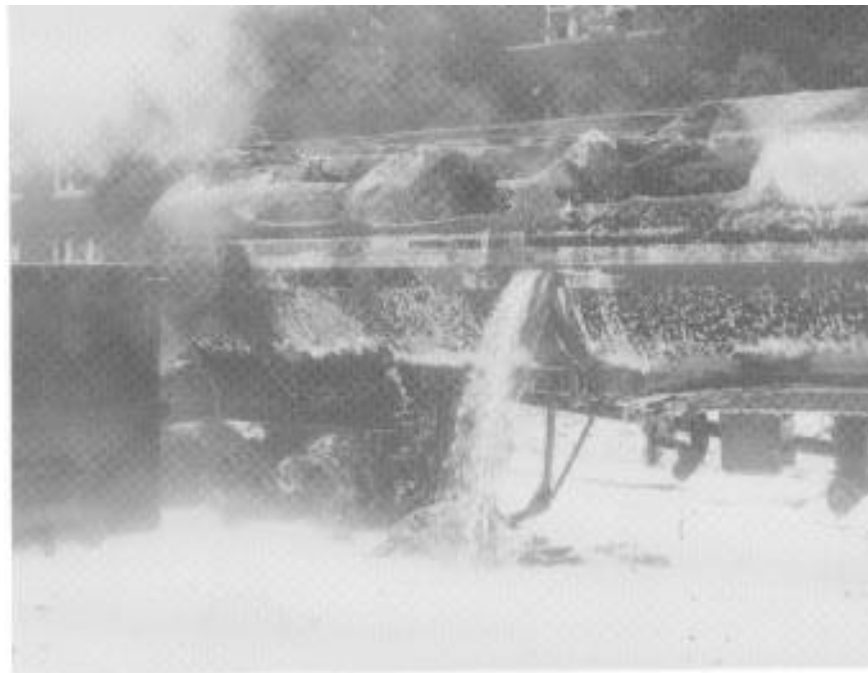
12. Damage to rear of tank trailer; gasoline still pours from puncture.
