## **Live Oak/Milstar Complex and Carpet Service Center**

**LaGrange, Georgia**

This is Report 086 of the Major Fires Investigation Project conducted by Varley-Campbell & Associates, Inc. under contract EMW-94-C-4423 to the United States Fire Administration, Federal Emergency Management Agency.

Tuesday, January 31, 1995

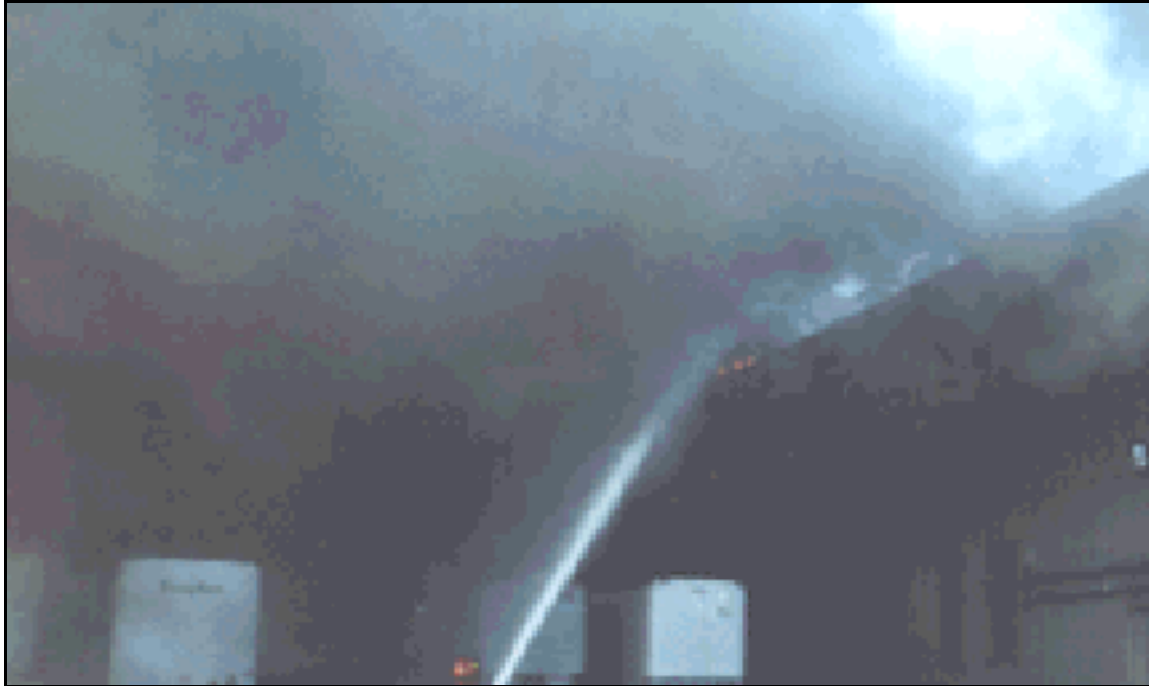
1. Point of initial fire department attack in the northeast corner of the 1972 addition. The first line entered the building at a location near the photograph's center between the truck trailer and the building.

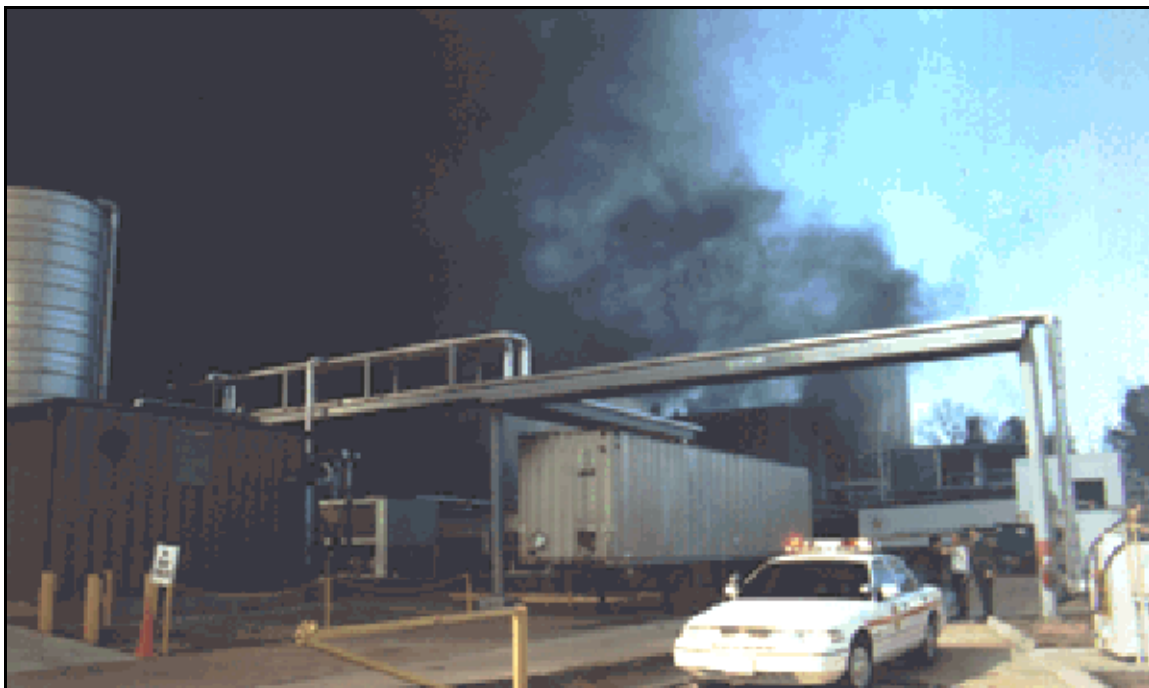
2. The location of Incident Command on the east side of the building. The truck trailer with the star (above the car's warning lights) is in photograph 1.

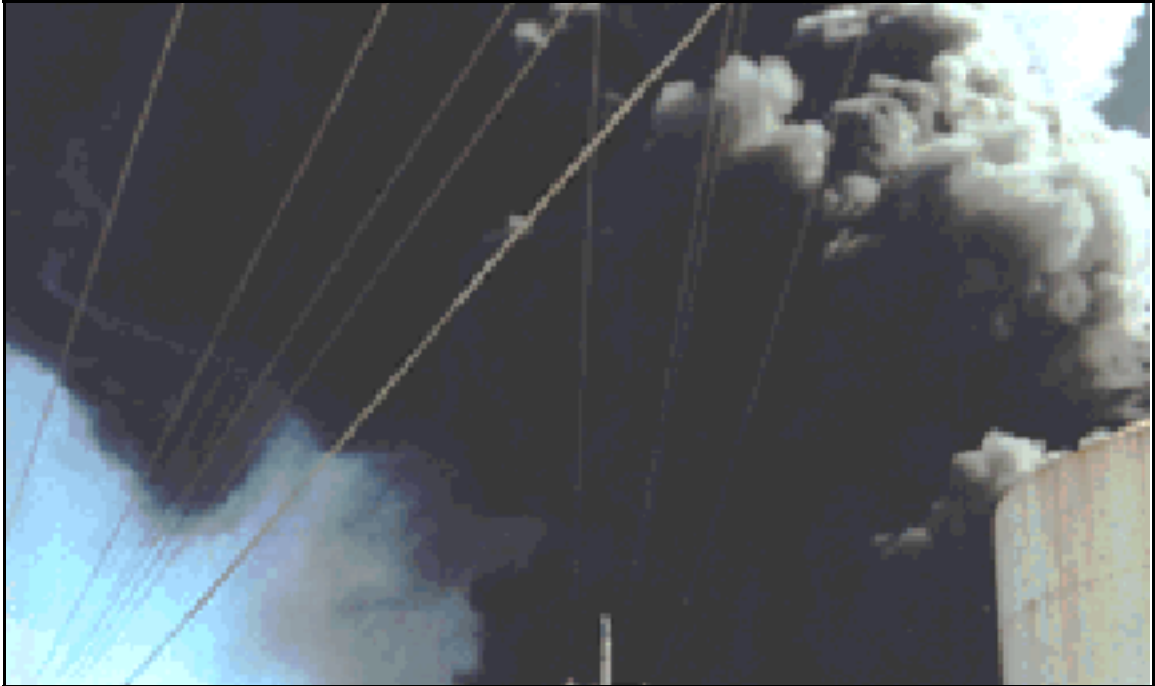
3. Conditions along the north side of the plant looking from west to the east. The photograph was taken very early in the fire and represents conditions not long after fire department arrival.

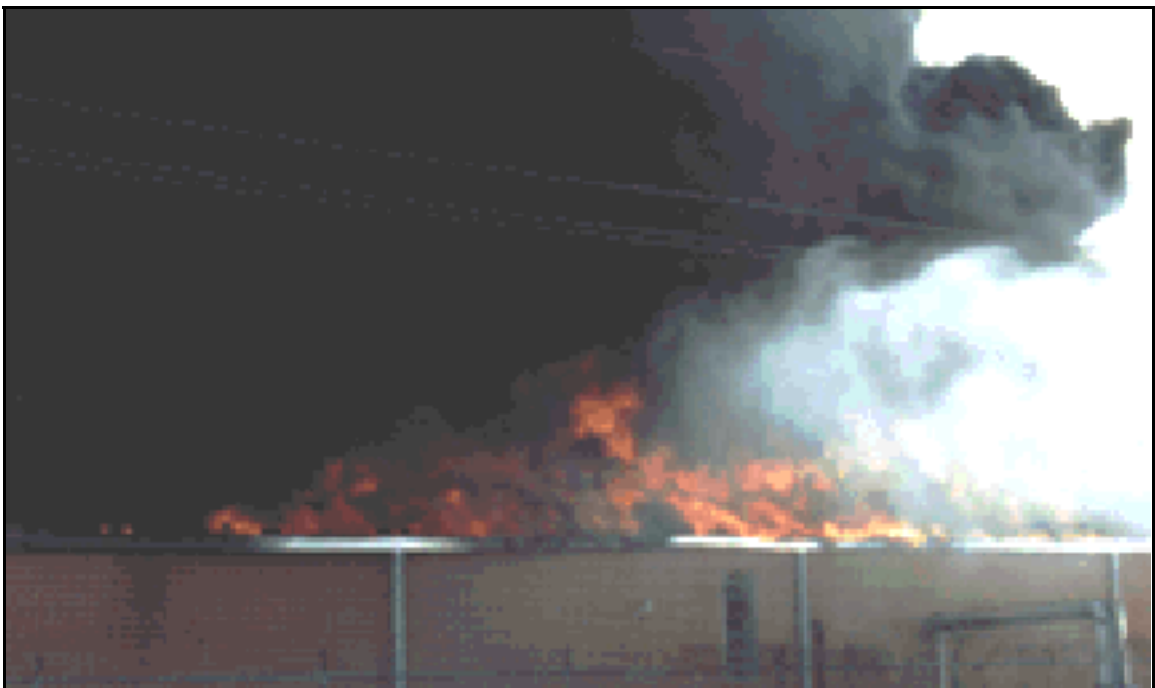
4. One of the early master streams on the fire on the north side. There is an elevation drop of 15 to 20 feet between street level and ground level at the brick wall. One of the heat transfer fluid boilers is in the background just off the engine's tail board.

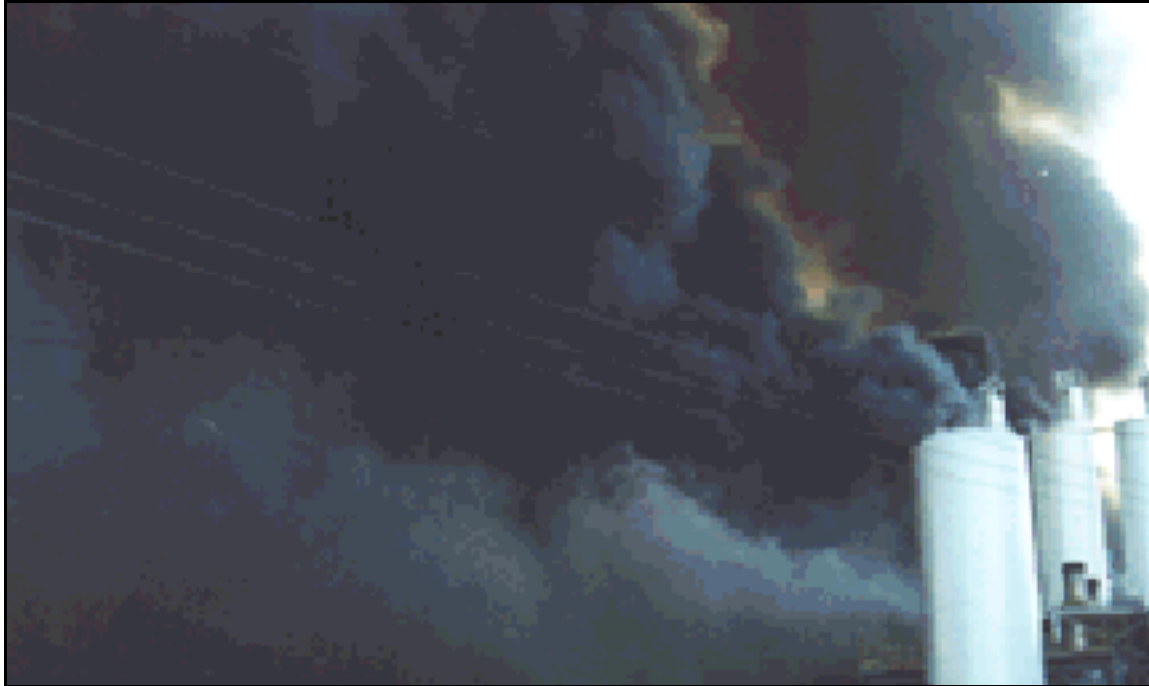
5. Conditions along Swift Street northeast of the plant. The large diameter supply line is in place to supply Engine 4 operating in the corner.

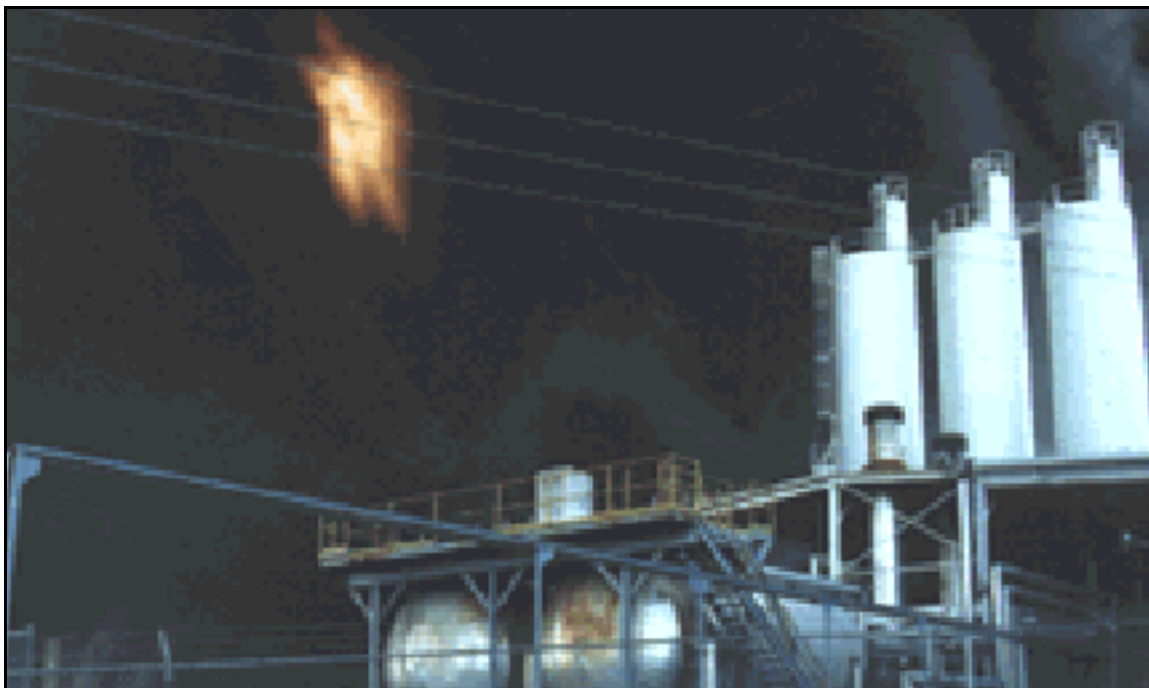
6. The two heat transfer fluid boilers and support equipment that supplied the carpet making range initially involved in the fire. Engine 4 is behind the concrete embankment.

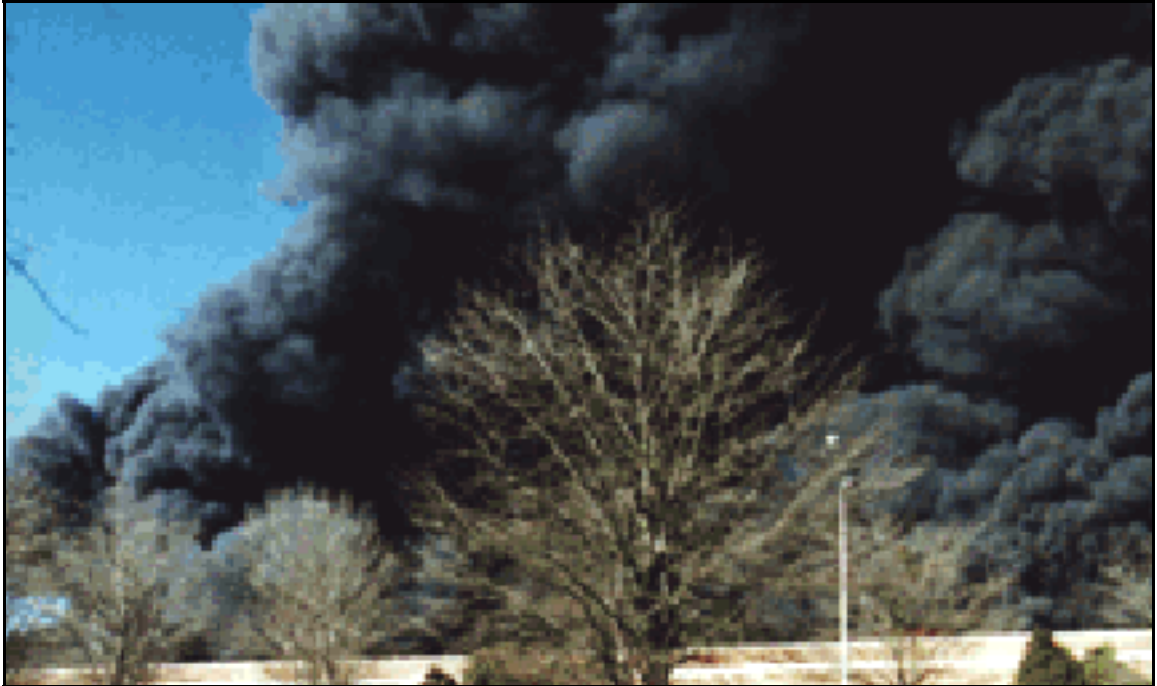
7. Conditions on the south side of the complex looking north from a position out from the northeast corner. At this point, the fire involves most of the 1972 addition.

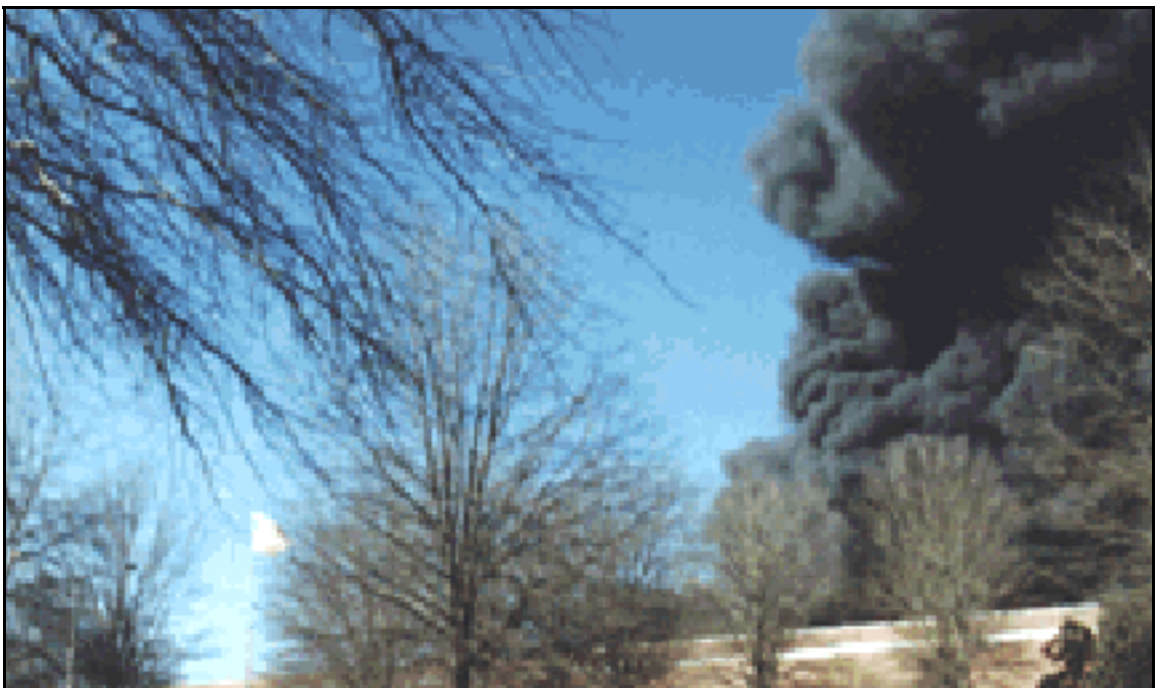
8. Conditions on the south side of the complex looking north from a position out from the northeast corner. At this point, the fire involves most of the 1972 addition.

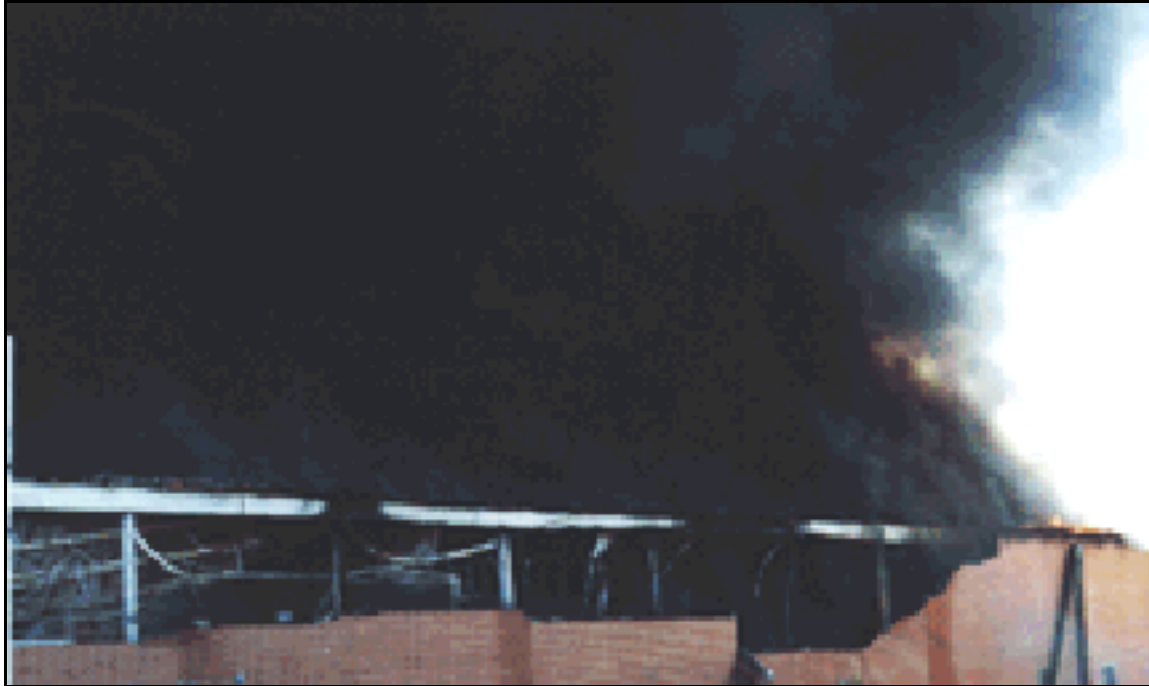
9. Conditions at the northwest corner of the building looking west from near Swift and Polk Streets. The outside post indicator valves (PIV's) and outside flow alarm bells for the sprinkler risers can be seen.

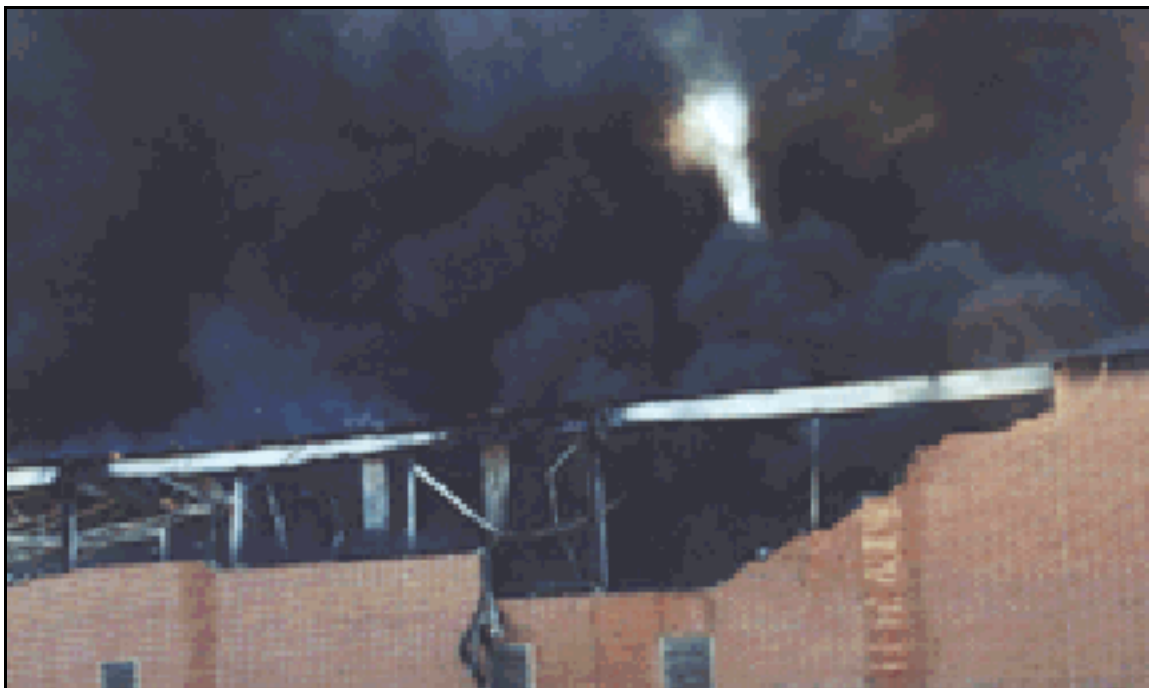
10. Close-up of the area in photograph 9. In addition to the flow alarm bells and PIV's, the top of a yard hydrant is in the lower left corner.

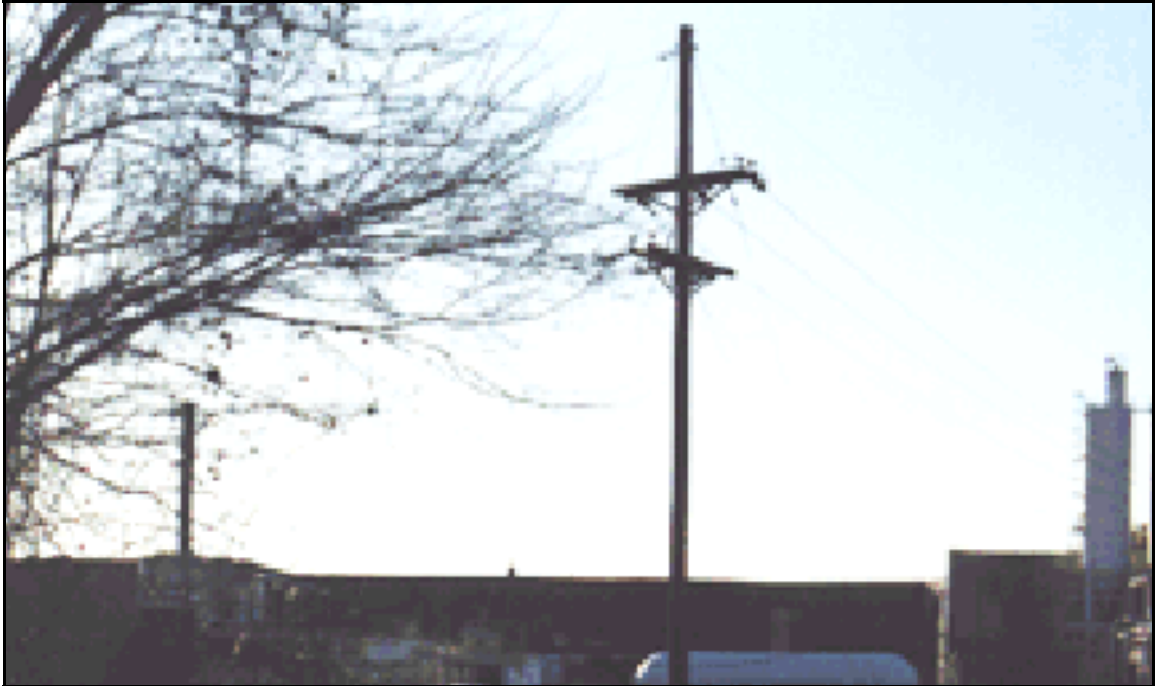
11. Several days after the fire, the northeast corner of the complex. The LP-gas storage tanks, raw material storage silos, and heat transfer fluid boilers and support equipment are shown. Taken from Swift Street looking west.

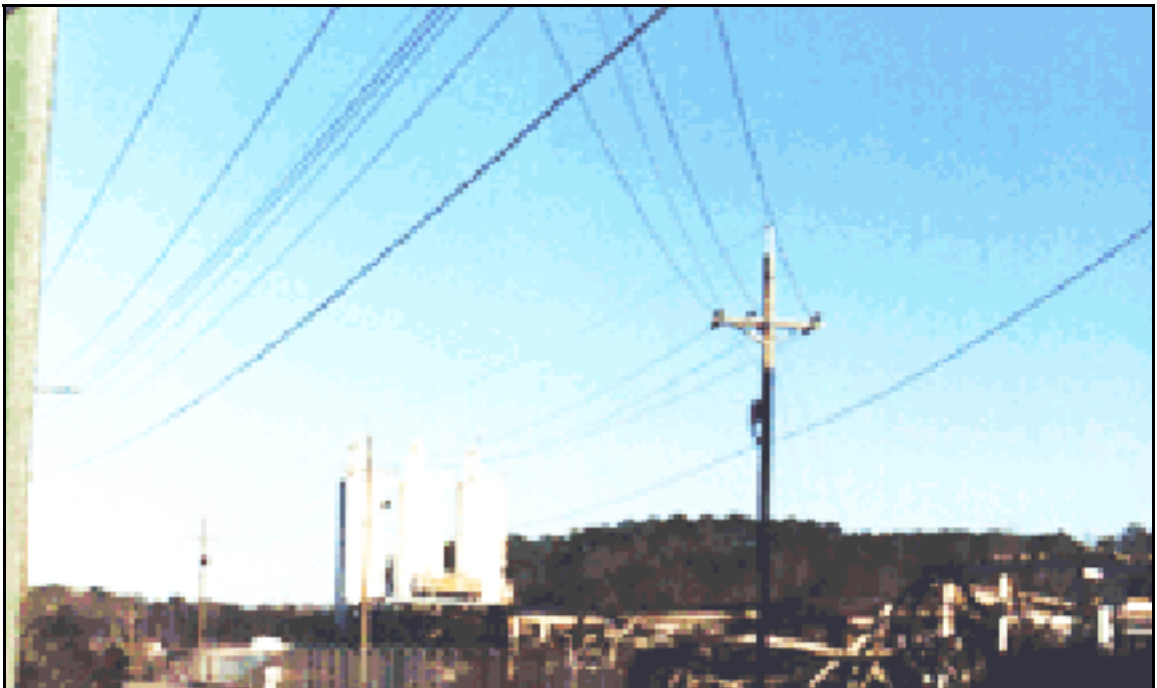
12. Nearly the same position as photograph 3. One of the fire protection water storage tanks is in the right hand side of the photograph. Taken looking east from near the intersection of Swift and Polk Streets.

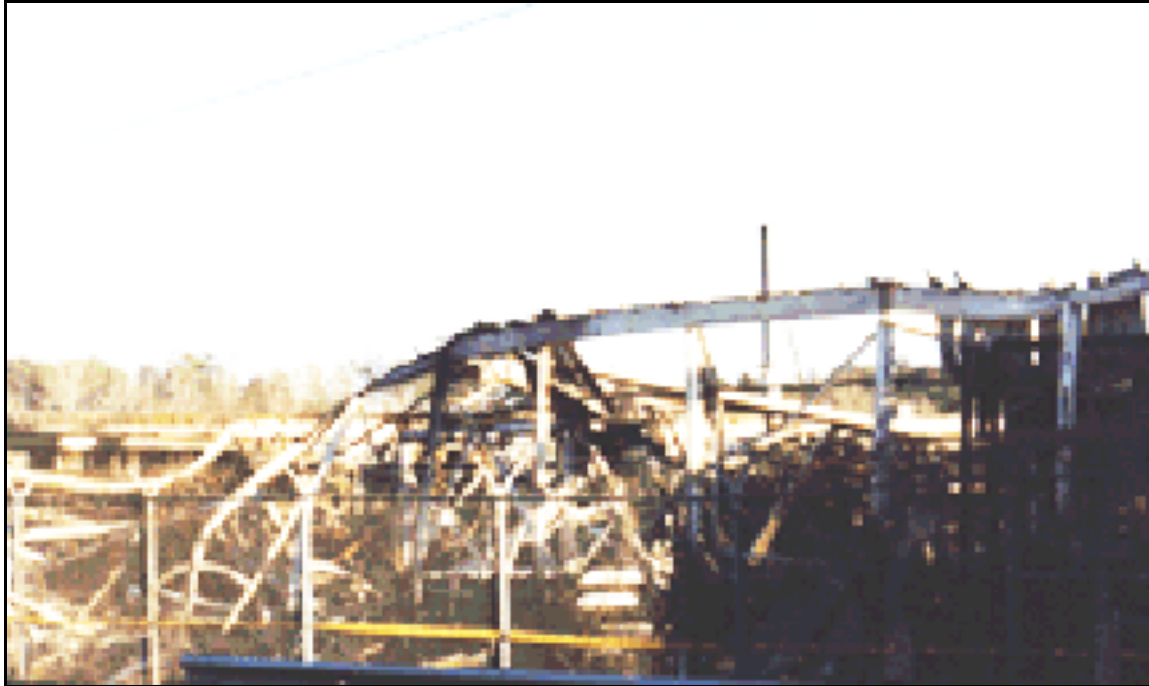
13. Some of the same area in photograph 4 but from a different angle and after the fire. In the bottom right hand corner is one of the heat transfer fluid boilers.

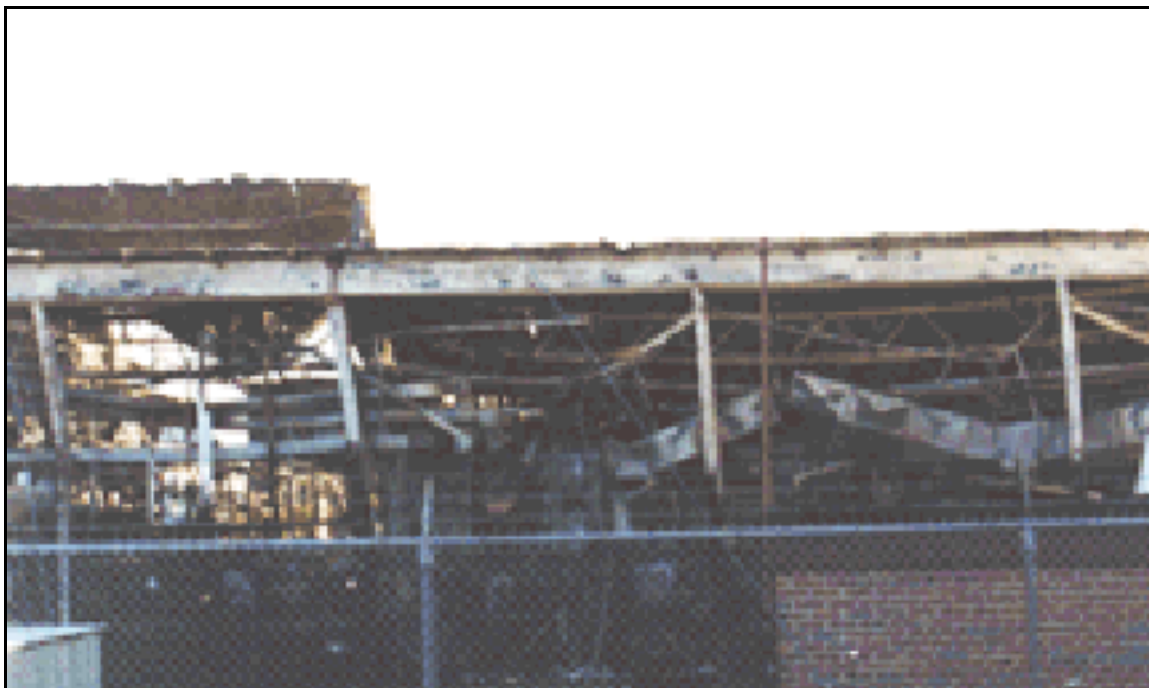
14. The east fire pump house and a view into the building showing some of the manufacturing equipment and ductwork. The west side of the heat transfer fluid boiler in photographs 4 and 13 is on the left edge of the photograph.
