Technical Report Series

## Manufacturing Mill Fire Methuen, Massachusetts

This is Report 110 of the Major Fires Investigation Project conducted by Varley-Campbell & Associates, Inc. under contract EMW-94-C-4423 to the United States Fire Administration, Federal Emergency Management Agency.

December 11, 1995

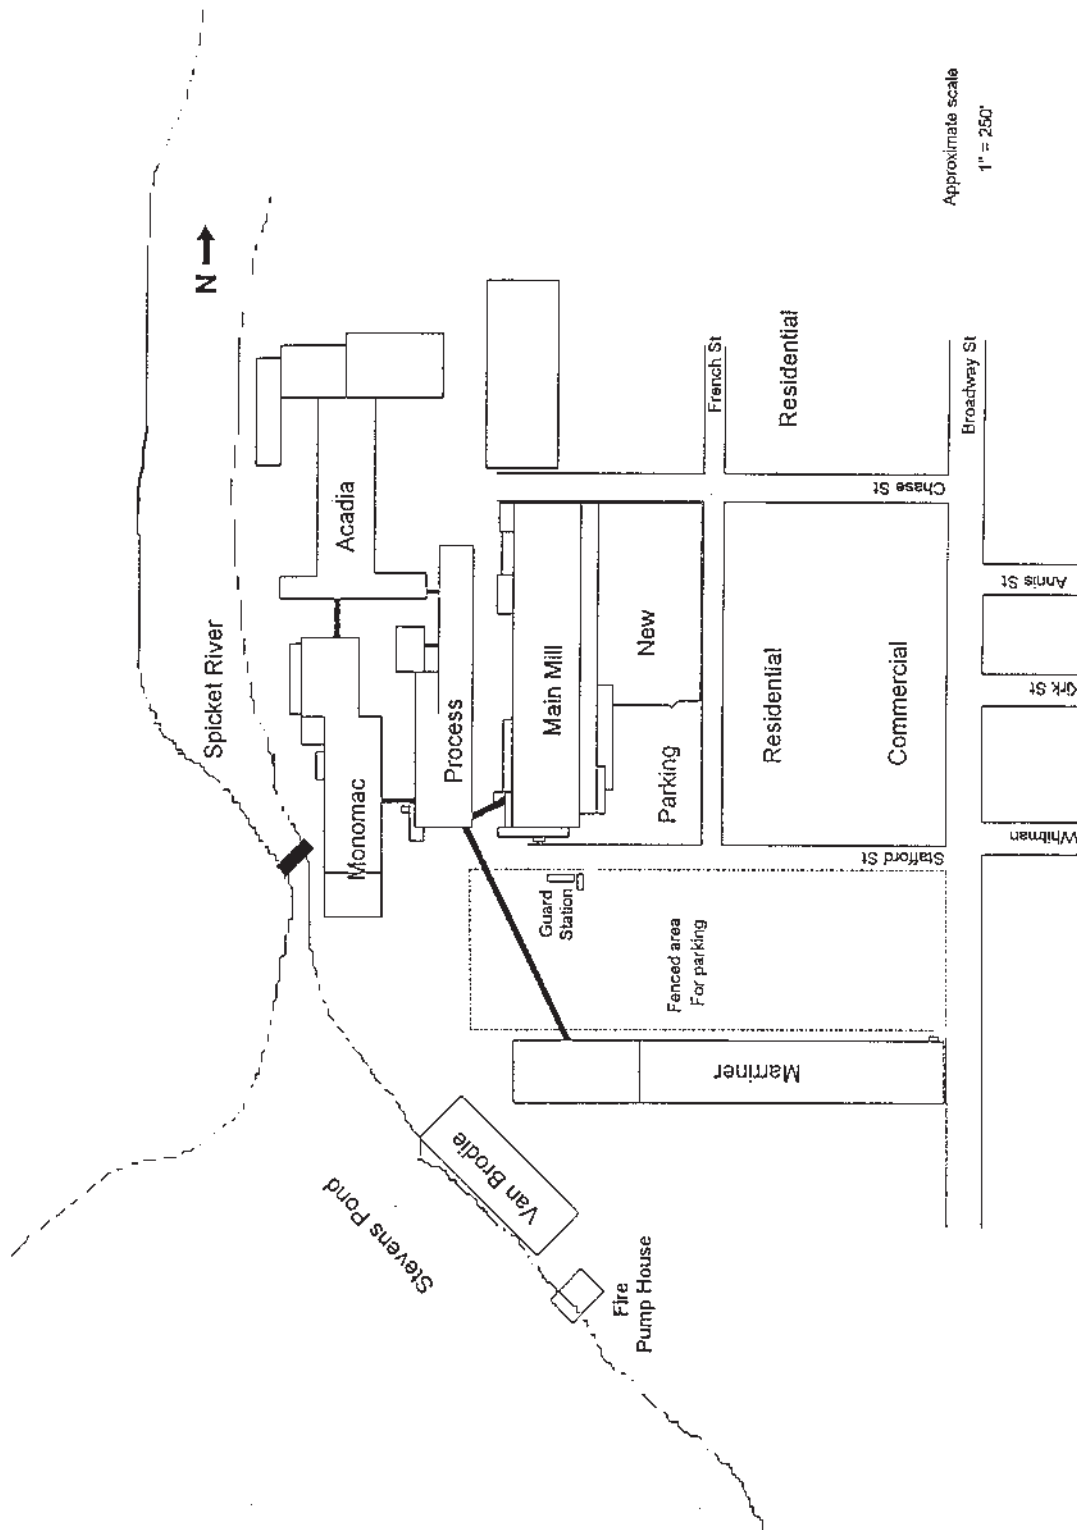
**Figure 1**  
Area Plan

The fire originated in the Monomac building, which was approximately 500 ft. long, 100 ft. wide and 5 stories (approximately 100 ft.) high. The Acadia Mills building, which was about 360x100 ft. in area and three stories (60 ft.) in height was located about 50 ft. north of the Monomac Building. These two large buildings ran north and south, parallel to the Spickett River, and were connected by an enclosed overhead passageway at the third floor level. (Figure 1).

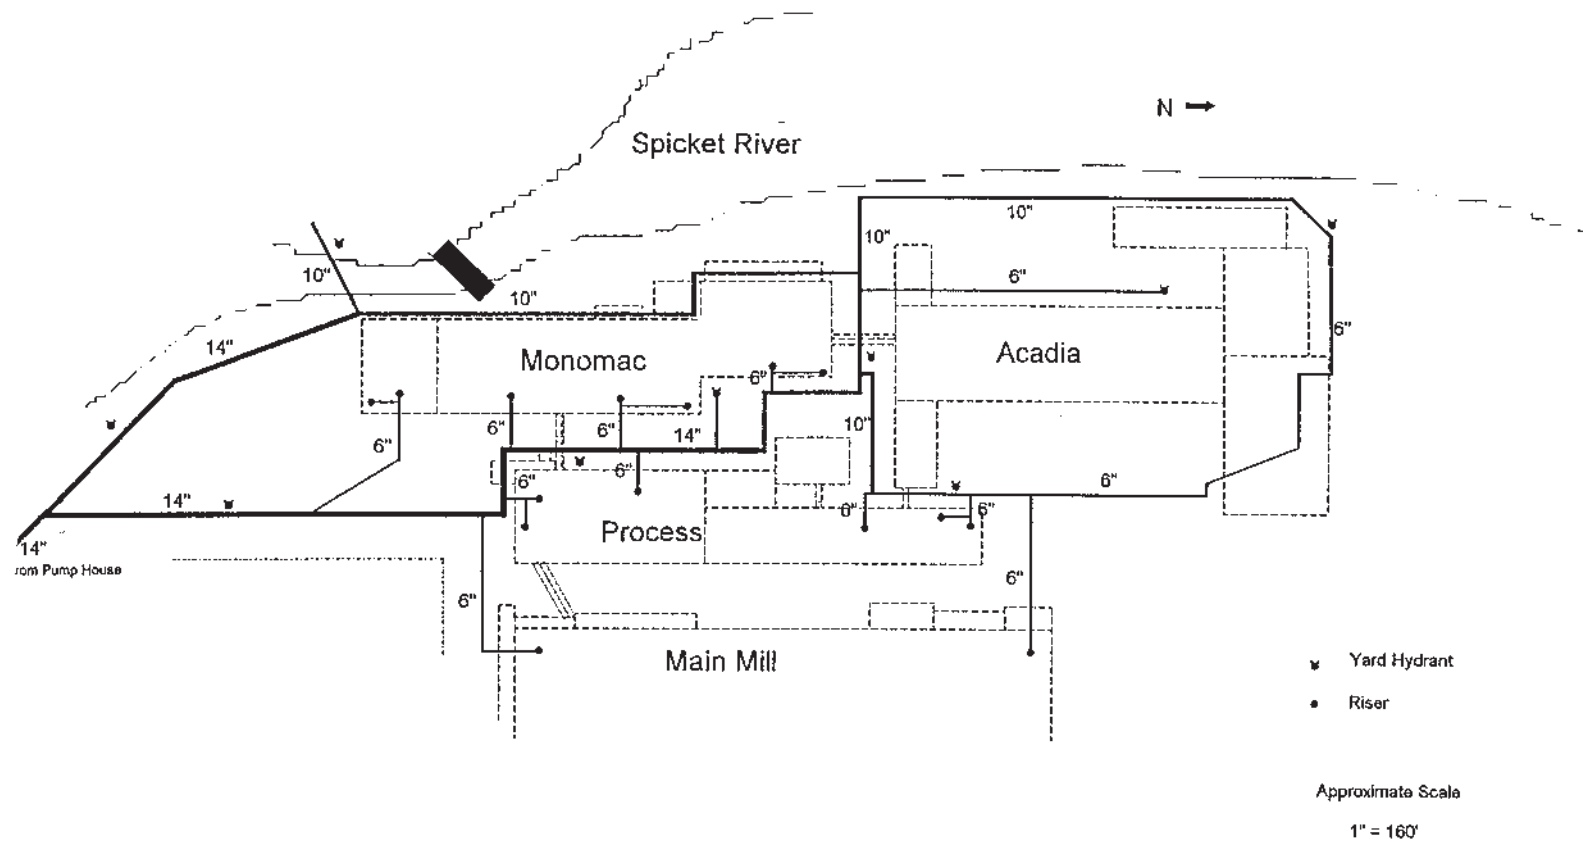
**Figure 3**  
Private Water System

The on-site fire protection system was supplied by a 2000 gpm electric fire pump and a 2000 gpm diesel powered backup pump which both drew water from the river. Both pumps could operate simultaneously to supply a rated capacity of 4000 gallons per minute to the fire protection systems. A 750 gpm jockey pump was set to maintain a static pressure of 120 psi in this system. A 14" main delivered water from the pump house to the alley between the Monomac and Process buildings. A 10" main was buried to the west of the Monomac and Acadia buildings, parallel to the river, and the loop was completed by a 6" main. (Figure 3)

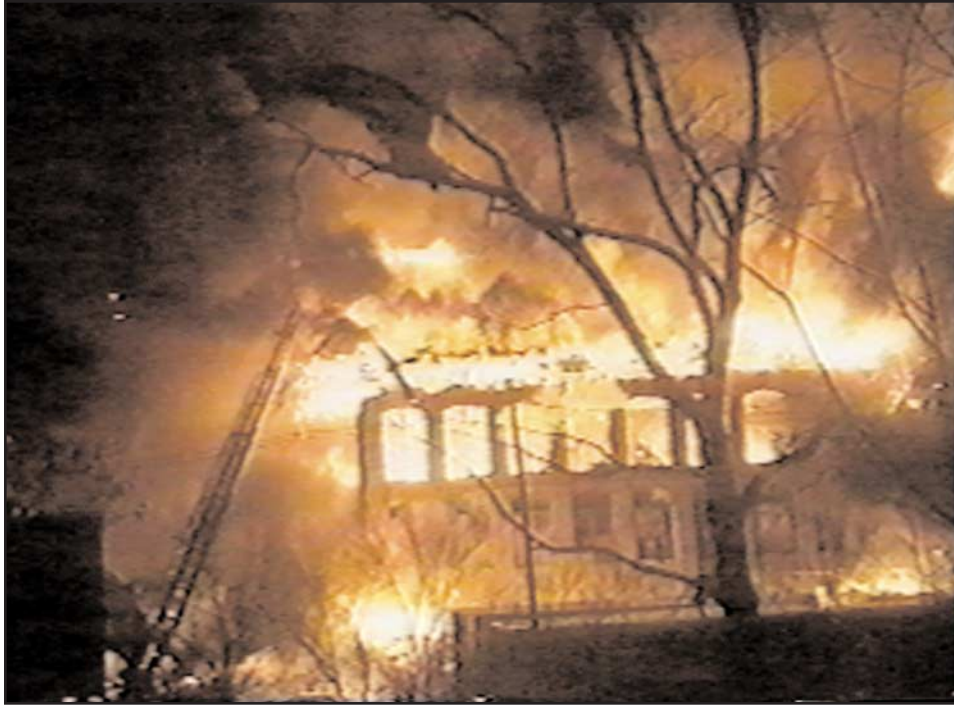
1. Ladder pipe operations near the northwest corner of the Monomac Building early in the fire. Vantage point was across the Spickett river.

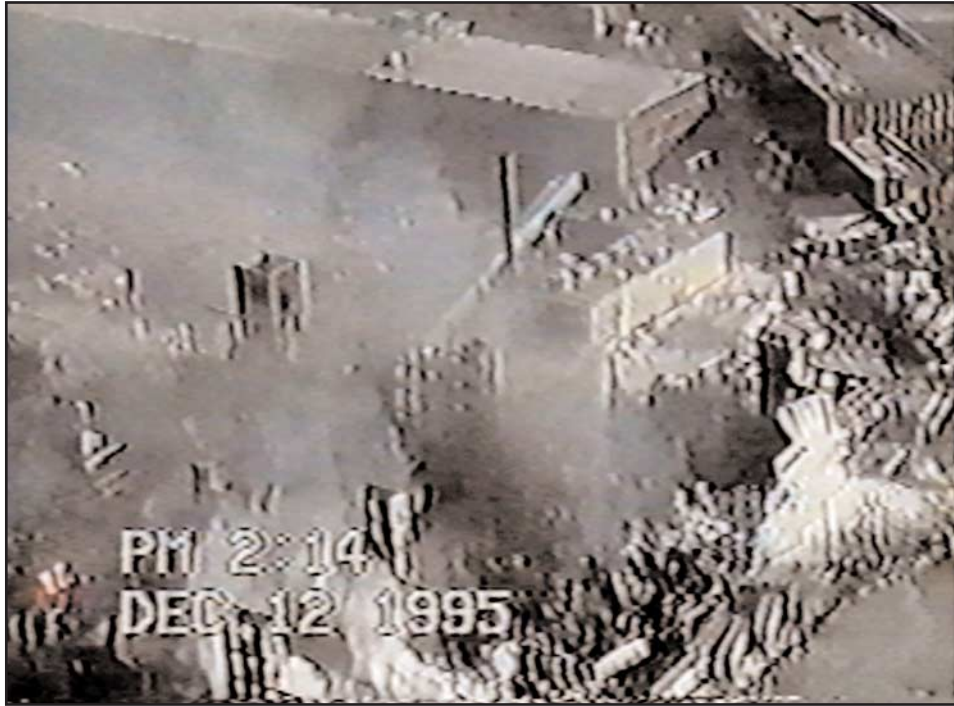
3. Ariel view of the fire scene early afternoon on December 12, 1995 looking southwest. The Mariner and Van Brodie Buildings are in the background.

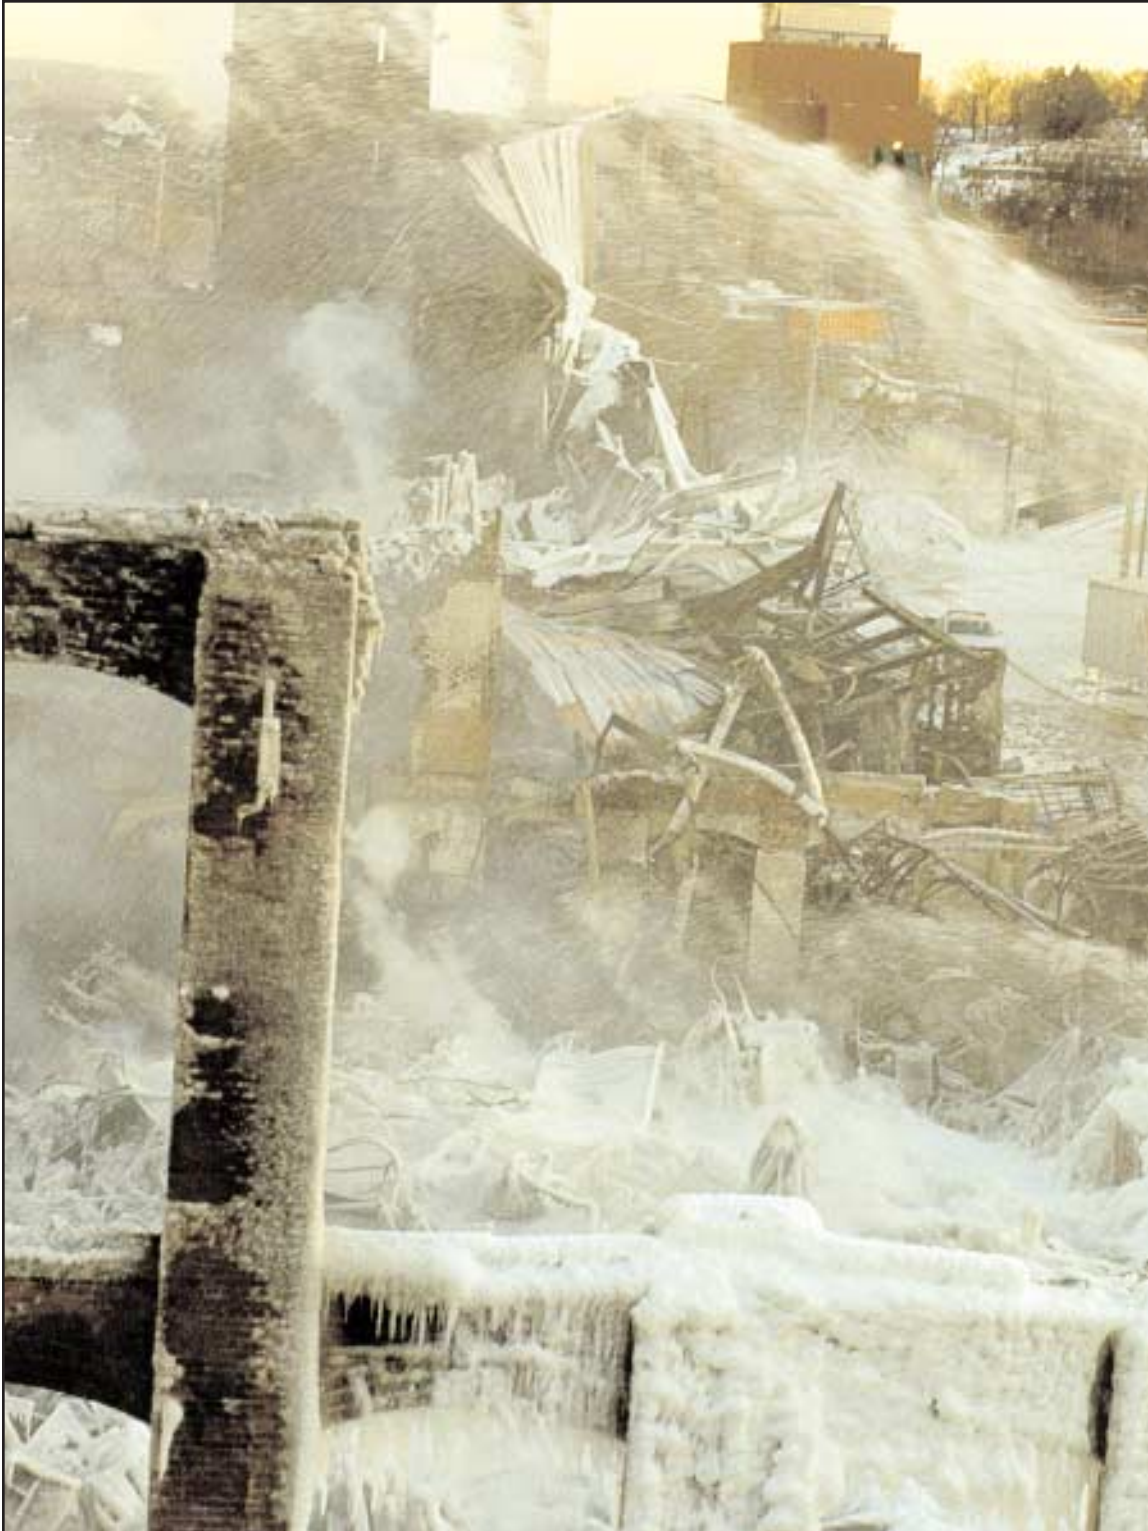
5. Remains of the Monomac Building looking to the south.

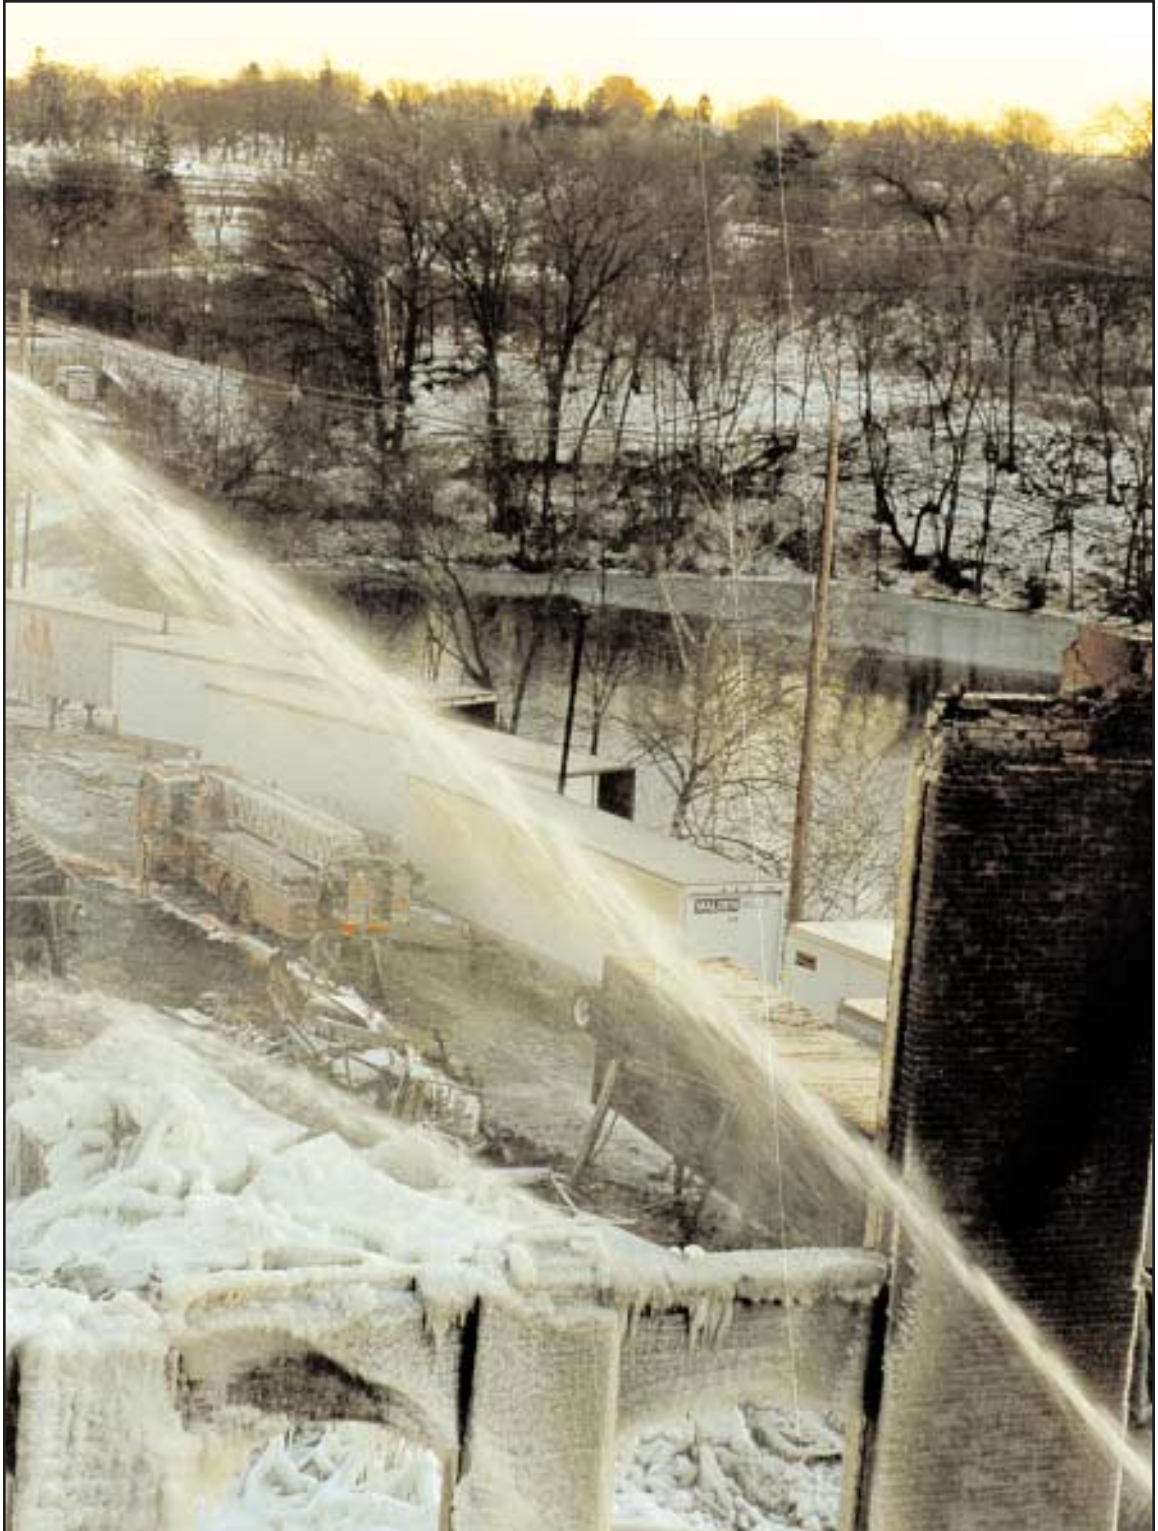
The Spickett River formed the west perimeter of the property. Between the buildings and the river was an open area, approximately 50 feet wide. A large number of 40 foot trailers, some of which were used for storage, were parked in this area. Several trailers were parked at the loading dock and more were parked along the west wall of the building.

6. Conditions on the west side of the site with the truck trailers and the Spickett River.

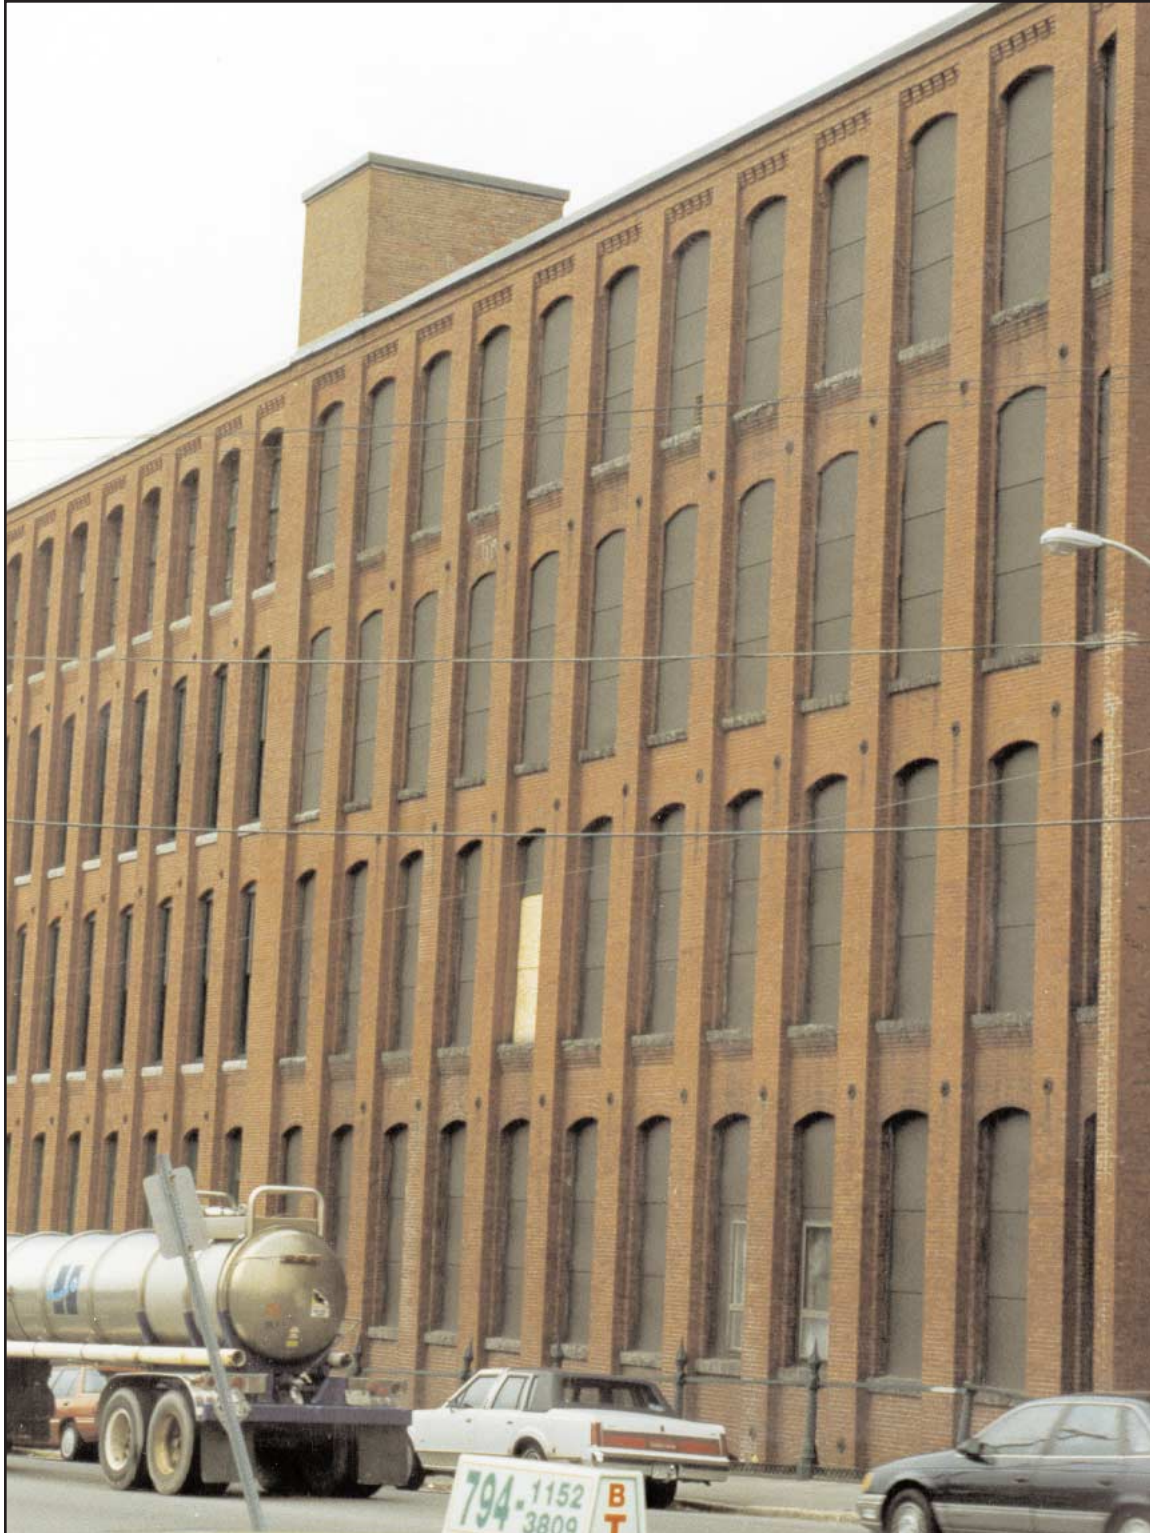
11. Windows once needed for natural light have been covered over, making visible fire location difficult. In addition, depending on the materials used, ventilation may be difficult.
