**Tanker Truck Fire**

**Date of Incident: August 14, 2001**

**Type of Incident: Fatal**

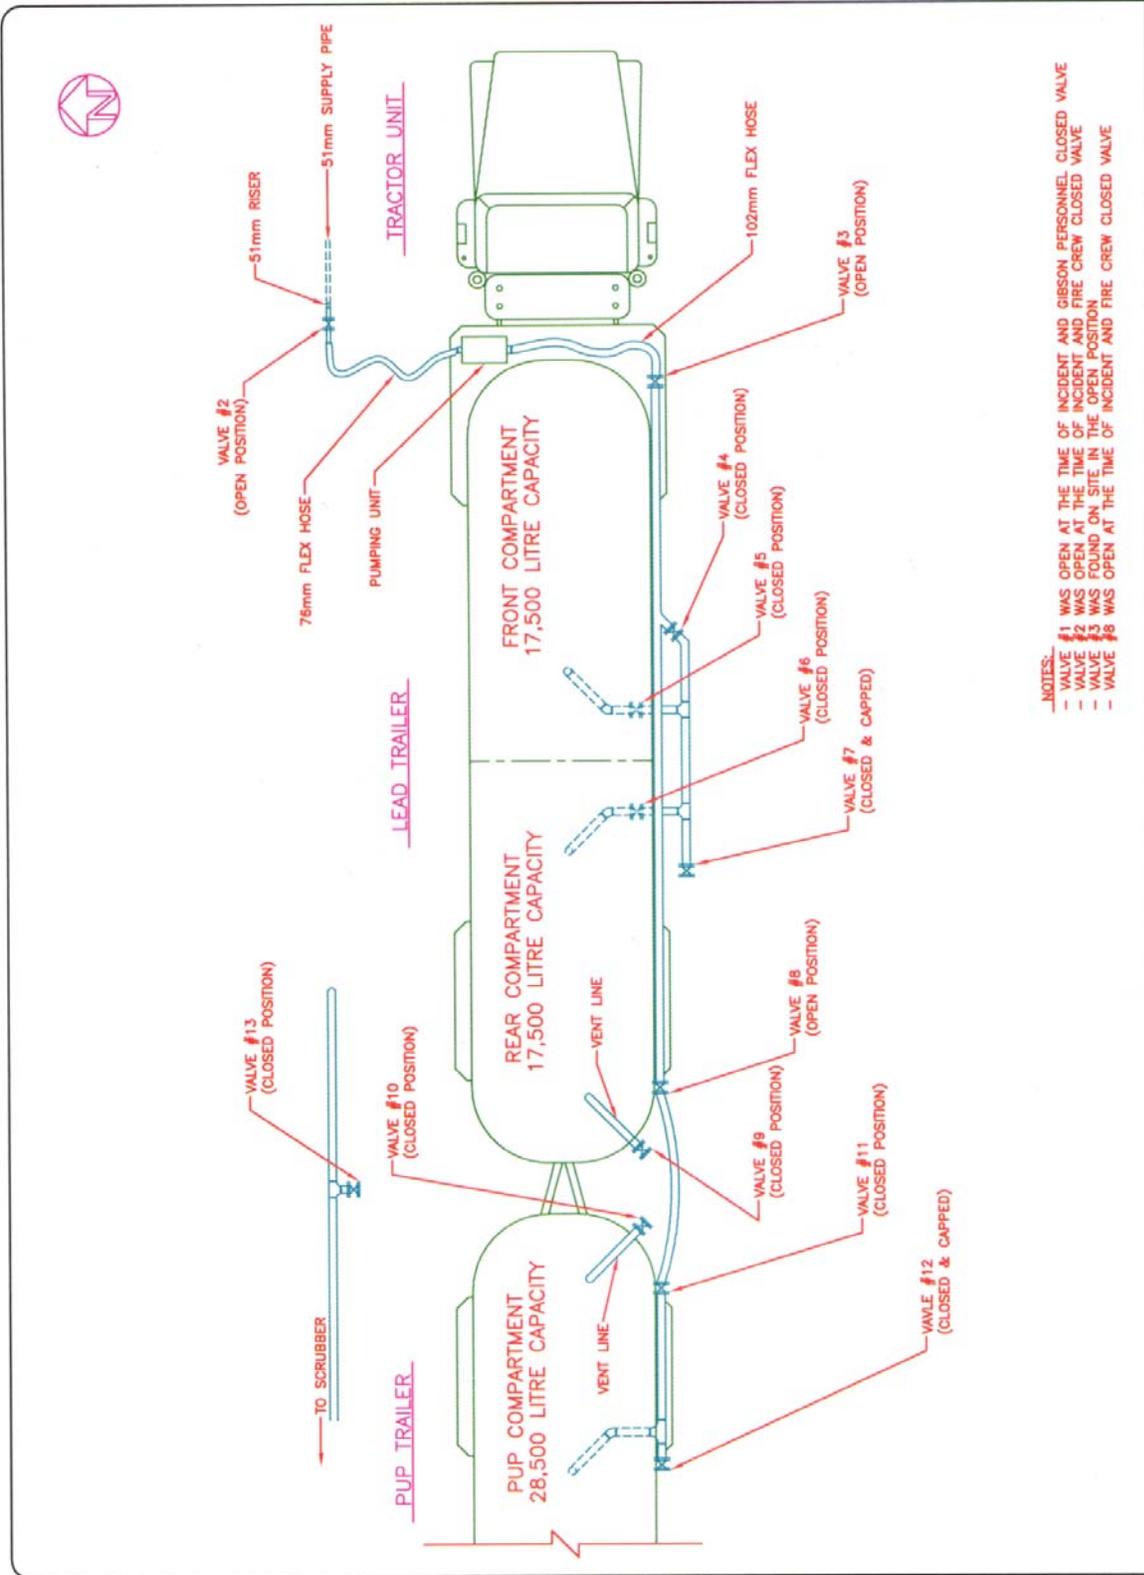
- 7.2.1 Discharge valves in the loading piping system were closed, which did not allow the condensate to flow and created over pressure in the flex hose.
- 7.2.2 The loading pump on the truck was a positive displacement model pump, which continually built pressure in the flex hose.

- NOTES:
- VALVE #1 WAS OPEN AT THE TIME OF INCIDENT AND GIBSON PERSONNEL CLOSED VALVE
  - VALVE #2 WAS OPEN AT THE TIME OF INCIDENT AND FIRE CREW CLOSED VALVE
  - VALVE #3 WAS FOUND ON SITE IN THE OPEN POSITION
  - VALVE #8 WAS OPEN AT THE TIME OF INCIDENT AND FIRE CREW CLOSED VALVE

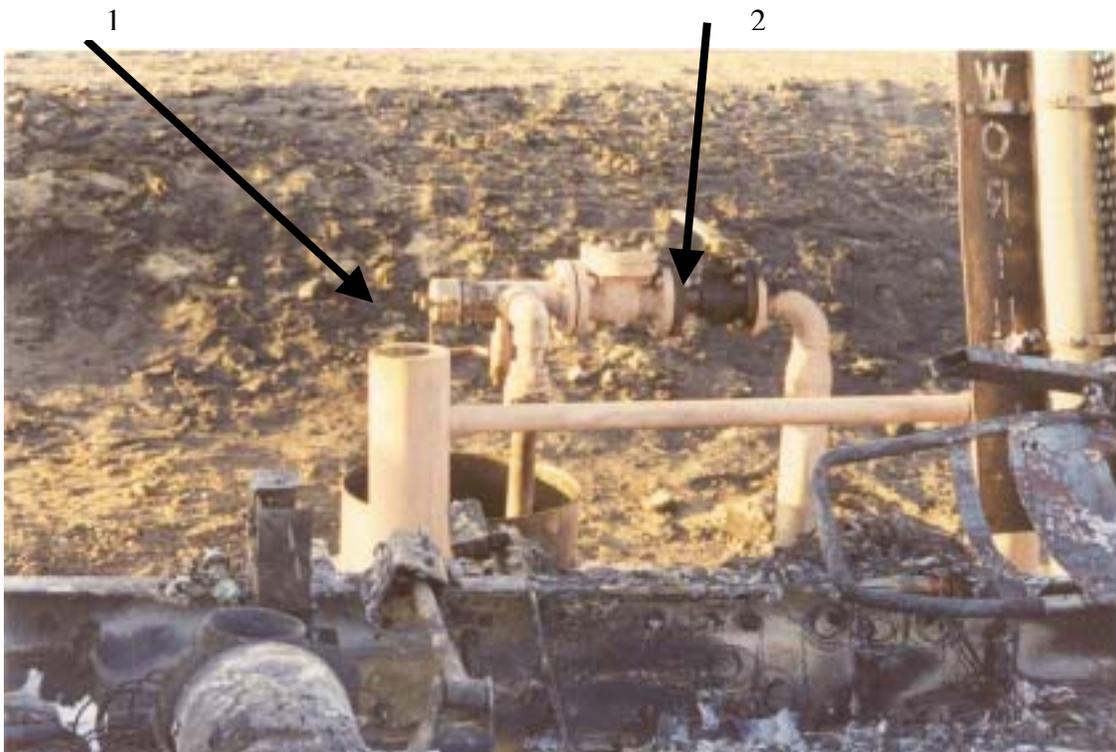
**Photograph 1:** Shows the loading riser.

1. Shows where the truck driver attached the flex hose to the loading riser.
2. Shows the loading riser equipped with a ball valve.

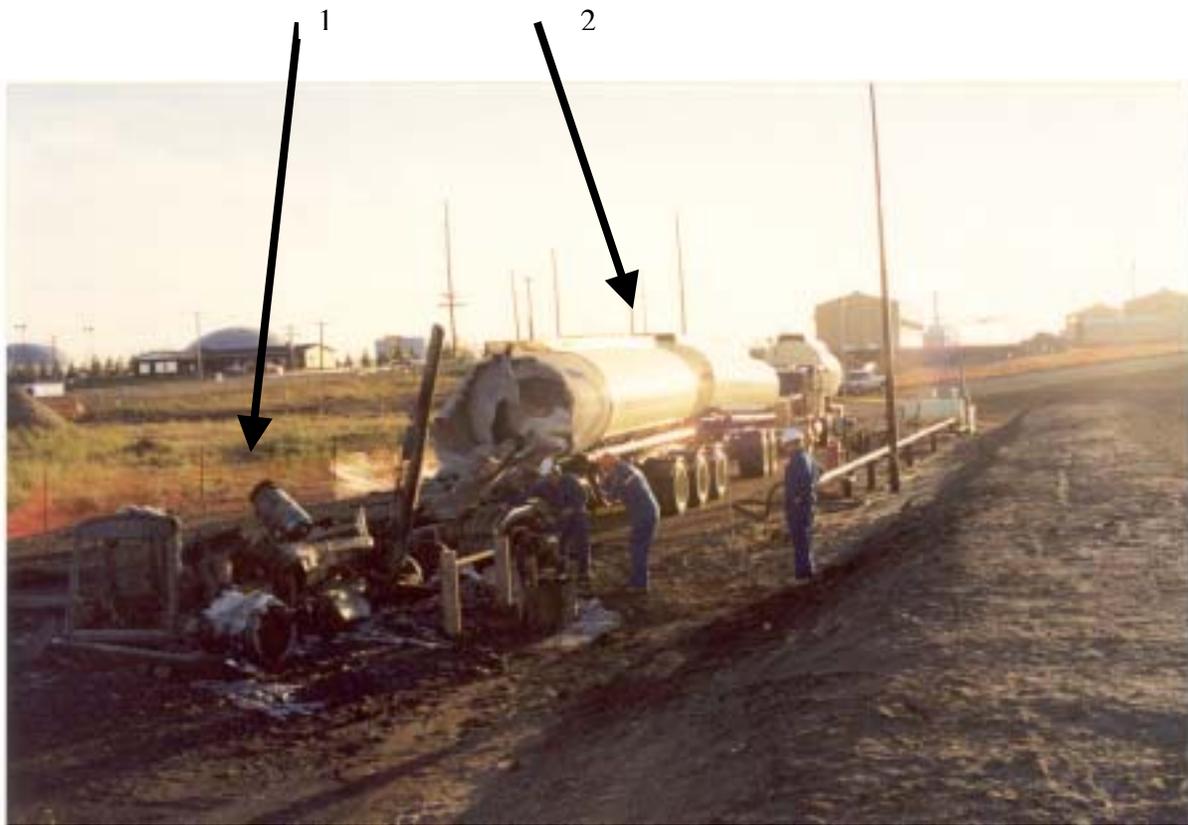
**Photograph 2:** Shows the damaged truck and loading tank trailers.

- 6.3 Witnesses observed a large plume of natural gas condensate spewing into the air. At approximately 3:45 p.m. the truck's engine began to accelerate and the natural gas condensate plume ignited. Two explosions occurred. Fire engulfed the truck cab and severely damaged the front compartment of the 35,000-litre storage tank trailer.

1. Shows the burned 2000 Kenworth truck.
2. Shows the two storage tank trailers attached to the truck: a 35,000-litre capacity lead tank and a 28,500-litre capacity rear tank.

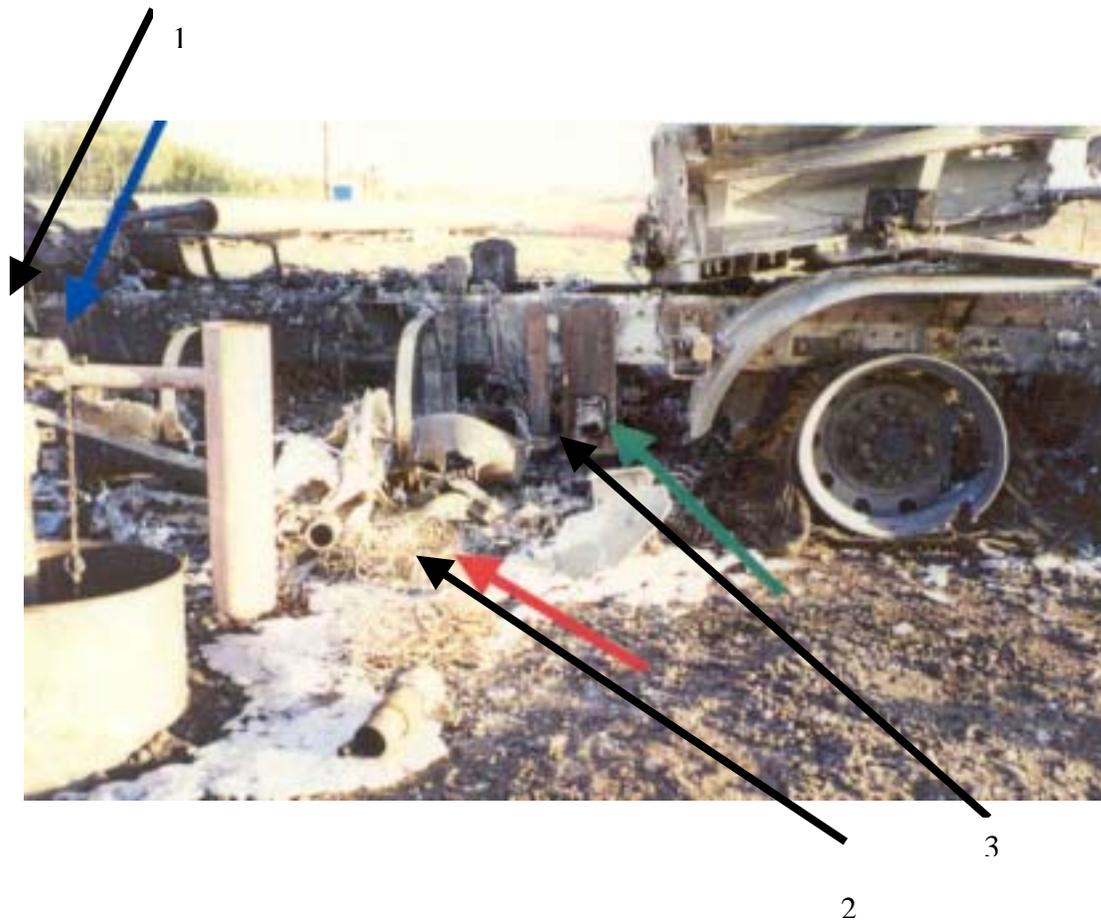
**Photograph 3:**

- 7.1.1 Over pressure burst the flex hose and released flammable natural gas condensate into the air. The released flammable natural gas condensate ignited with an ignition source from the truck engine compartment.

1. Shows the flex hose attachment point on the loading riser.
2. Shows the remains of the burned flex hose.
3. Shows the intake connection of the loading pump.

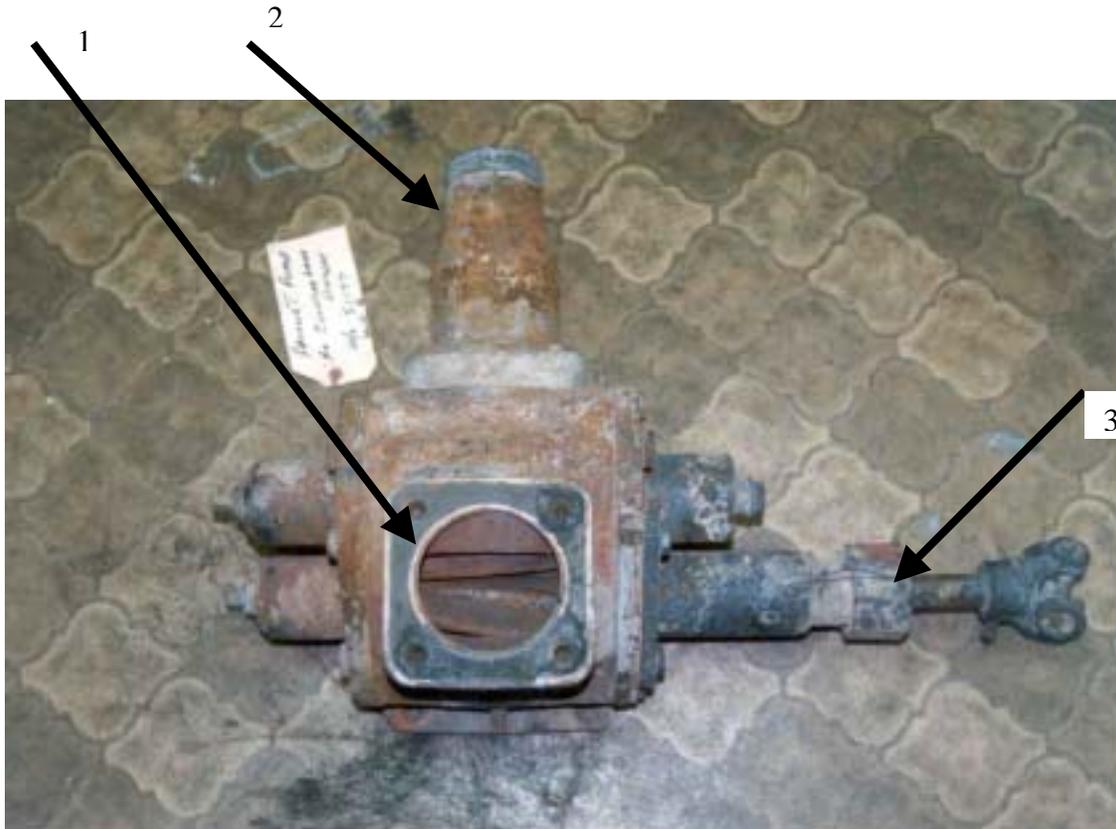
**Photograph 4:** Shows the Roper, Model 3648 pump that was mounted on the truck.

1. Shows the pump's discharge outlet.
2. Shows the pump's inlet connection.
- 3 Shows the drive shaft of the pump that was attached to the truck's engine power take-off.

- 9.3.1 Workplace Health and Safety will meet with the prime contractor to review the consulting engineer's report regarding the installation of pressure relief valves on positive displacement pumps.

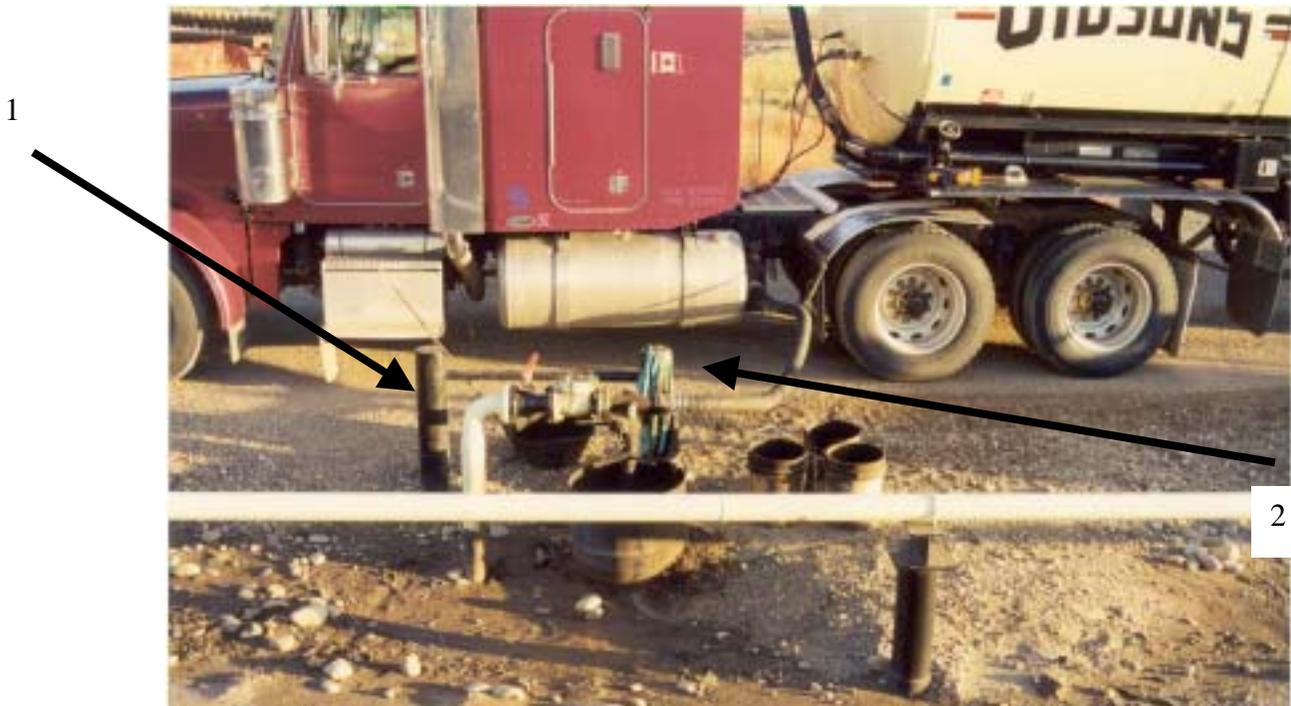
**Photograph 5:** Shows a typical loading arrangement.

1. Shows a loading riser and control valve.
2. Shows the loading riser connected to the pump on a truck with a flex hose.
