CHAPTER I

INTRODUCTION

Shortly after 1:00 p.m. on October 23, 1989, an explosion and fire ripped through the Phillips 66 Company, Houston Chemical Complex in Pasadena, Texas. Twenty-three workers were killed and more than 130 injured. Two production plants within the Phillips complex were completely destroyed, causing nearly \$750 million worth of damage. Debris from the explosion was thrown as far as 6 miles into the neighboring community. The accident was one of the worst industrial workplace accidents in the United States in the past 20 years.

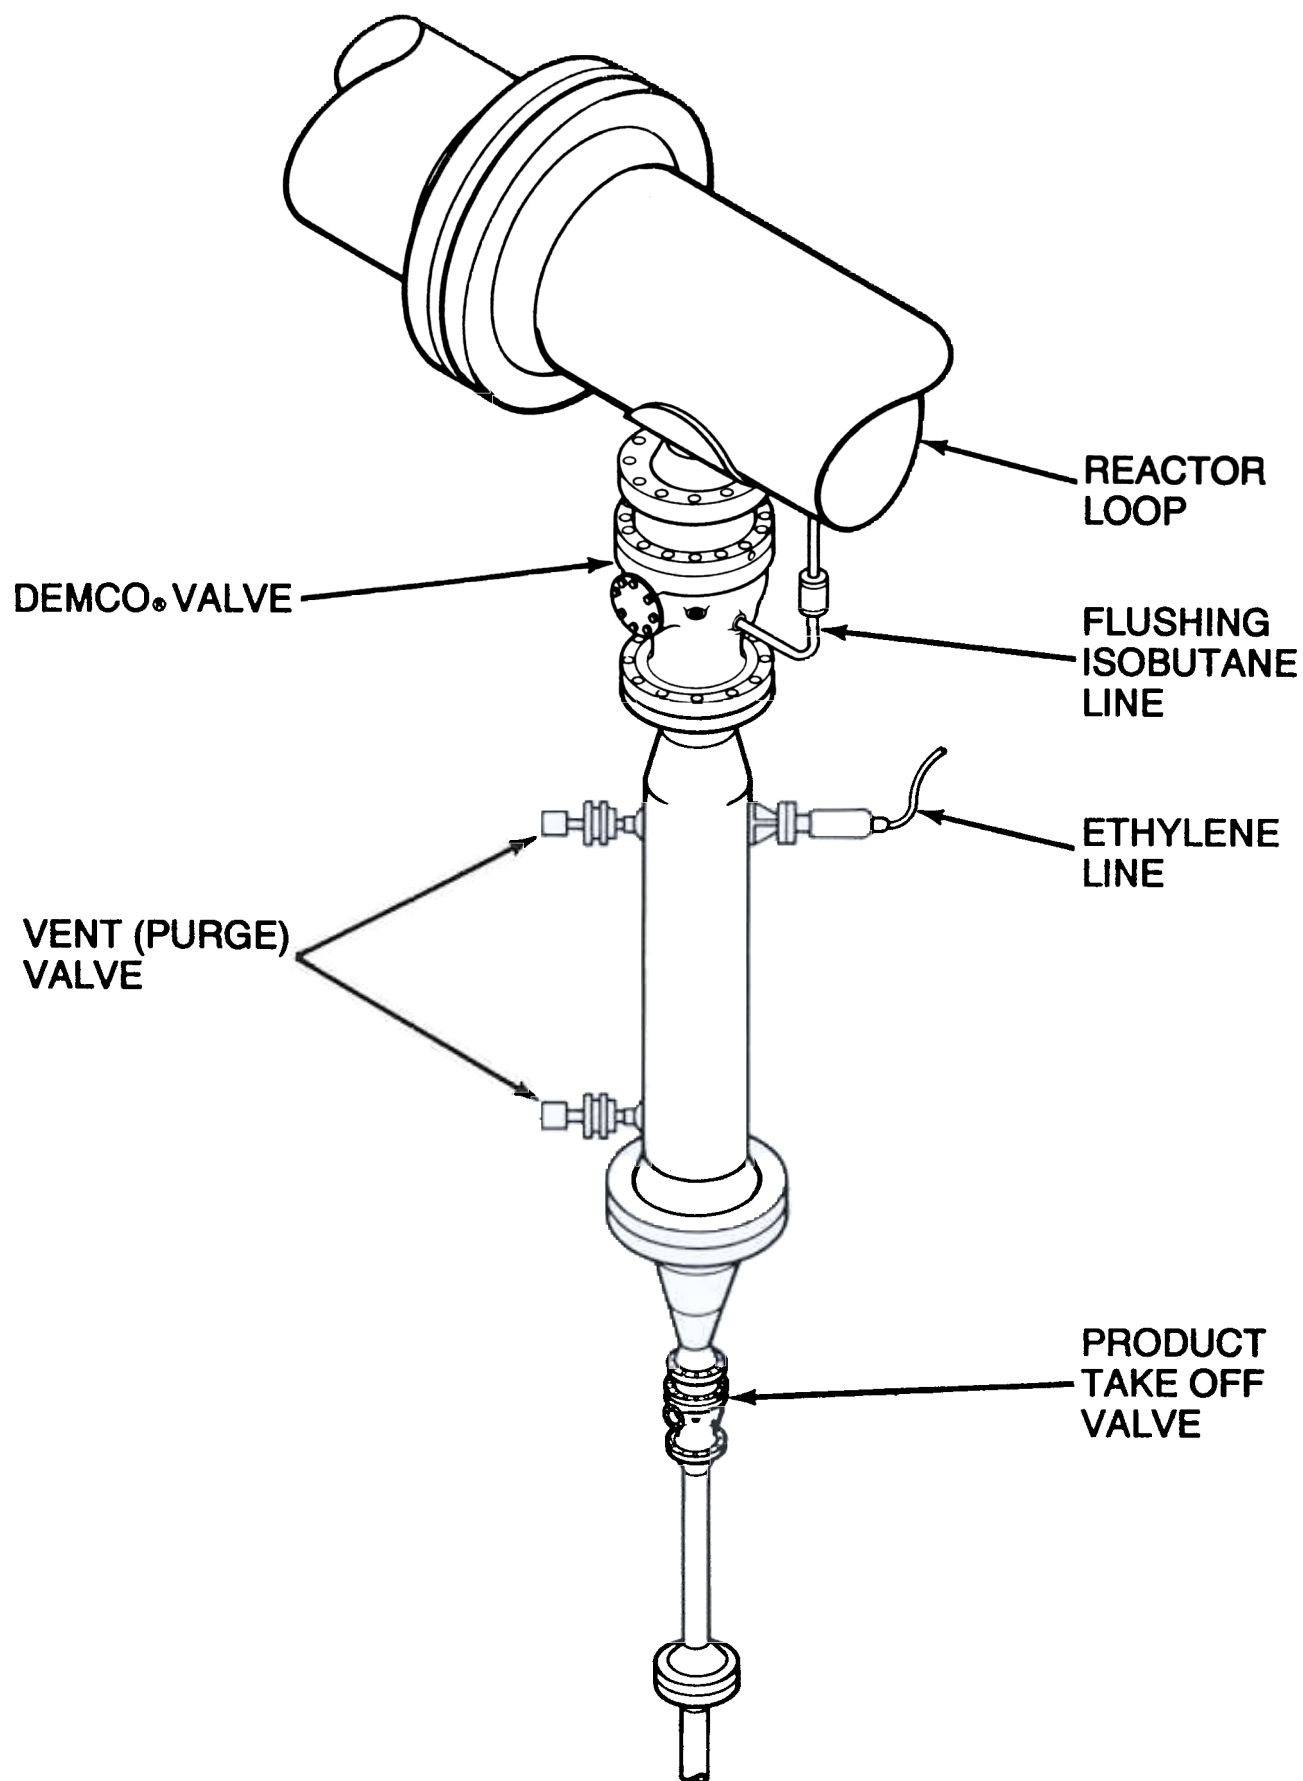
Figure 3. Typical Piping Settling Leg Arrangement

In the Phillips reactor, the plastic material frequently clogged the settling legs. When this happened, the DEMCO® valve for the blocked leg was closed, the leg disassembled, and the block removed. During this maintenance process, the reaction continued and the product settled out in the legs that remained in place. If the DEMCO® valve were to open during a cleaning-out operation, there would be nothing to prevent the escape of the gas to the atmosphere.

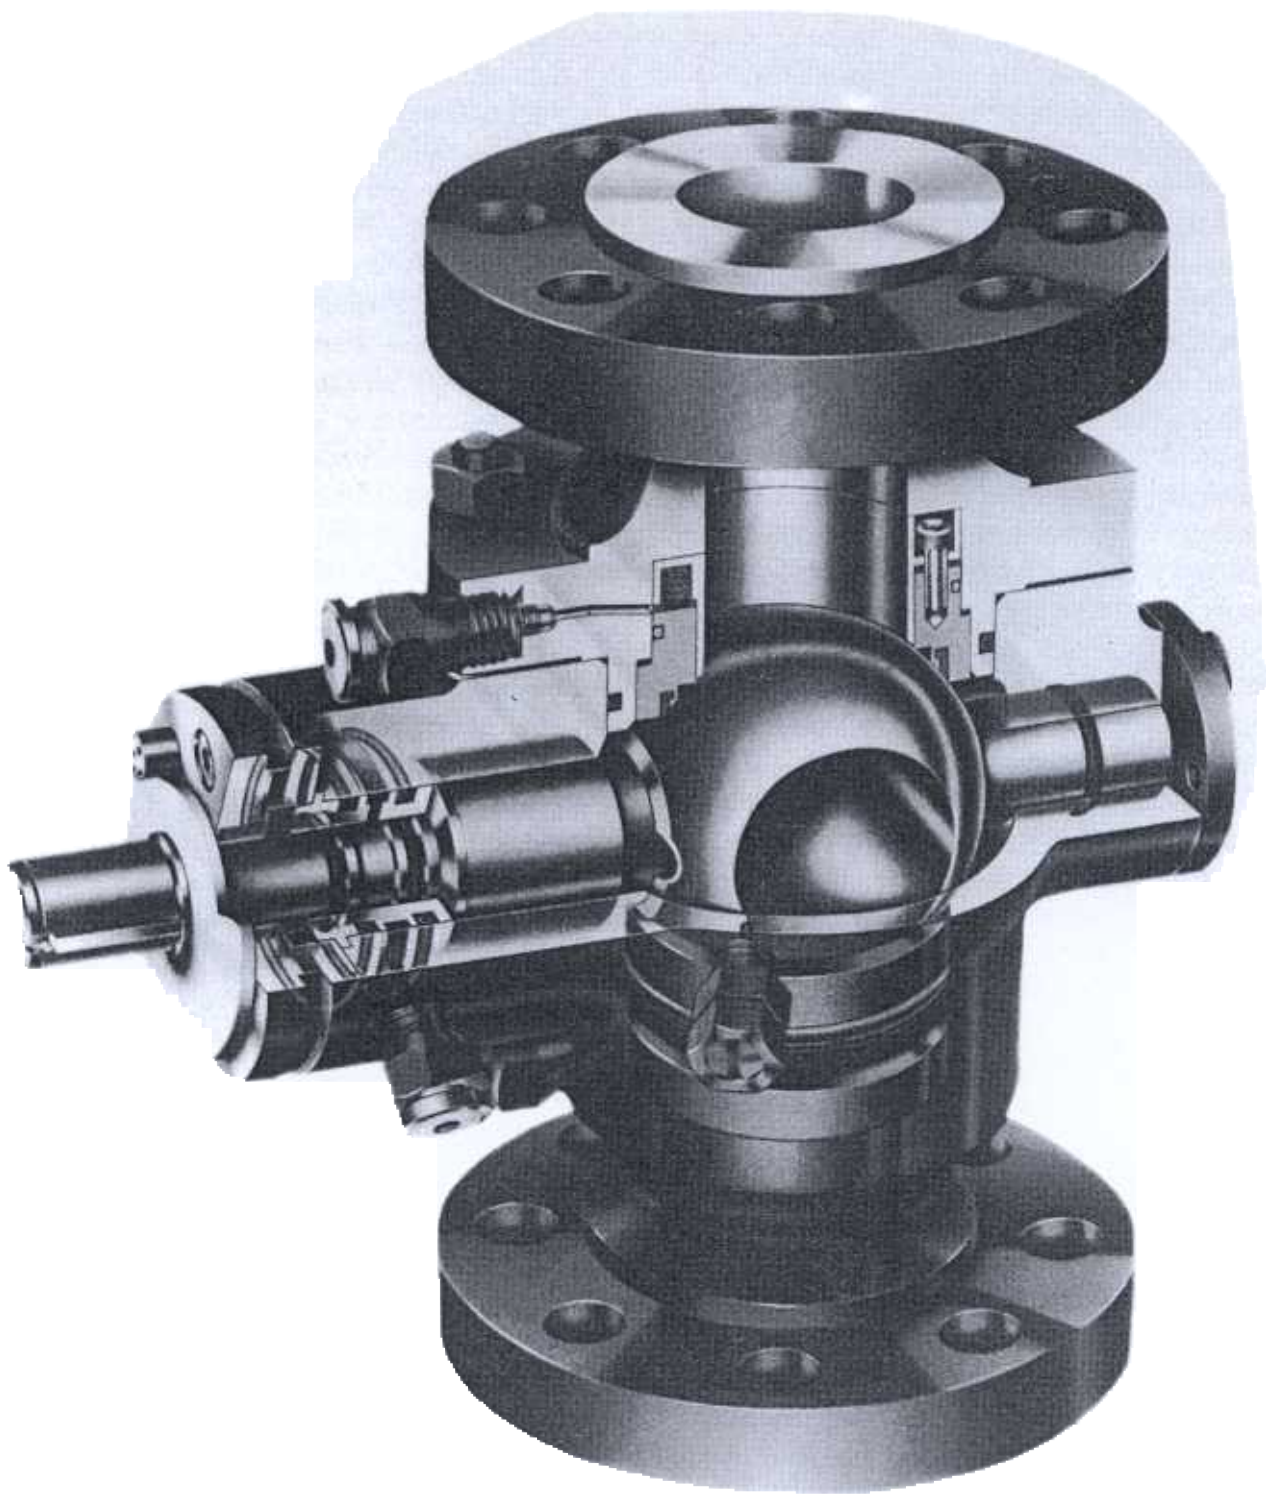
Figure 4. DEMCO® Valve

High-density polyethylene is manufactured in Plants IV and V of the Phillips Complex from ethylene gas dissolved in isobutane, which is reacted in long pipes under elevated pressure and temperature. Various chemicals are added to the process to modify the polyethylene to meet the desired product characteristics. This combination of process gases at elevated pressure and temperature is extremely flammable. The dissolved ethylene reacts with itself to form polyethylene particles that gradually come to rest in settling legs (see Figure 3), where they are eventually removed through valves at the bottom. At the top of each of these legs, there is a single ball valve (DEMCO® brand) where the legs join with the reactor pipes. The DEMCO® valve (see Figure 4) is kept open during production so that the polyethylene particles can settle into the leg.

OSHA's investigation concludes that on October 23 more than 85,000 pounds of highly flammable gas were suddenly released through an open DEMCO® valve. In less than 2 minutes, the gas rapidly found its way to an ignition source and exploded. The explosion and ensuing fire occurred at approximately 1:00 p.m. Estimates of the time that elapsed from the release of the gas to the initial explosion ranged from 90 seconds to 2 minutes. A second explosion occurred 10 to 15 minutes later when two isobutane storage tanks exploded. Each explosion damaged other units, creating a chain-reaction of explosions. One witness reported hearing ten separate explosions over a 2-hour period.
