Departmental investigation
into the fire aboard the
Australian flag oil tanker
TASMAN
in the port of Melbourne,
Victoria on
19 December 1998

Navigation Act 1912 Navigation (Marine Casualty) Regulations investigation into the fire aboard the Australian flag oil tanker *TASMAN* in the port of Melbourne, Victoria on 19 December 1998

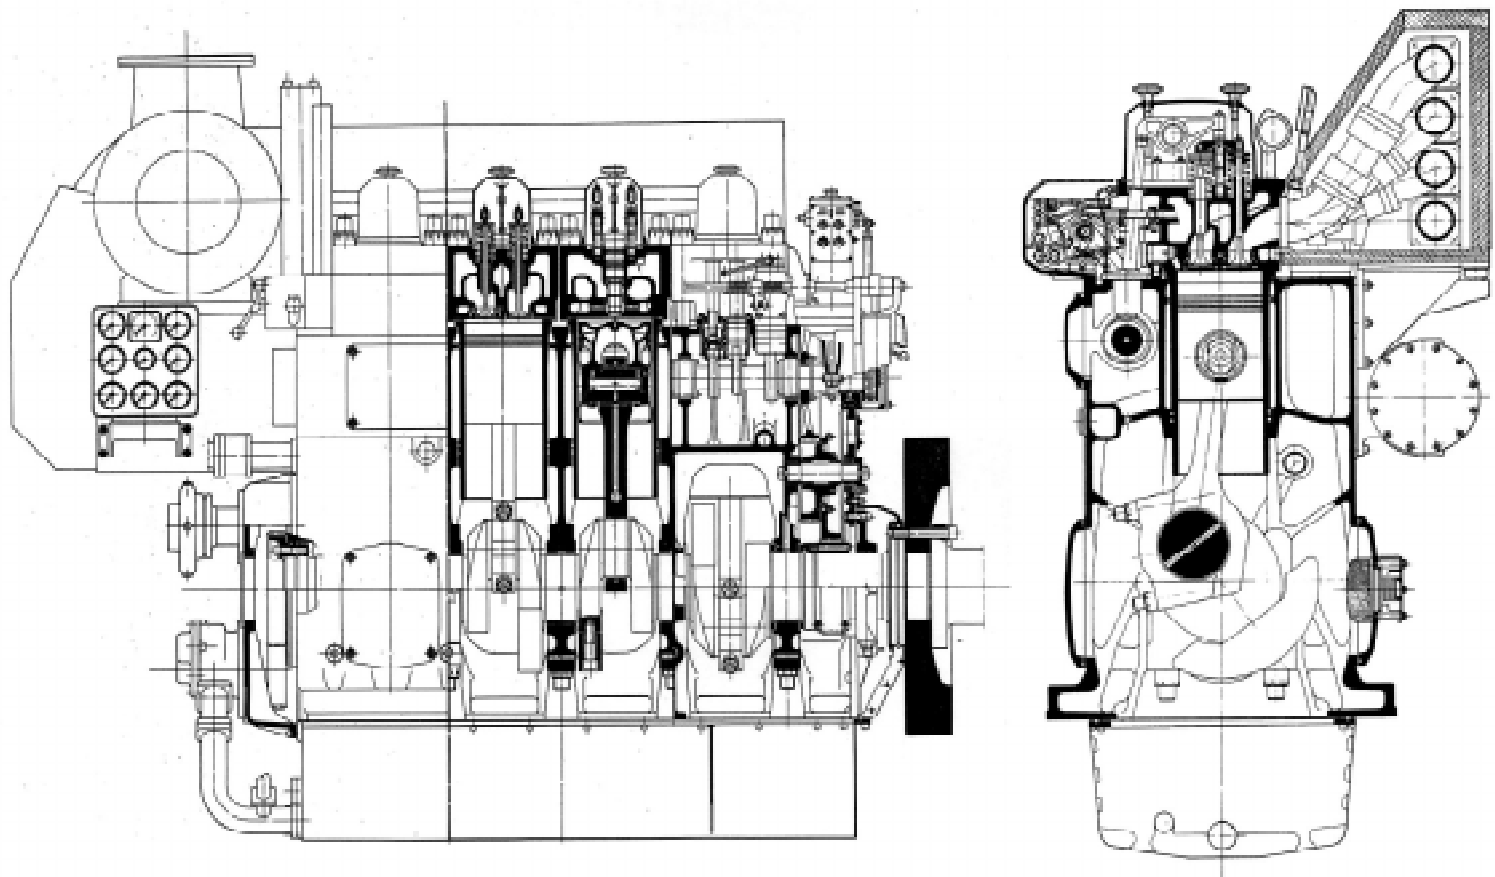
FIGURE 9

Tasman's no. 1 generator set is driven by a Wärtsilä VASA 8R22HF-D diesel engine. It is an eight cylinder, four-stroke engine of 220 mm bore and 240 mm stroke, having a power output of 1160 kW at 900 rpm. Diagrams showing the general configuration of this engine type are shown on figure 9. All three generators can run on diesel oil or on heavy fuel oil and, at the time of the fire, no. 1 generator was running on heavy fuel oil. In accordance with the DIN numbering system, the units (cylinders) are numbered from the drive (the forward) end.

Wärtsilä VASA R22 – general configuration

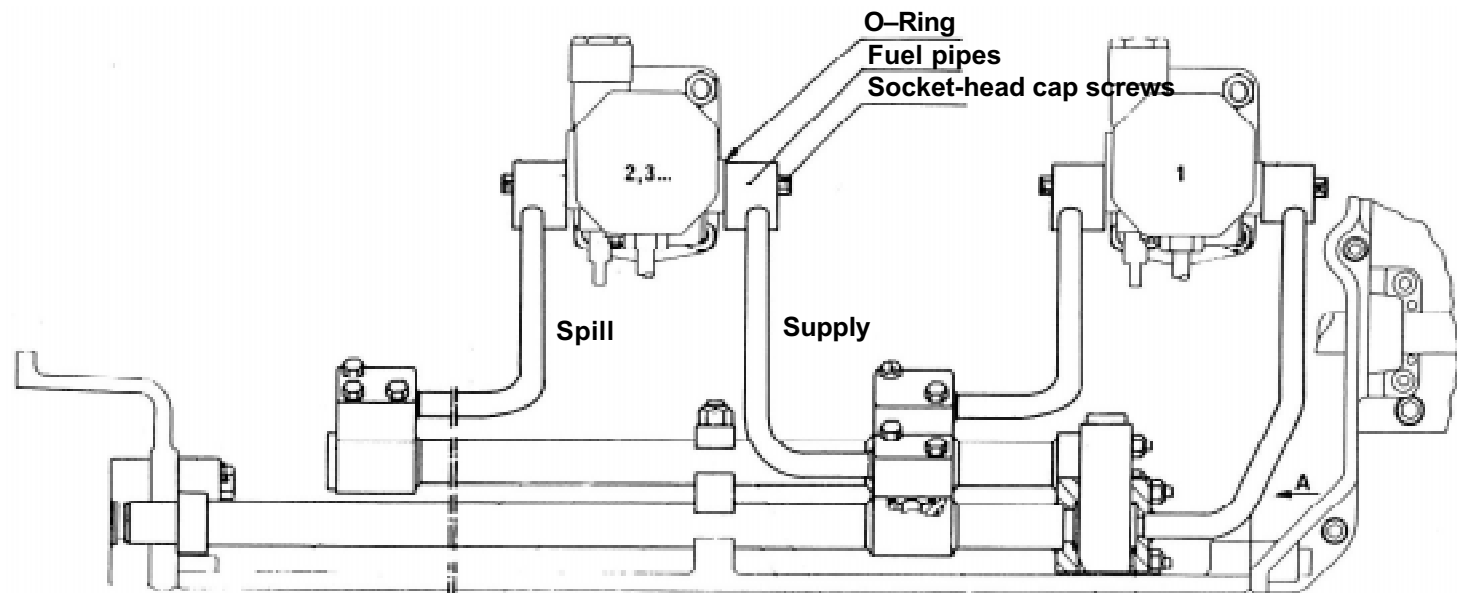
FIGURE 10

Plan of fuel pumps, supply and spill pipework in 'hot box'

The units have individual 'L'Orange' fuel injection pumps. Fuel is supplied to each injection pump via a separate pipe connecting from the fuel supply rail. The end of this pipe is attached to the fuel pump body with a flanged joint, sealed by a 19.2×3 mm O-ring, recessed into the flange. (fig. 11). The flange is secured to the pump body by two 8 mm dia. \times 45 mm long allen screws. On the opposite side of the fuel pump, the fuel spill port is connected to the spill rail by a similar pipe and flanged joint. A diagram showing the arrangement of the fuel supply and spill pipework is shown as figure 10.
