U. S. CHEMICAL SAFETY AND HAZARD INVESTIGATION BOARD

# INVESTIGATION REPORT

## PROPANE TANK EXPLOSION (2 DEATHS, 7 INJURIES)

Herrig Brothers Feather Creek Farm  
Albert City, Iowa  
APRIL 9, 1998

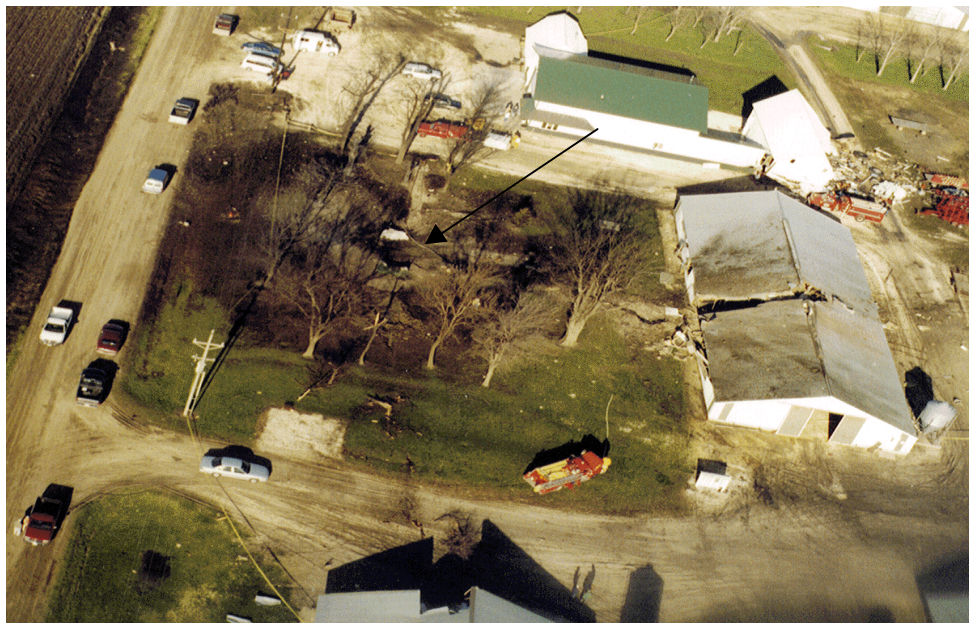
**Figure 1. Aerial View of the Farm on April 10, 1998**

On April 9, 1998, at approximately 11:28 pm, an 18,000-gallon propane tank exploded at the Herrig Brothers Feather Creek Farm (the farm) in Albert City, Iowa. The blast occurred less than half an hour after an all-terrain vehicle (ATV), driven by a minor without the owner's permission, damaged two aboveground propane pipes and a fire resulting from that accident engulfed the tank. The explosion that occurred at the farm is known as a Boiling Liquid Expanding Vapor Explosion or BLEVE.<sup>1</sup> Tank fragments produced by the BLEVE killed two volunteer fire fighters.<sup>2</sup> In addition, seven other emergency response personnel were injured, and several buildings were damaged by the blast. The arrow in Figure 1 points to the location of the tank prior to the blast.

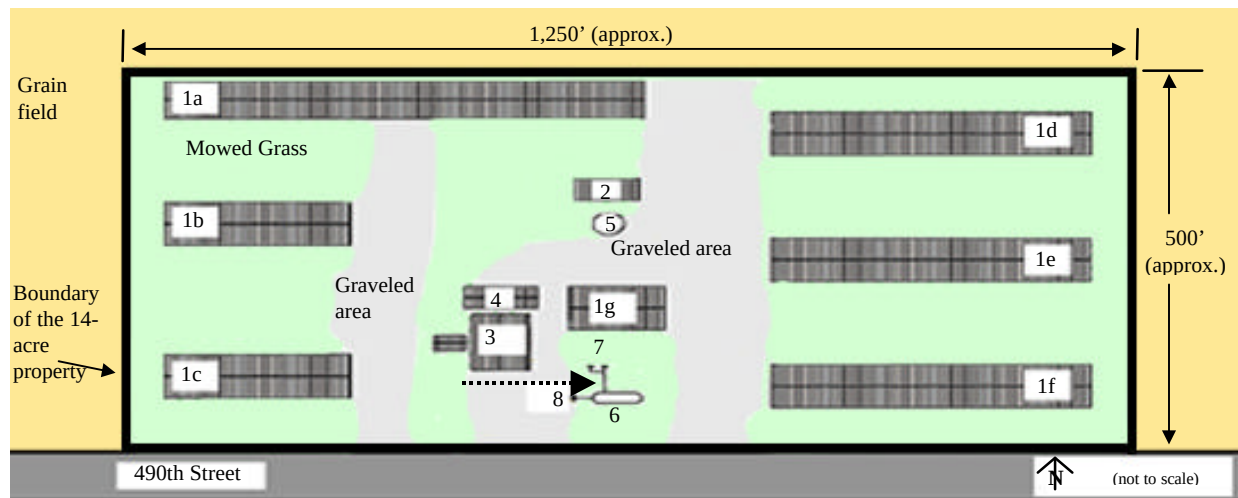
**Figure 2. Plot Plan of Farm, 2243 490th Street, Albert City, Iowa**

The propane tank, which was made of carbon steel, was approximately 42 feet long and 9 feet in diameter. It was located approximately 78 feet north of the 490th Street centerline (see Figure 2, item 6). The tank rested on two concrete saddles with the bottom of the tank located approximately 4 feet above ground level. Figure 3 is a view of the tank looking north from 490th Street.

At approximately 11:00 pm, one of the youths began driving an all-terrain vehicle (ATV) around the farm. Then the driver of the ATV picked up a passenger and continued his ride. The ATV was heading east between the propane tank and a turkey barn when it struck the two aboveground propane pipes (liquid and vapor lines) that ran from the propane tank to direct-fired vaporizers approximately 37 feet to the north of the tank (See Figure 2). The ATV damaged both the liquid and vapor lines.

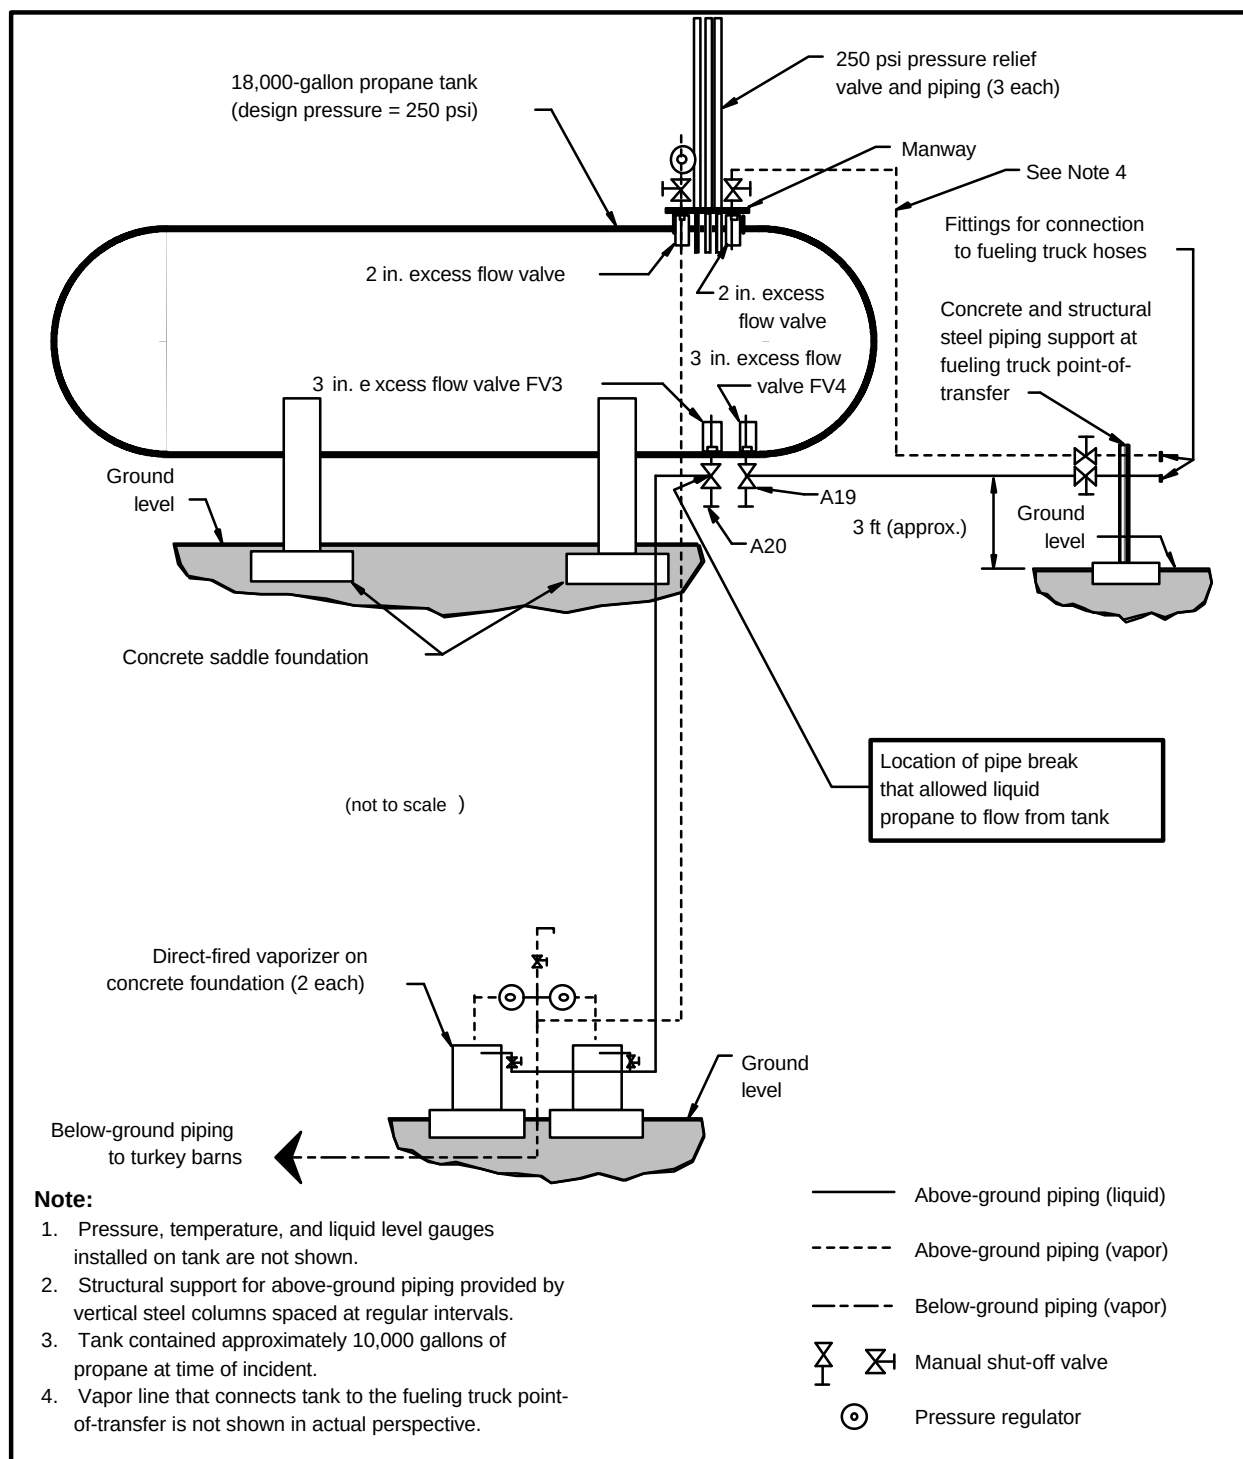
**Figure 6. Piping Diagram for the Propane Storage and Handling System**

During normal operations, liquid propane was withdrawn from the tank through the 3-inch excess flow valve (FV3 in Figure 6), past the open shut-off valve (A20 in Figure 6), and then into the  $\frac{3}{4}$ -inch outlet pipe to the vaporizers shown in Figure 7. These vaporizers used heat to convert the liquid propane into a gas. After passing through a pressure regulator, the propane gas was piped underground to the various space heaters and furnaces located in the buildings on the farm.

Shut-off valves A19 and A20, used on the liquid propane piping lines (see Figure 6), were rated for 400-psi service at temperatures up to 150°F. However, pressure required to cause failure is usually at least twice the rated operating pressure. Shut-off valves A19 and A20 did not fail by overpressurization. Observed damage was probably caused by impact following the explosion.

Testing of piping components retrieved from the Herrig Brothers Farm following the incident was conducted by NASA at the Kennedy Space Center in Florida to reconstruct the incident scenario. This testing was conducted to establish the flow performance and behavioral characteristics of excess flow valve FV3 (see Figure 6), which was part of the 18,000-gallon propane storage and handling system piping impacted by the ATV.

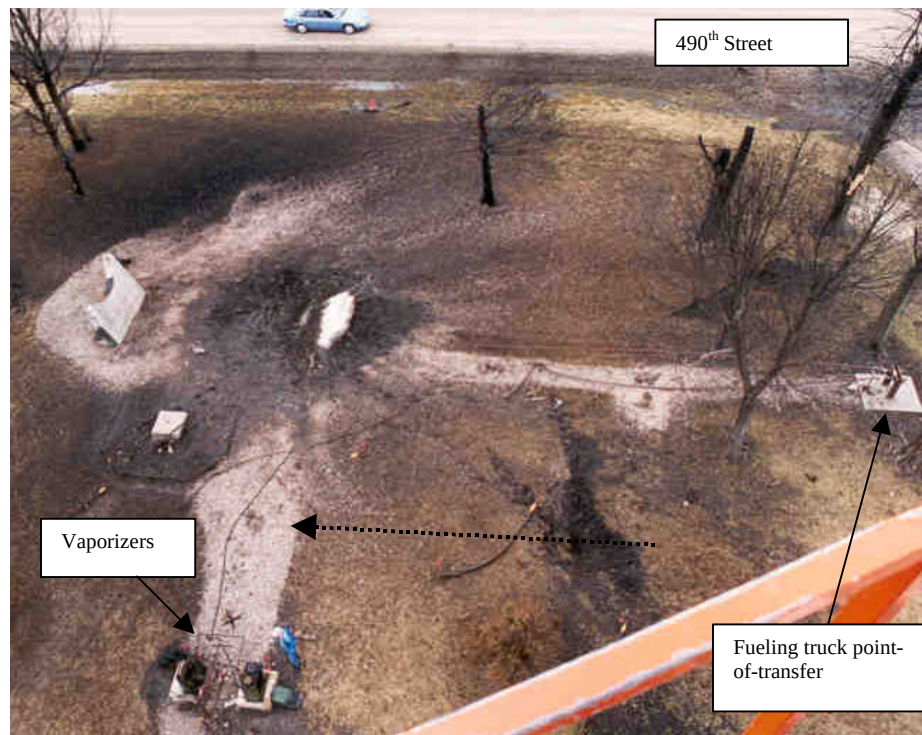
Figure 7. Aerial View of Tank Area

- 1) Parallel liquid and vapor lines used for propane supply ran to the west for approximately 40 feet. These lines terminated at the fueling truck point-of-transfer located at the edge of a gravel parking area (see Figure 2, item 8 and Figure 7). These lines were not involved in this incident.
- 2) Parallel liquid and vapor lines also ran north from the tank for approximately 37 feet to two direct-fired vaporizers<sup>6</sup> (vaporizers) (see Figure 2, item 7 and Figure 7). The liquid line was located to the east of the vapor line. The ATV struck these two lines.

On cold winter days, as much as 1,000 gallons of propane were required to heat the buildings and structures on the farm. Based on this usage, fueling truck deliveries occurred as often as every week during severe winter months. When a fueling truck arrived at the farm, it parked in the gravel area located west of the propane tank (see Figure 2, item 8). The dotted arrow in Figure 7 below represents the approximate course of the ATV prior to striking the propane lines.

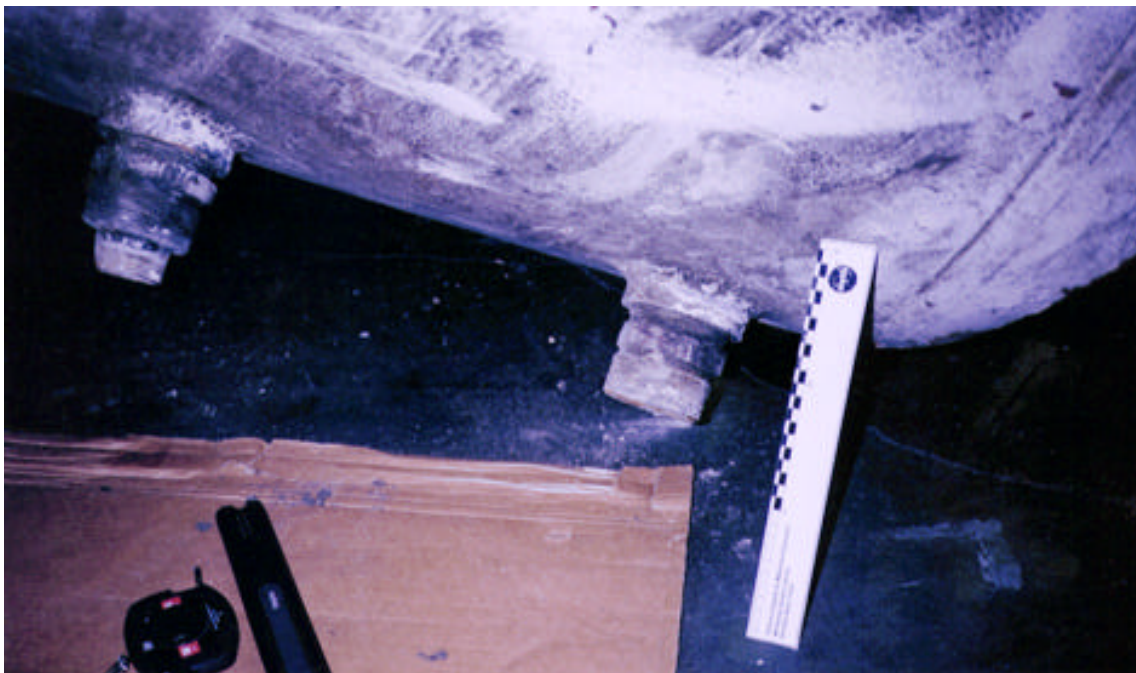
FIGURE 1

- 2.4 Two liquid excess flow control valves from the base of the ruptured propane tank were sent to KSC for testing and examination. The two valves are shown installed in the tank section in Figures 1 and 2. Figure 3 shows the excess flow control valve designated FV4 (that previously connected to the liquid tank fill stub) after the valve had been removed from the tank section. Valve FV4 is shown as-received in the laboratory in Figure 4. Figure 5 shows the second excess flow control valve, FV3, as-received in the laboratory. Valve FV3 fed the pipeline connected to the vaporizer system.

The two liquid excess flow control valves in the tank section prior to removal for testing purposes.

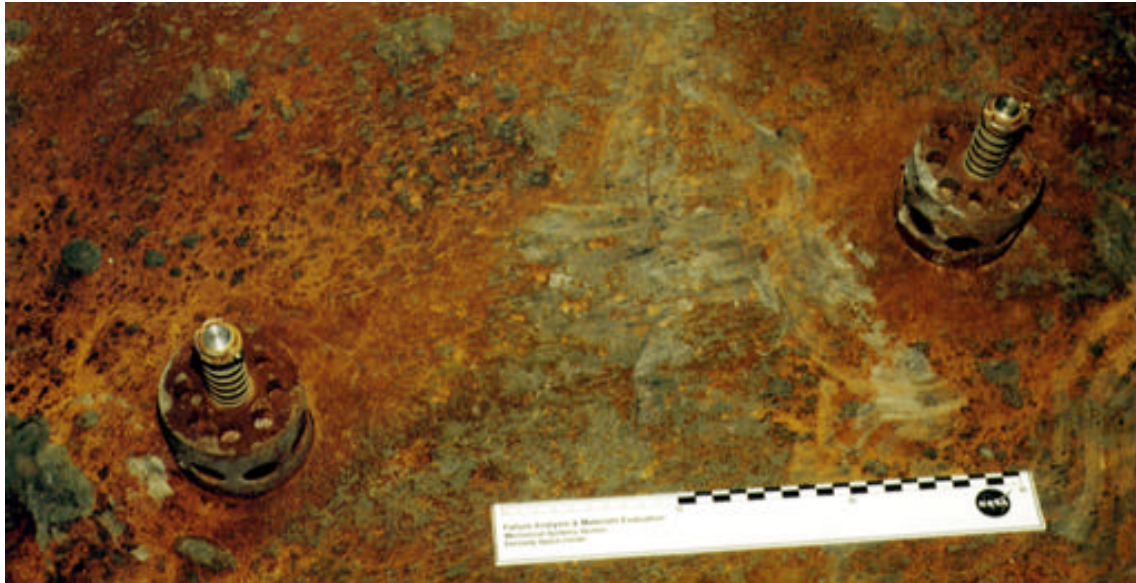
FIGURE 2

The two liquid excess flow control valves as seen from the interior side of the tank section.
