U.S. CHEMICAL SAFETY AND HAZARD INVESTIGATION BOARD

# INVESTIGATION REPORT

## THERMAL DECOMPOSITION INCIDENT

**BPAMOCO POLYMERS, INC.**

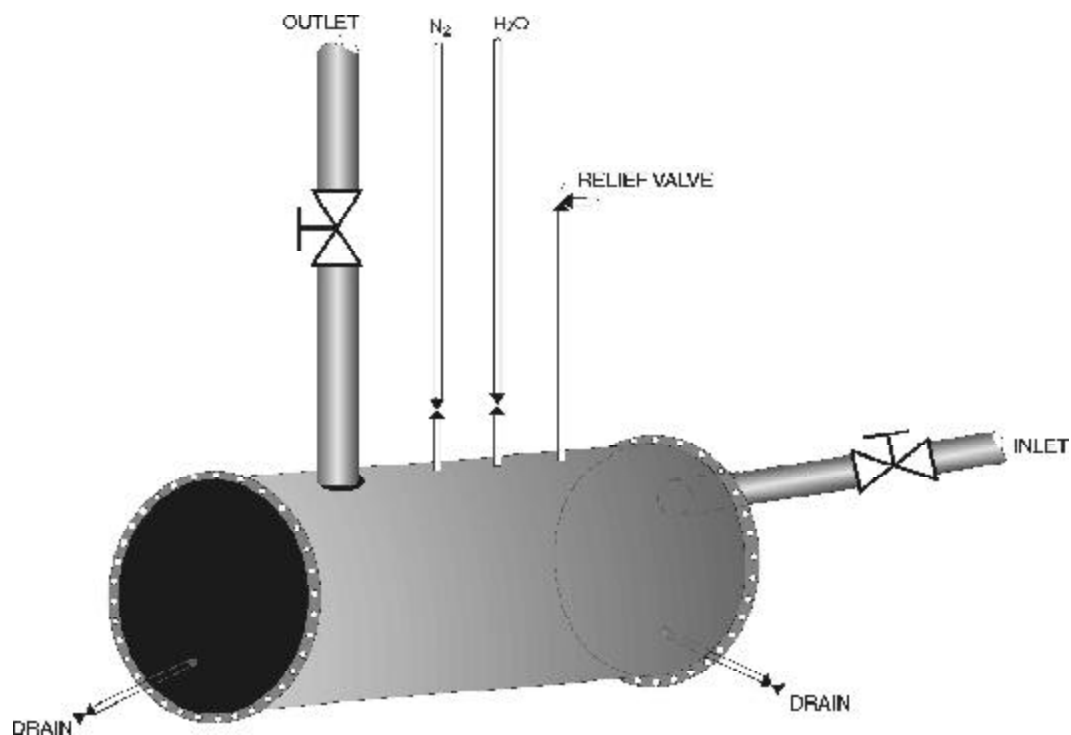
Figure 2. KD-502 polymer catch tank (simplified representation).

During normal process operation, the prepolymer produced in the reactor is fed to the extruder. During periods of startup and shutdown, and when there are mechanical difficulties with the extruder, the reactor effluent is diverted to a waste collection vessel—referred to as the polymer catch tank (Figures 2 and 3). The catch tank is a 750-gallon horizontal cylindrical steel vessel with a flat cover bolted to each end. Before startup, it is empty except for a removable branched metal frame that serves as a surface on which polymer agglomerates.

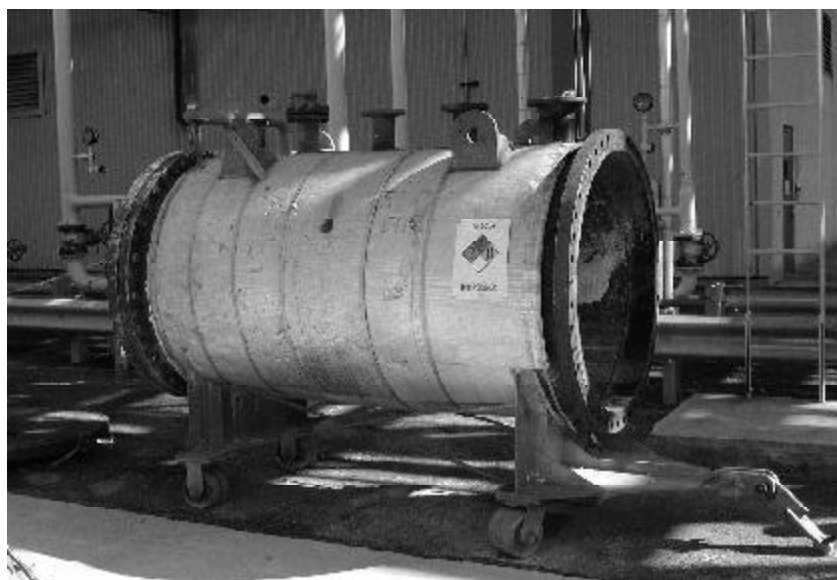
Figure 3. KD-502 polymer catch tank (actual vessel with one cover removed).

The flushing operation continued normally until approximately 3:45 pm, at which time an engineer noticed vapor leaking from the top of the bolted cover on the polymer catch tank between the 11 and 2 o'clock positions. Plant personnel described the leaking vapors as characteristic of the solvent.

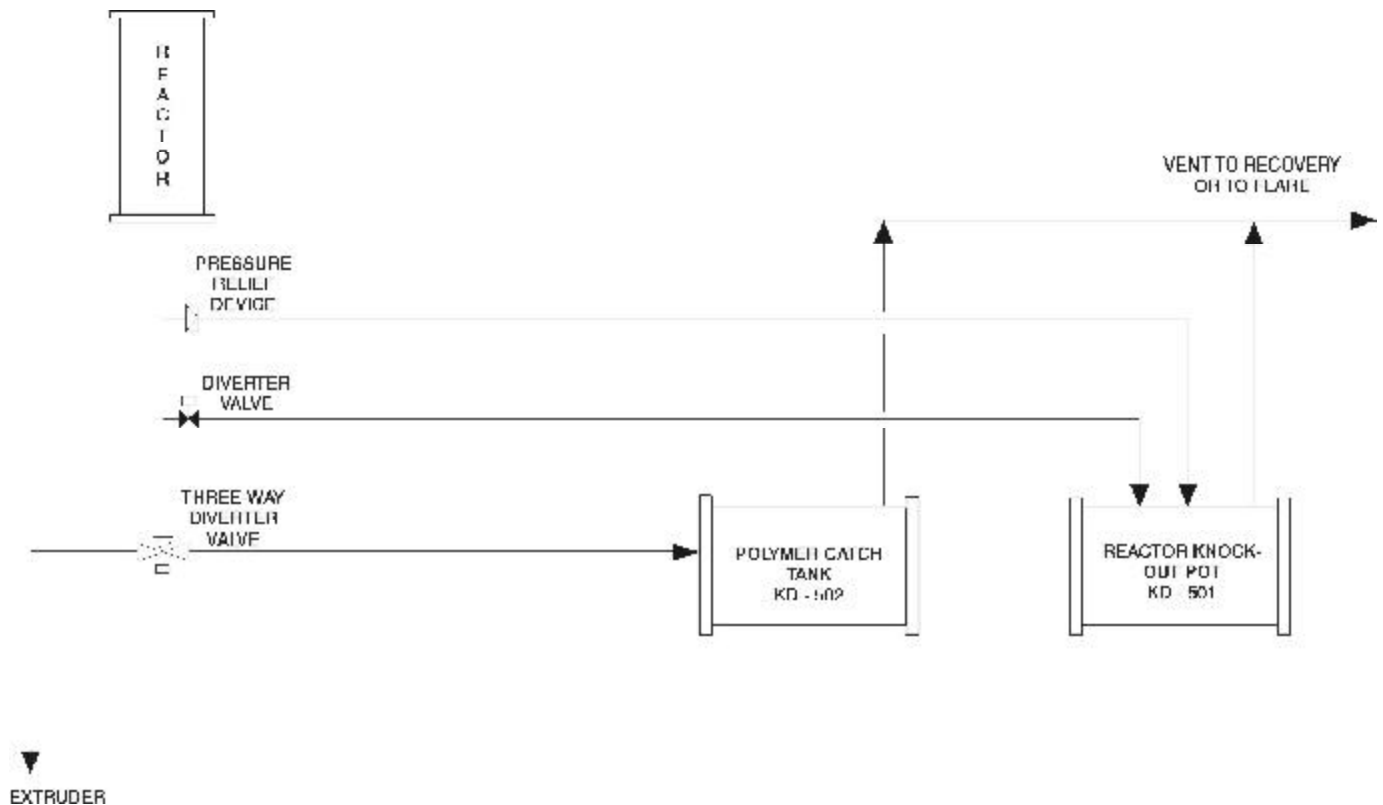
Figure 4. Simplified process diagram showing polymer catch tank and reactor knockout pot.

Typically, during startup of the process, the effluent from the reactor is **directed to the polymer catch tank for 50 minutes** before being diverted to the extruder (Figure 4). Prepolymer that accumulates inside the catch tank during startup normally cools and solidifies.

The reactor knockout pot (KD-501) is a waste vessel very similar in design to the polymer catch tank. Figure 4 depicts its arrangement and connectivity to the process. The emergency pressure relief devices at the outlet of the reactor discharge to the knockout pot. The reactor effluent can be directed to the knockout pot when the catch tank is too full.
