Accident Investigation Report

Sulfuric Acid Spill and Resulting Injury at 200 Area Effluent Treatment Facility

February 23, 2000

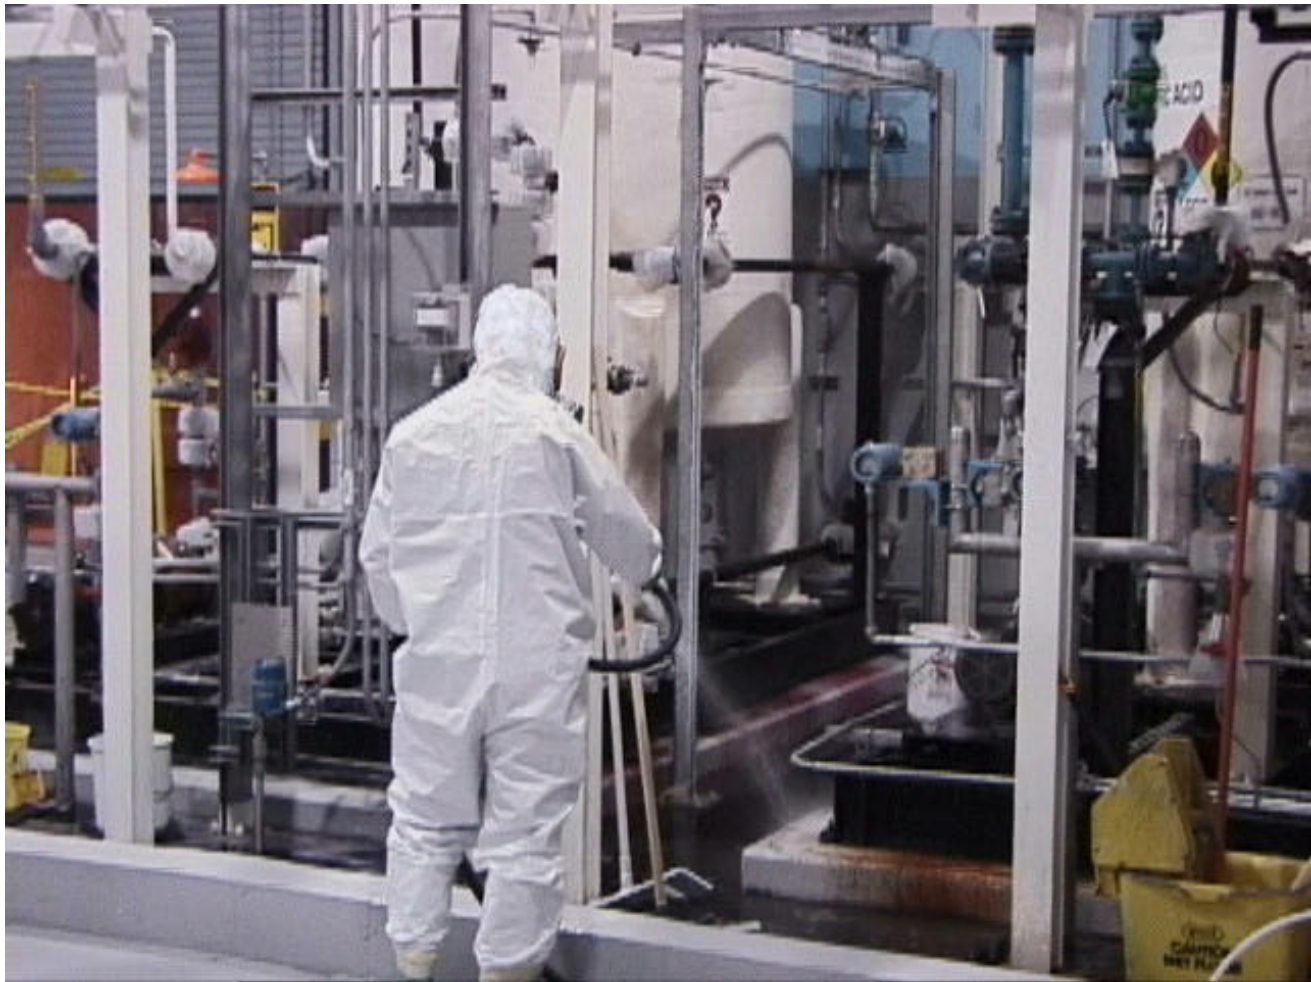
Chemical Berm Area during Cleanup

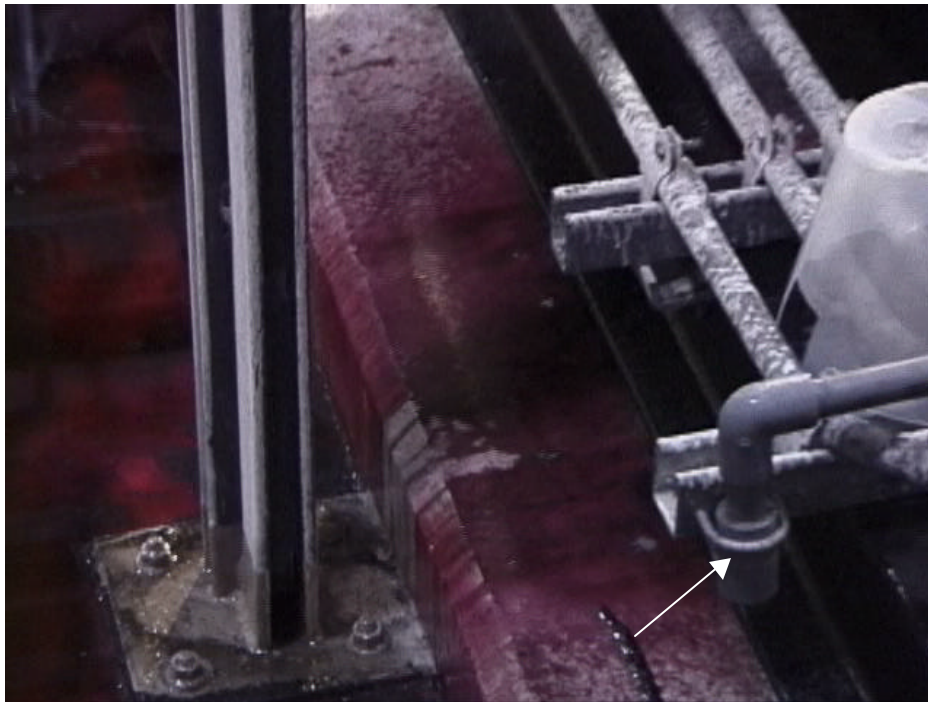
Figure 2. End of CPVC acid pump drain line and support clamp
(Courtesy of Waste Management Federal Services of Hanford, Inc.)

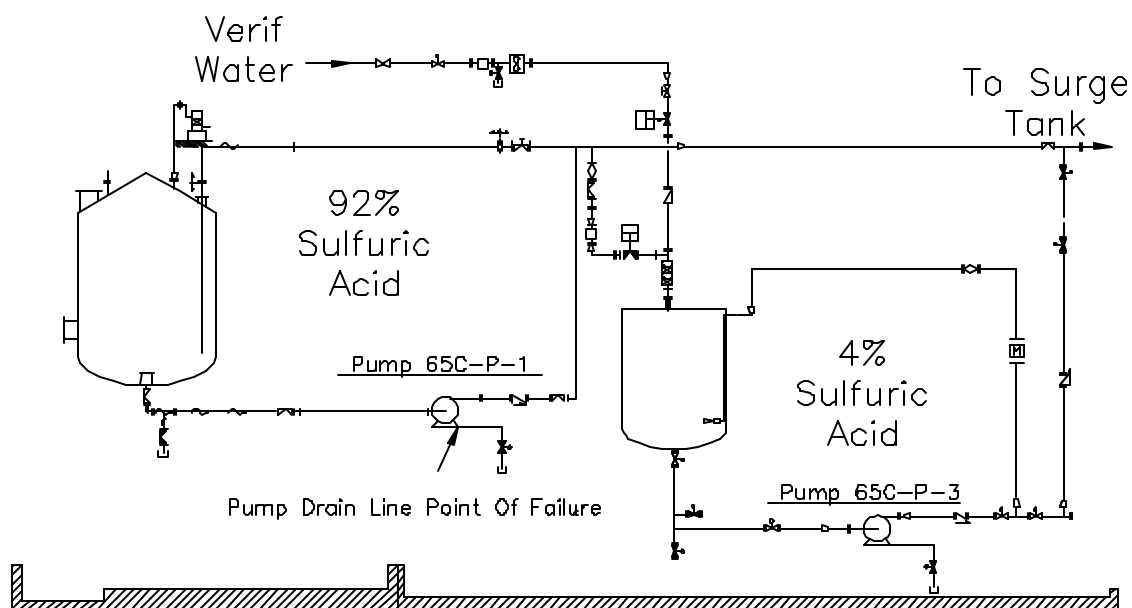
Configuration of the piping is shown in Figures 4 and 5. The drain line is essentially a 31" section of pipe containing two 90° elbows, a CPVC ball valve, and an end cap to allow pump drainage. The drain line is supported at the pump by the fitting threads and by a clamp on the drain end. It is assumed that only Teflon tape was used on fitting threads during installation.

Figure 4. Section of P&ID drawing showing pump/drain line configuration
(Courtesy of Waste Management Federal Services of Hanford, Inc.)

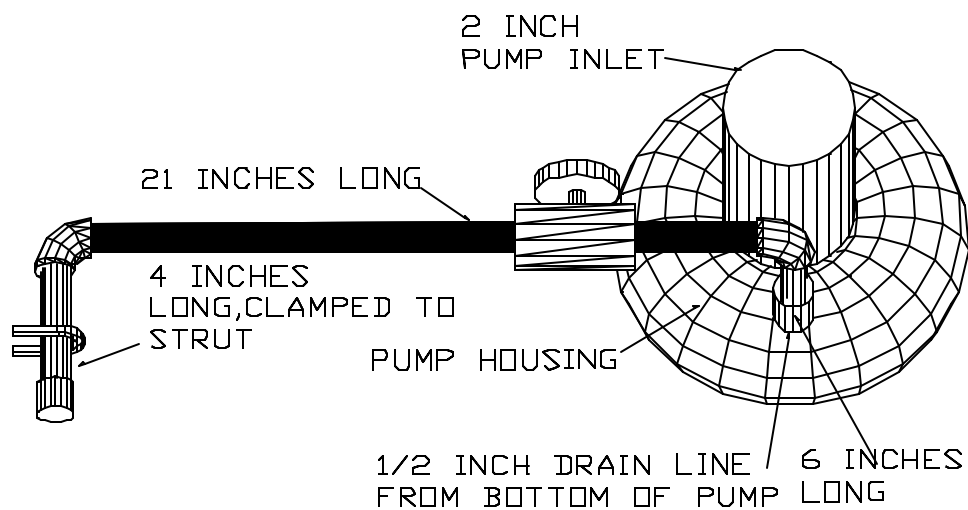
Figure 5. AutoCad 3D drawing of CPVC piping configuration
(Courtesy of Waste Management Federal Services of Hanford, Inc.)

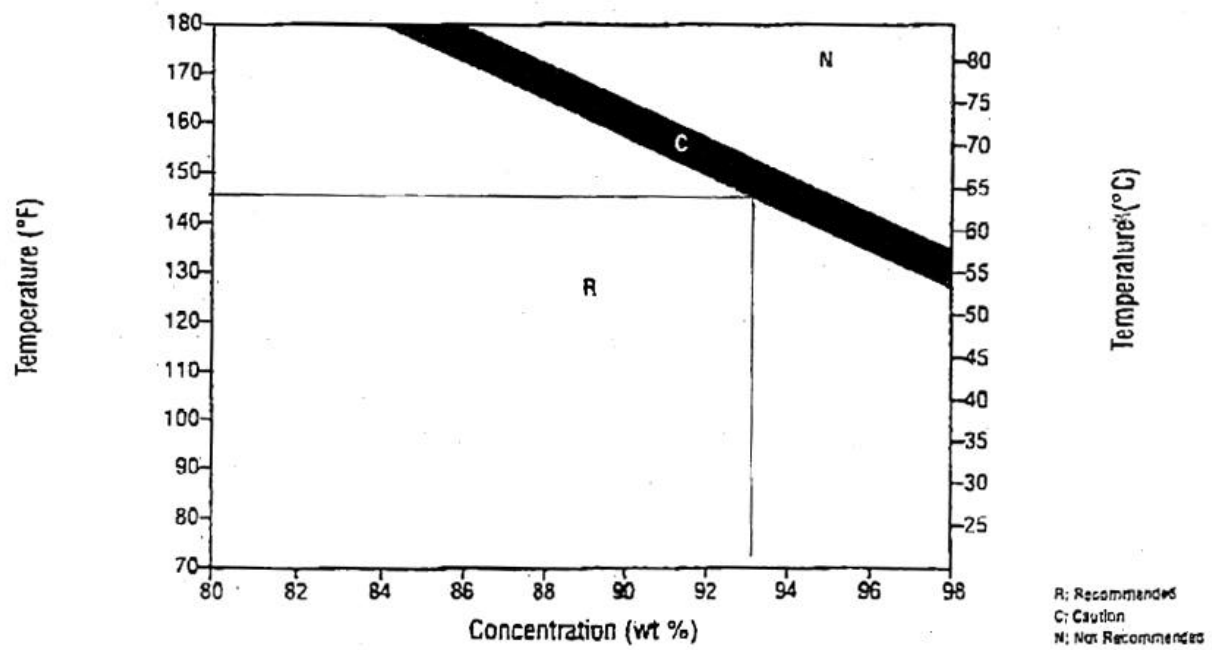
As a result of previously-observed degradation and known pump thermal excursions, Hanford ETF personnel reviewed published chemical resistance data and consulted with B.F. Goodrich technical representatives [2, 13, 14]. Published B.F. Goodrich data generically rates Corzan[®] CPVC as “Recommended” in 93 wt% sulfuric acid up to approximately 145°F (Figure 10). Published disclaimers also state that pressure ratings may not apply throughout the recommended range and that determining chemical compatibility of as-fabricated components is the responsibility of the end-user.

Figure 10. Resistance of generic Corzan® CPVC in sulfuric acid [14].

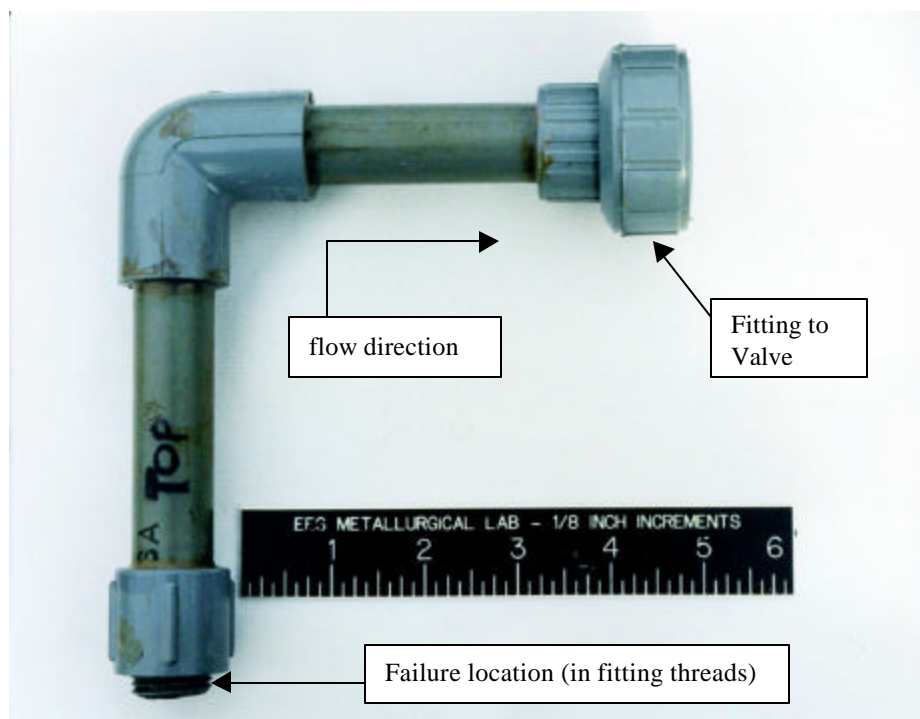
Photographs of the failed CPVC drain line assembly (up to the CPVC ball valve) are shown in Figures 11-18. The overall assembly is shown in Figure 11, with the flow direction and top of the assembly labeled for orientation. Note the color variation between the piping (manufacturer unknown) and the fittings (Spears), as well as the presence of CPVC solvent cement at the fitting joints. Figure 12 shows the pipe marking "CPVC 4120", with a closer view of the failed fitting revealing the manufacturer and part # identification, Figure 13.

Figure 11. CPVC drain line assembly, as received condition, top side (Neg.#54967, ~1X)

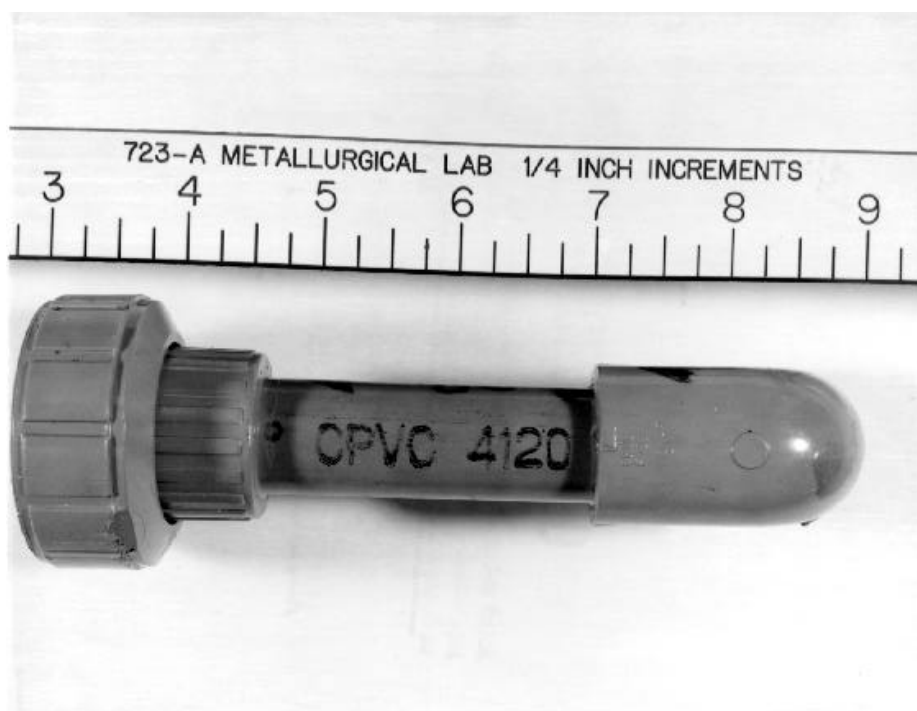
Figure 12. Marking of CPVC piping, supplier/manufacturer unknown (Neg.#55014, ~0.75X)

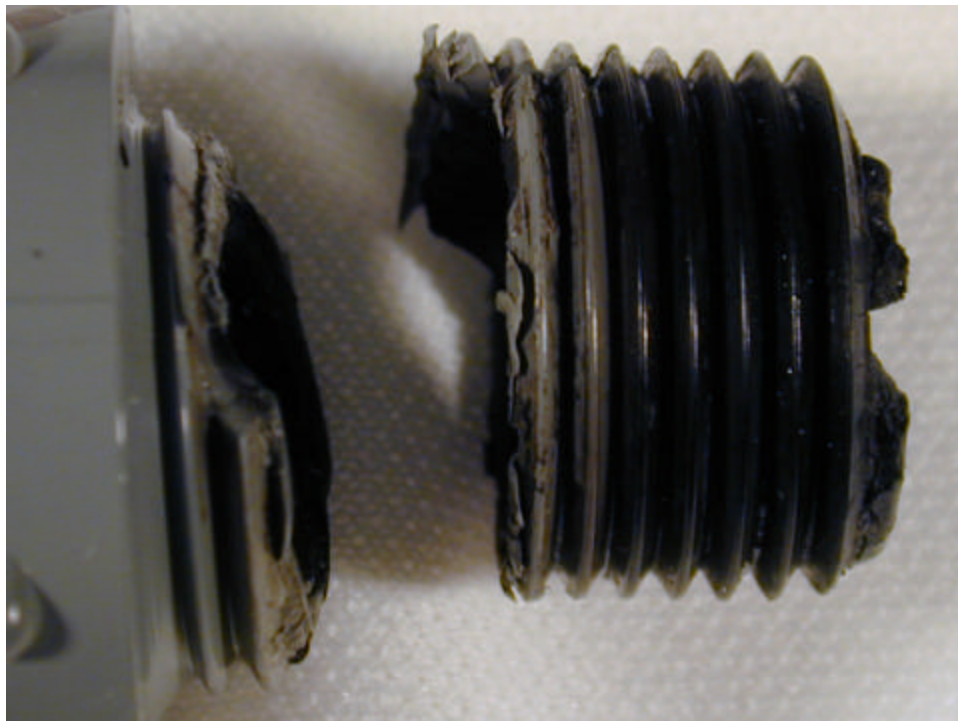
The arrow and markings in Figure 13 indicate the region of post-failure removal (bottom of pipe) from the pump casing. The remaining threaded portion was removed separately, Figure 14. Note that the threads from within the pump casing were more severely discolored on both interior and exterior surfaces, indicating greater degradation due to more severe chemical attack and/or higher temperature. Acid residue also possible on the pump casing threads prior to piping installation.

Figure 14. Remaining threaded portion from within pump casing

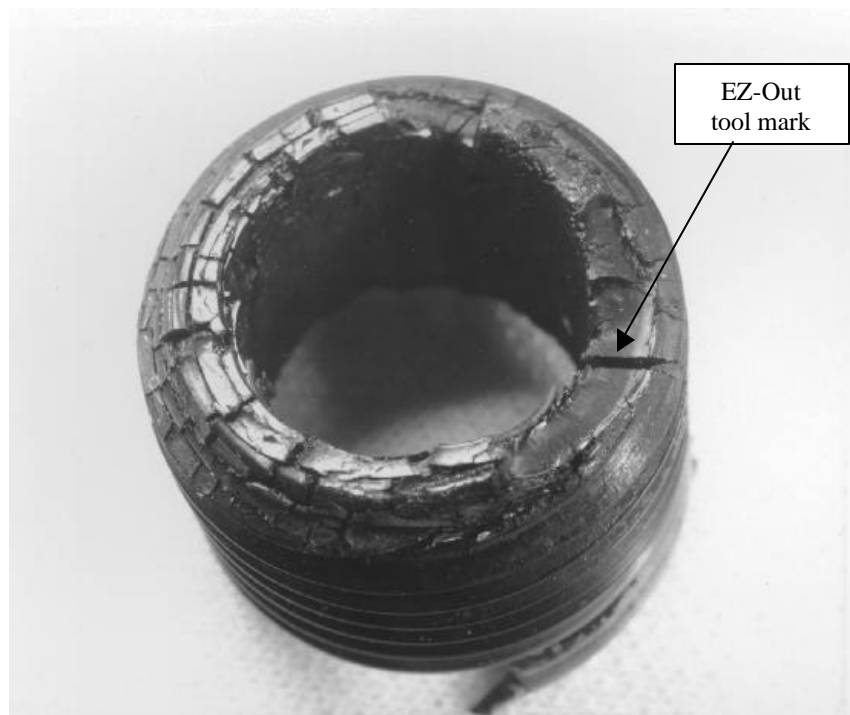
Figure 18. Opposite end of fitting threads (pump side)
(Neg#54965, ~4X)

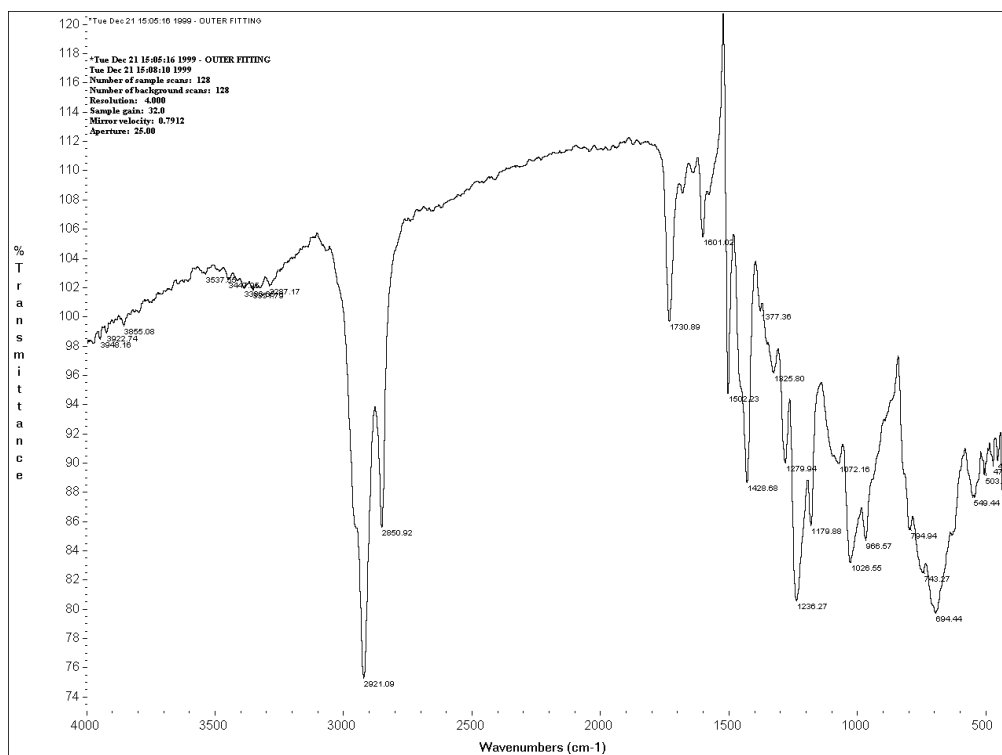
Although relatively dark in color (due to carbon black additives), the gray CPVC materials produced very clean and distinguishable spectra. Spectra obtained for all samples were matched with reference CPVC spectrum in the instrument software library. Spectra obtained for the Corzan[®] resin, Spears Mfg. fittings and piping (unknown supplier) are shown in Figures 27-30. No significant variation in spectra was observed. Because most additives for processing are used at very low levels (less than 1 wt%) and can be transparent to IR radiation, detection by this technique may not be possible. As with most resin manufacturers, B.F. Goodrich likely adds certain proprietary additives to their CPVC compounds for identification, but specific information on these could not be obtained.

Figure 29. FT-IR spectrum for failed Hanford fitting

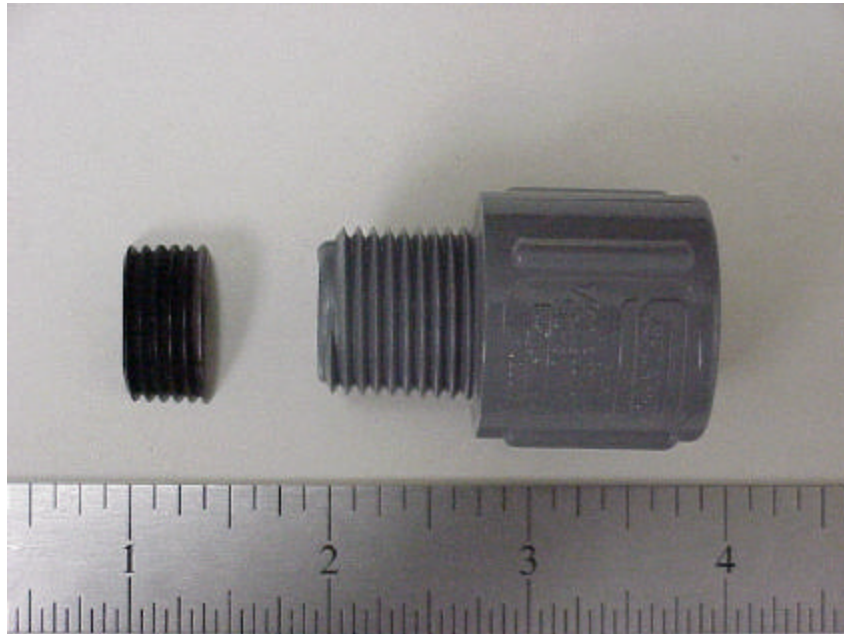
Figure 31. Failed fitting specimen and new, non-degraded fitting

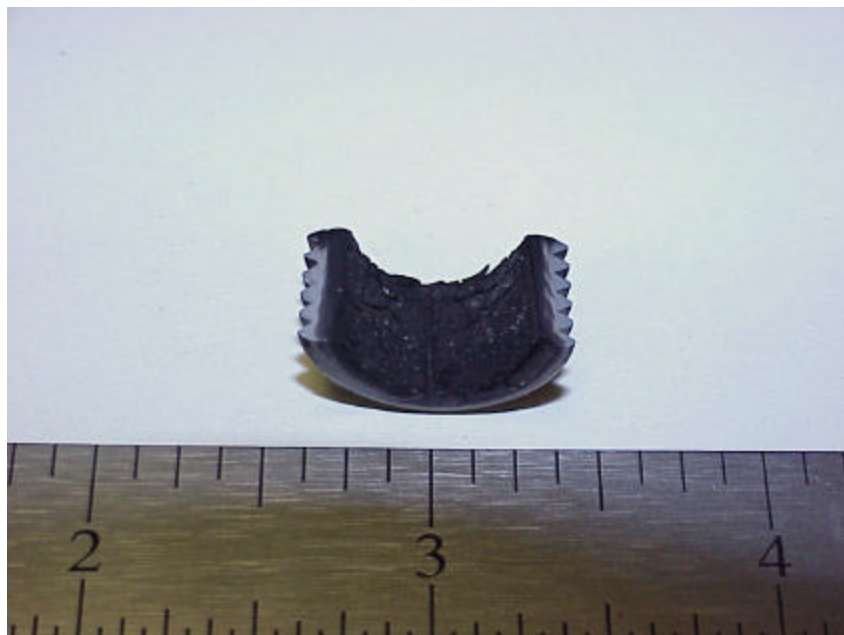
A test sample was made from one half of the threaded Hanford fitting (Figure 30) and ten test samples were made from five new (CPVC) fittings. The sample preparation consisted of cutting off the threaded portion of new fittings and half-sectioning, to make two samples from each fitting. A cut was made longitudinally in three of the new samples to simulate the cut in the Hanford sample (#6) that was made with an EZ-Out tool during post-failure extraction from the sulfuric acid pump (Figure 32). The test sample shape and the nominal dimensions are shown in Figure 33.

Figure 32. Failed fitting specimen (C-shape), with EZ-Out mark

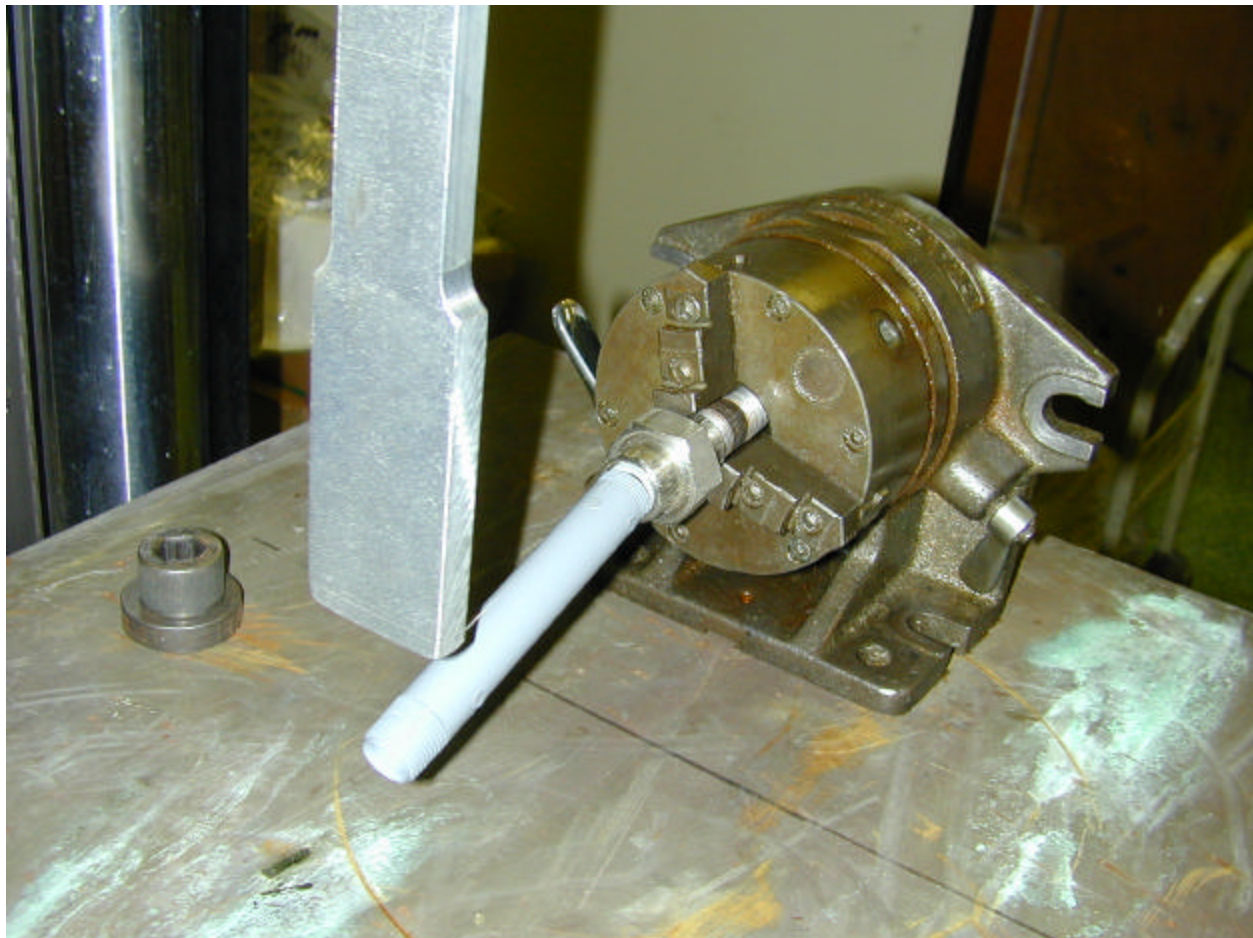
Bend testing of actual 6" Sch.80 CPVC pipe nipples was also performed to determine the amount of force required to bend a 6" section and break in the threaded region, similar to the failed drain line. A large tensile specimen was used to apply a bending moment to a 6" pipe nipple, with approximately 5-6 threads engaged and 2-3 threads remaining outside the fitting, similar to the drain line fitting (Figure 36).

Using the maximum displacement rate possible on the 723-A Instron Tensile Machine (15 in./min.) and a 2000 lb. load cell, a maximum force of approximately 90 lbs. (89.5 lbs) was determined to be necessary to break the pipe in the threads. Additional tests at varying rates and under impact conditions would have to be performed to fully evaluate such behavior, but this value gives an indication of the high notch-sensitivity of PVC/CPVC compounds, even in the non-degraded condition.

Figure 36. Bend testing of 6" Sch.80 CPVC pipe nipple (non-degraded)
