**TYPE A ACCIDENT  
INVESTIGATION BOARD REPORT  
OF THE JULY 28, 1998  
FATALITY AND MULTIPLE INJURIES  
RESULTING FROM RELEASE OF  
CARBON DIOXIDE  
AT  
BUILDING 648, TEST REACTOR AREA  
IDAHO NATIONAL ENGINEERING AND ENVIRONMENTAL  
LABORATORY**

**September 1998**

**Office of Oversight  
Environment, Safety and Health  
U.S. Department of Energy**

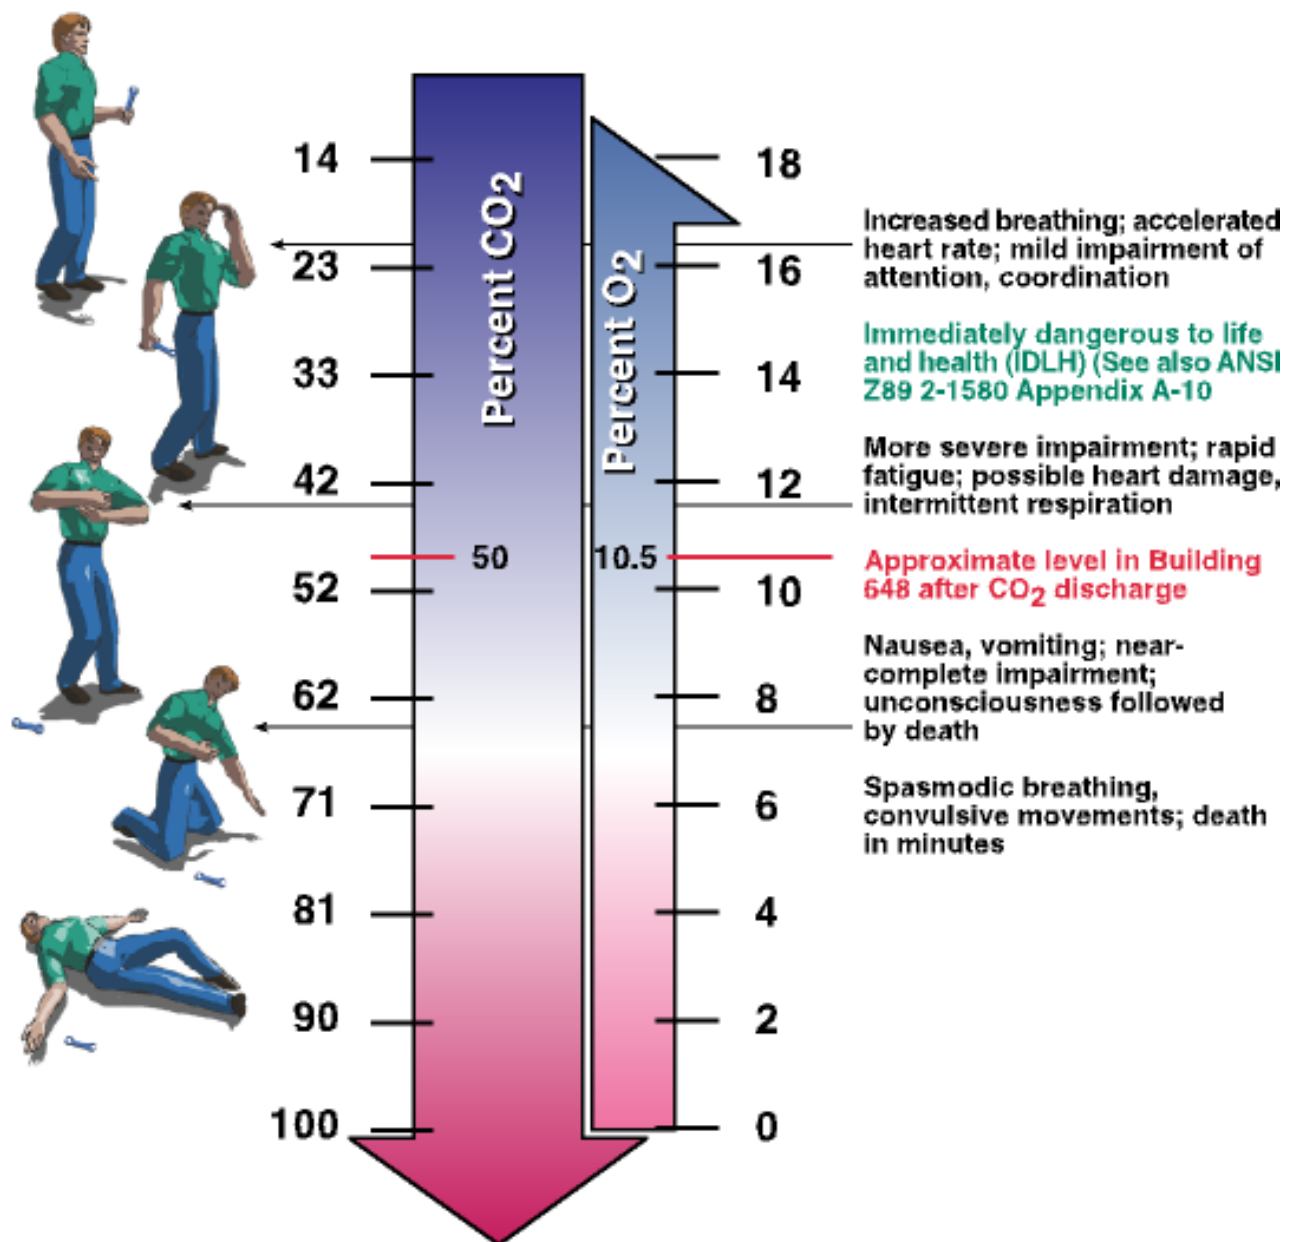
Figure 2-1. Physiological Effects of CO<sub>2</sub> Exposure

The percentage of CO<sub>2</sub> in the building following the accidental initiation of the fire suppression system was estimated at approximately 50 percent. This is well above the 30 percent minimum concentration necessary for fire protection and is lethal to occupants or individuals, as shown in Figure 2-1. At 50 percent CO<sub>2</sub>, the oxygen levels within the building would be approximately 10.5 percent, well below that needed to sustain life. This atmosphere can result in symptoms of nausea; vomiting; near-complete impairment; unconsciousness followed by death and spasmodic breathing; convulsive movements; and death in

minutes. The personnel in the building during the accident experienced vomiting, impairment of actions, spasmodic breathing seizures, and unconsciousness, and their attempts to escape were hindered by the disorienting physiological effects of CO<sub>2</sub>.

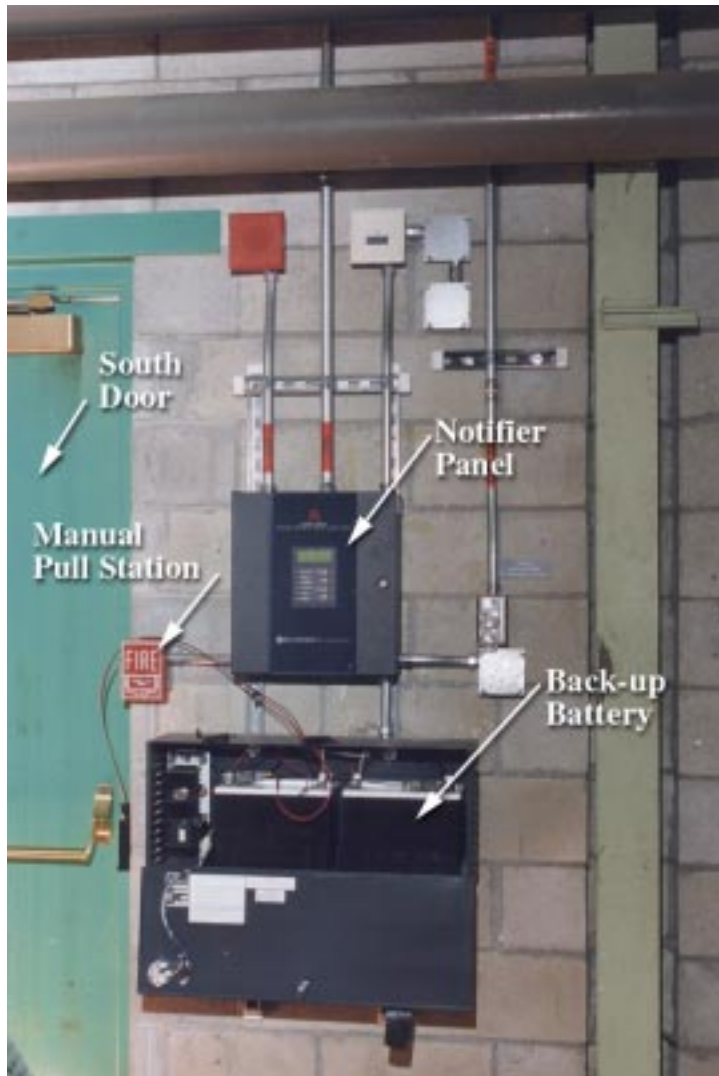
**Exhibit 3-1. Notifier Fire Alarm Panel**

**System Design.** The as-installed CO<sub>2</sub> releasing system does not monitor discharge of the suppression system it controls, as required by Sections 3-8.8.1 and 5-7 of NFPA 72, *National Fire Alarm Code*, 1996 edition. This requirement was not identified on the LMITCO approved engineering design documents, nor was its omission subsequently identified. Modifications completed in 1997 changed it to a single-zone system by eliminating selector valves (which controlled where the CO<sub>2</sub> discharged) and the basement level CO<sub>2</sub> piping and nozzles. Figures 3-2 and 3-3 depict the system prior to and after the modifications. Modifications to the CO<sub>2</sub> piping system are not detailed in either design or as-built drawings, with all mechanical design references deferring to original (1971) design documents. These design documents called for installation of pressure switches to the CO<sub>2</sub> manifold with a feedback loop to the fire alarm panel, but the switches and feedback loop were deleted and never installed (see Figure 3-1). LMITCO also failed to install this monitoring circuit during the 1997 modifications and fire alarm panel upgrade. It is not clear that designers understood the significance of having pressure operated backup alarm features in the CO<sub>2</sub> system or the impact of their original removal in 1971. The absence of these pressure switches and monitoring circuit precluded at least a 25-second pre-discharge warning alarm and the opportunity for safe evacuation prior to the CO<sub>2</sub> discharge. During the 1997 modification, LMITCO also failed to install a positive isolation device in the CO<sub>2</sub> system piping as required by OSHA regulations (see Section 3.1 under "Energy Isolation and Provisions for Positive Lockout").

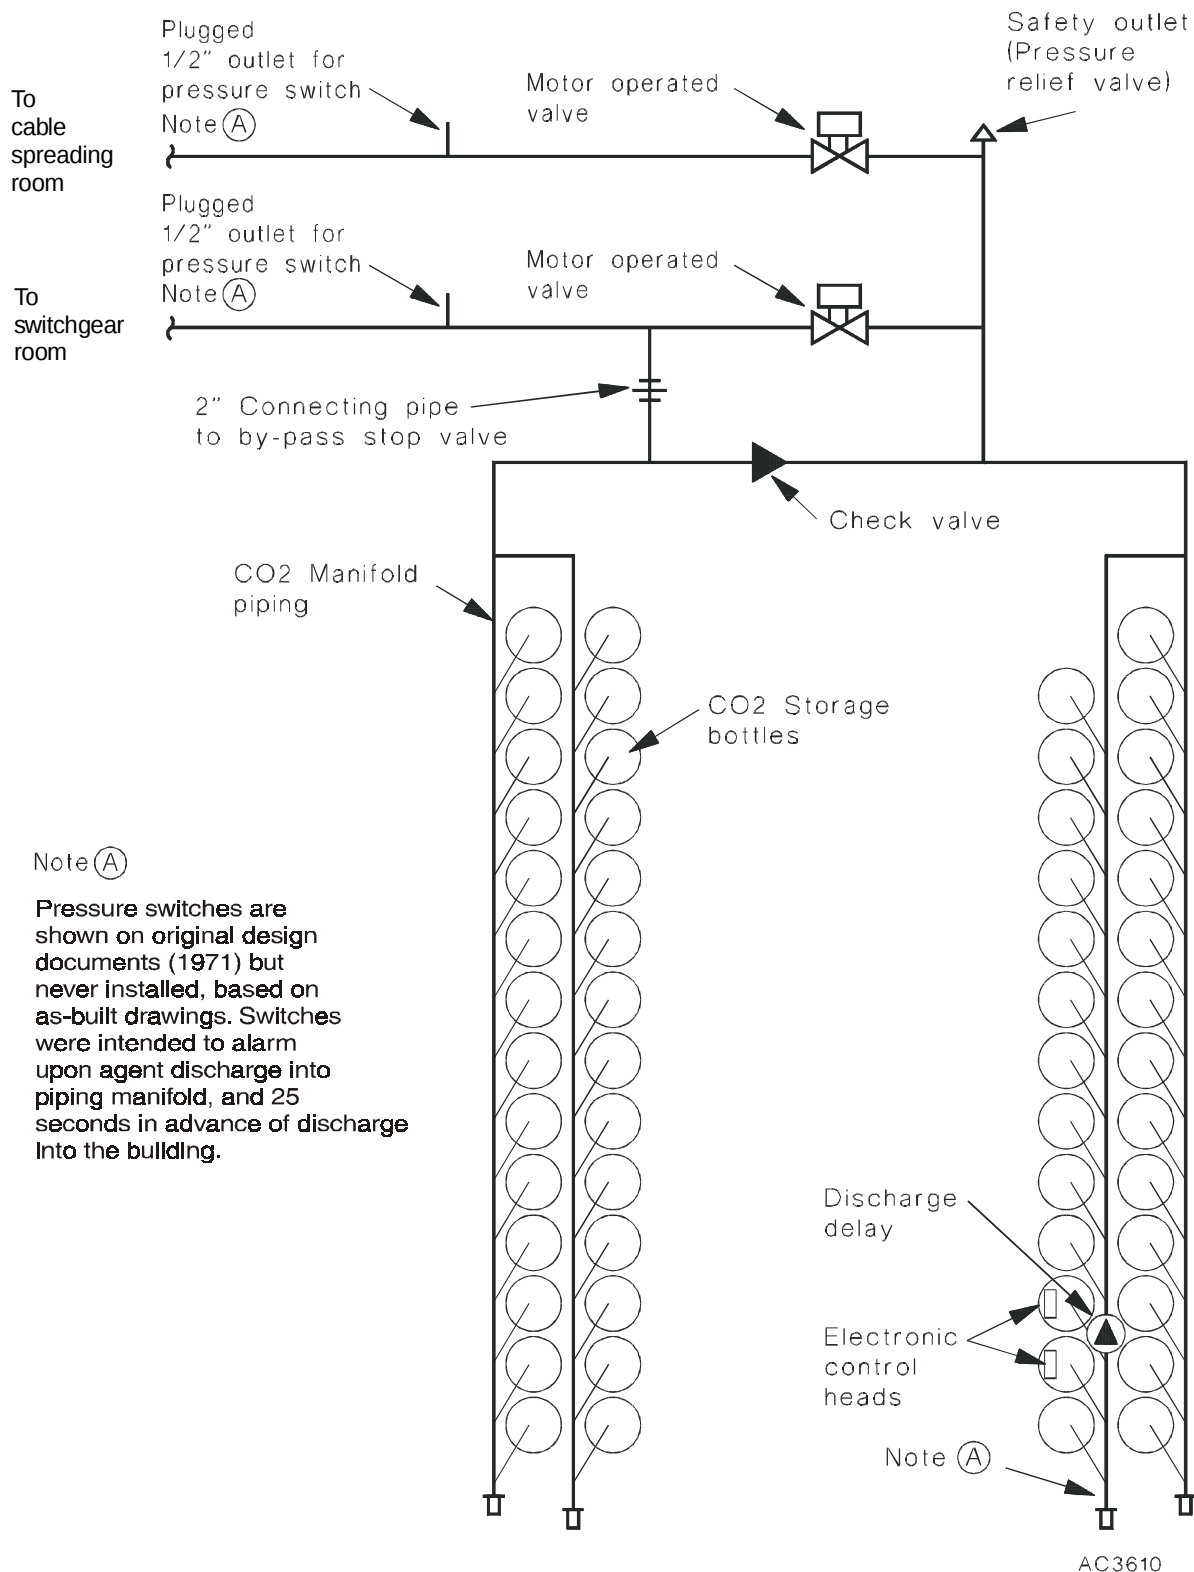
**Figure 3-2. Carbon Dioxide System Arrangement Pre Line Item Upgrade**

*The failure to install a carbon dioxide system discharge monitoring circuit prevented a 25-second pre-discharge warning alarm and safe escape.*

*Deviations in the fire alarm system installation could have made it easier for a transient electrical input to trigger the unexpected discharge.*

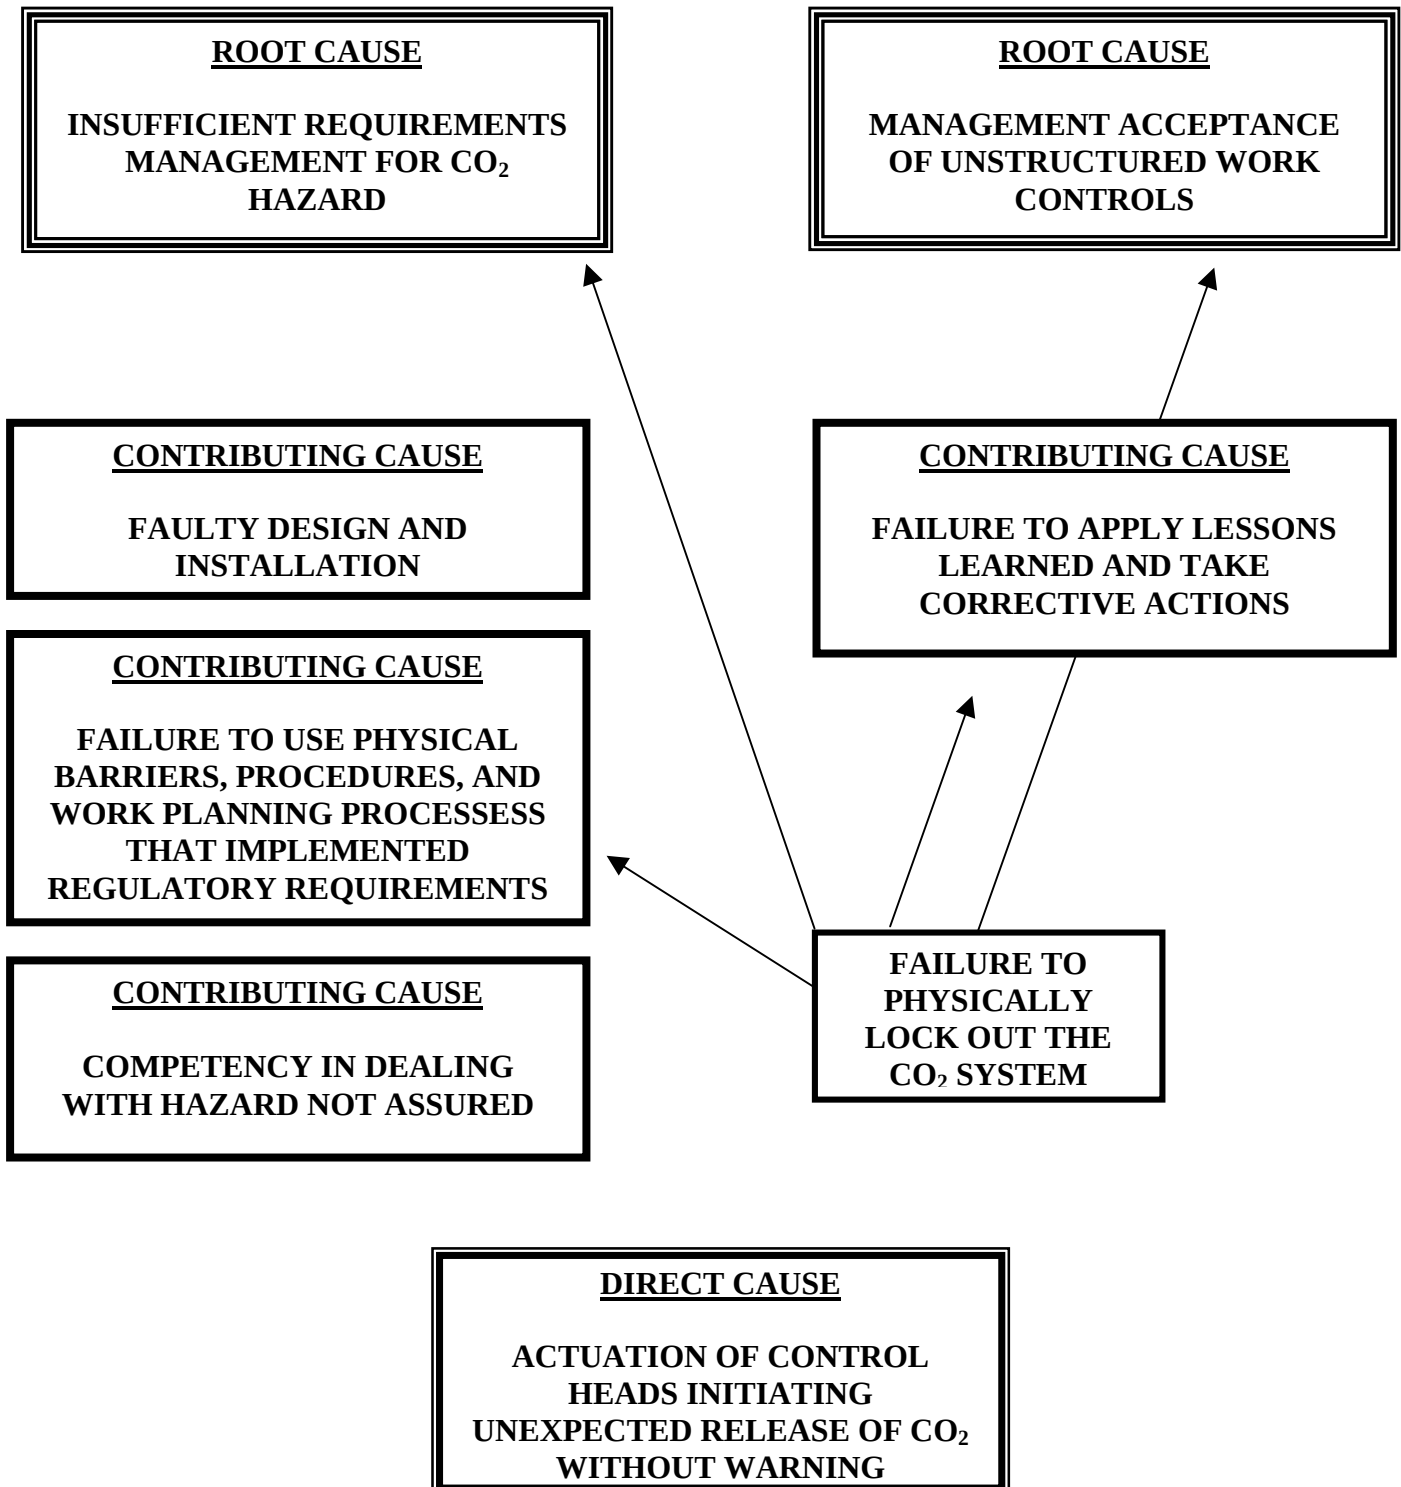
**FIGURE 4-2.  
CAUSAL FACTORS IMPACTING ACCIDENT MITIGATION**

**There were other contributing causes that impacted accident mitigation (i.e., failure to install a warning alarm and failure to adequately evaluate the impact of infrastructure reductions on worker safety). These causal factors are discussed in Sections 3.2 and 3.5 of the report, where more facts regarding them are presented. Section 4.0 discusses how they relate to the root causes of the accident, and Figure 4-2 depicts this relationship. See these sections for further discussion.**

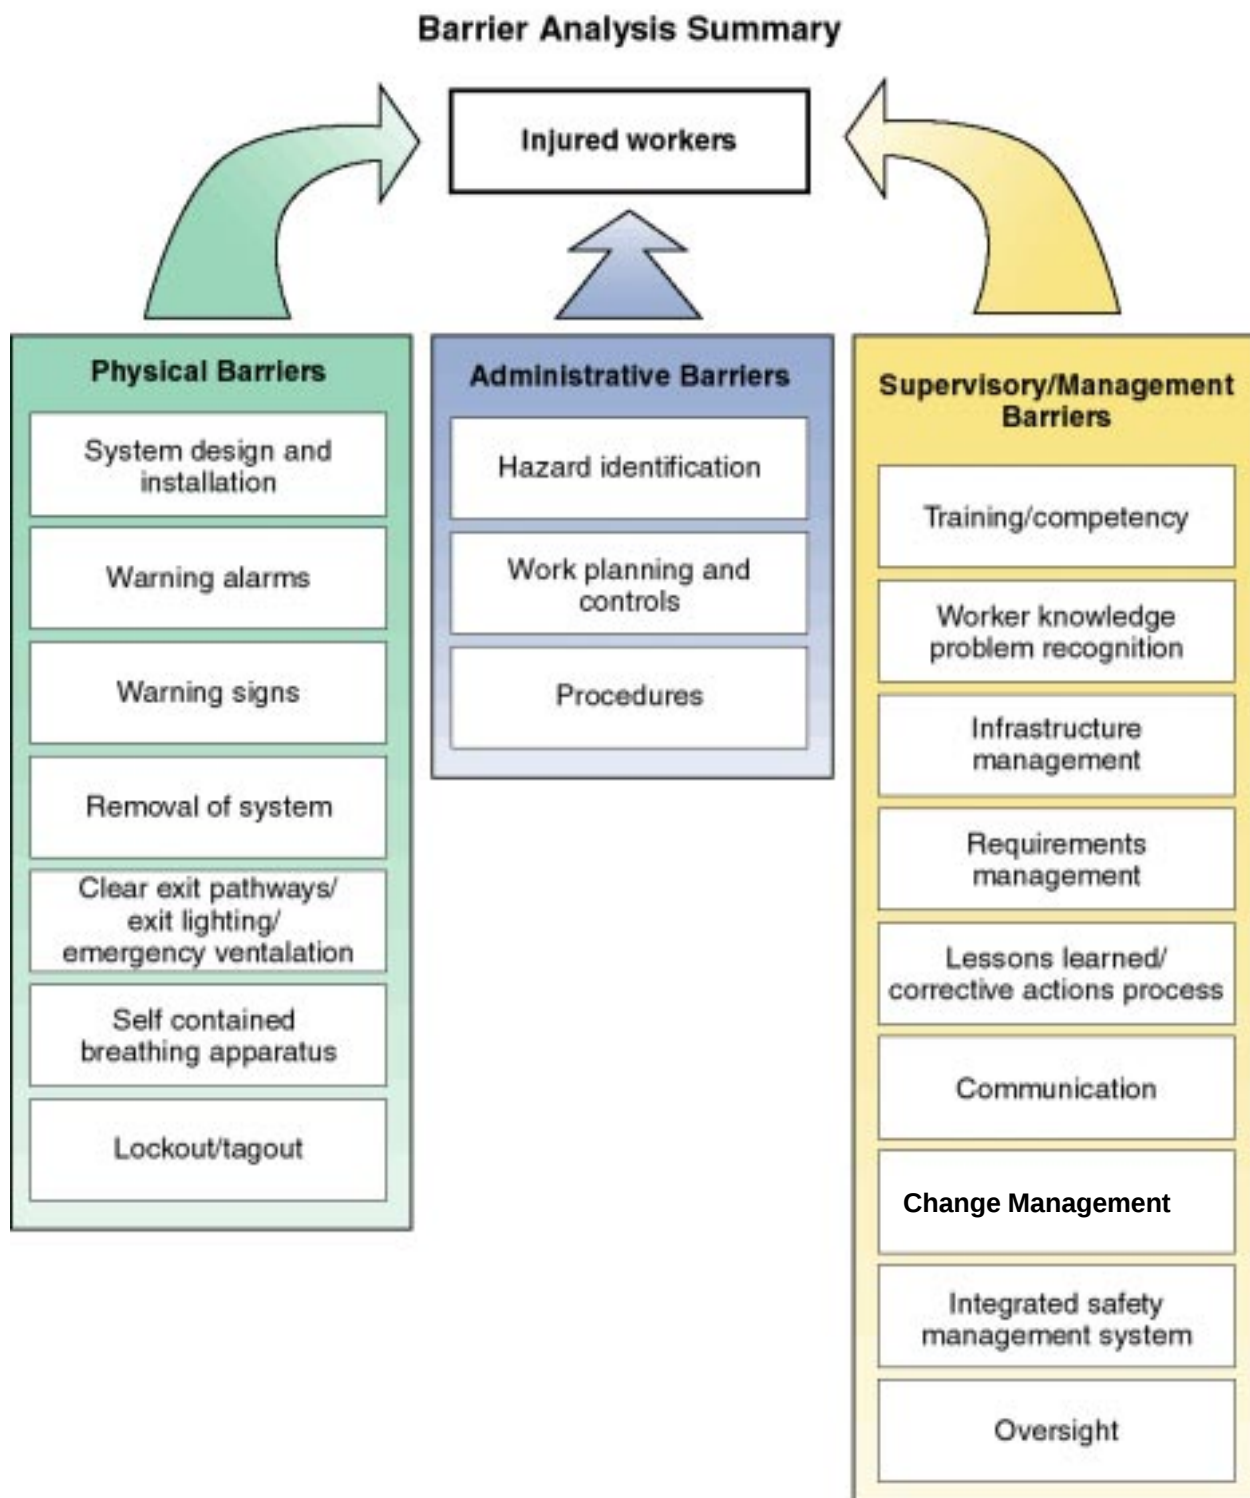
**Figure 4-3. Barrier Analysis Summary**

**Barrier Analysis.** In addition to the causal factor analysis, the Board performed a barrier analysis, which is a systematic assessment of the physical, administrative, and management elements that are intended to protect workers from hazardous materials and conditions. Figure 4-3 presents the results of the barrier analysis. Specifically, it identifies barriers that failed or that did not function as intended.

As seen on Figure 4-4, the lockout/tagout barrier had the capability to completely prevent the accidental CO<sub>2</sub> discharge and thus to eliminate the possibility of injuries and fatalities. The other physical barriers (e.g., CO<sub>2</sub> header pressure sensors and alarm feedback circuit, in conjunction with the 25-second mechanical discharge) would not have prevented the discharge but would have provided a pre-discharge alarm and time to escape the building if they had functioned properly, thus reducing the likelihood of injuries and fatalities. However, these systems were either not installed or failed.
