**Type B Accident Investigation Board Report  
on the September 4, 1998,  
Flammable Liquid Fire/Explosion  
at Fermi National Accelerator Laboratory  
Batavia, Illinois**

**October 16, 1998**

**Chicago Operations Office  
U.S. Department of Energy**

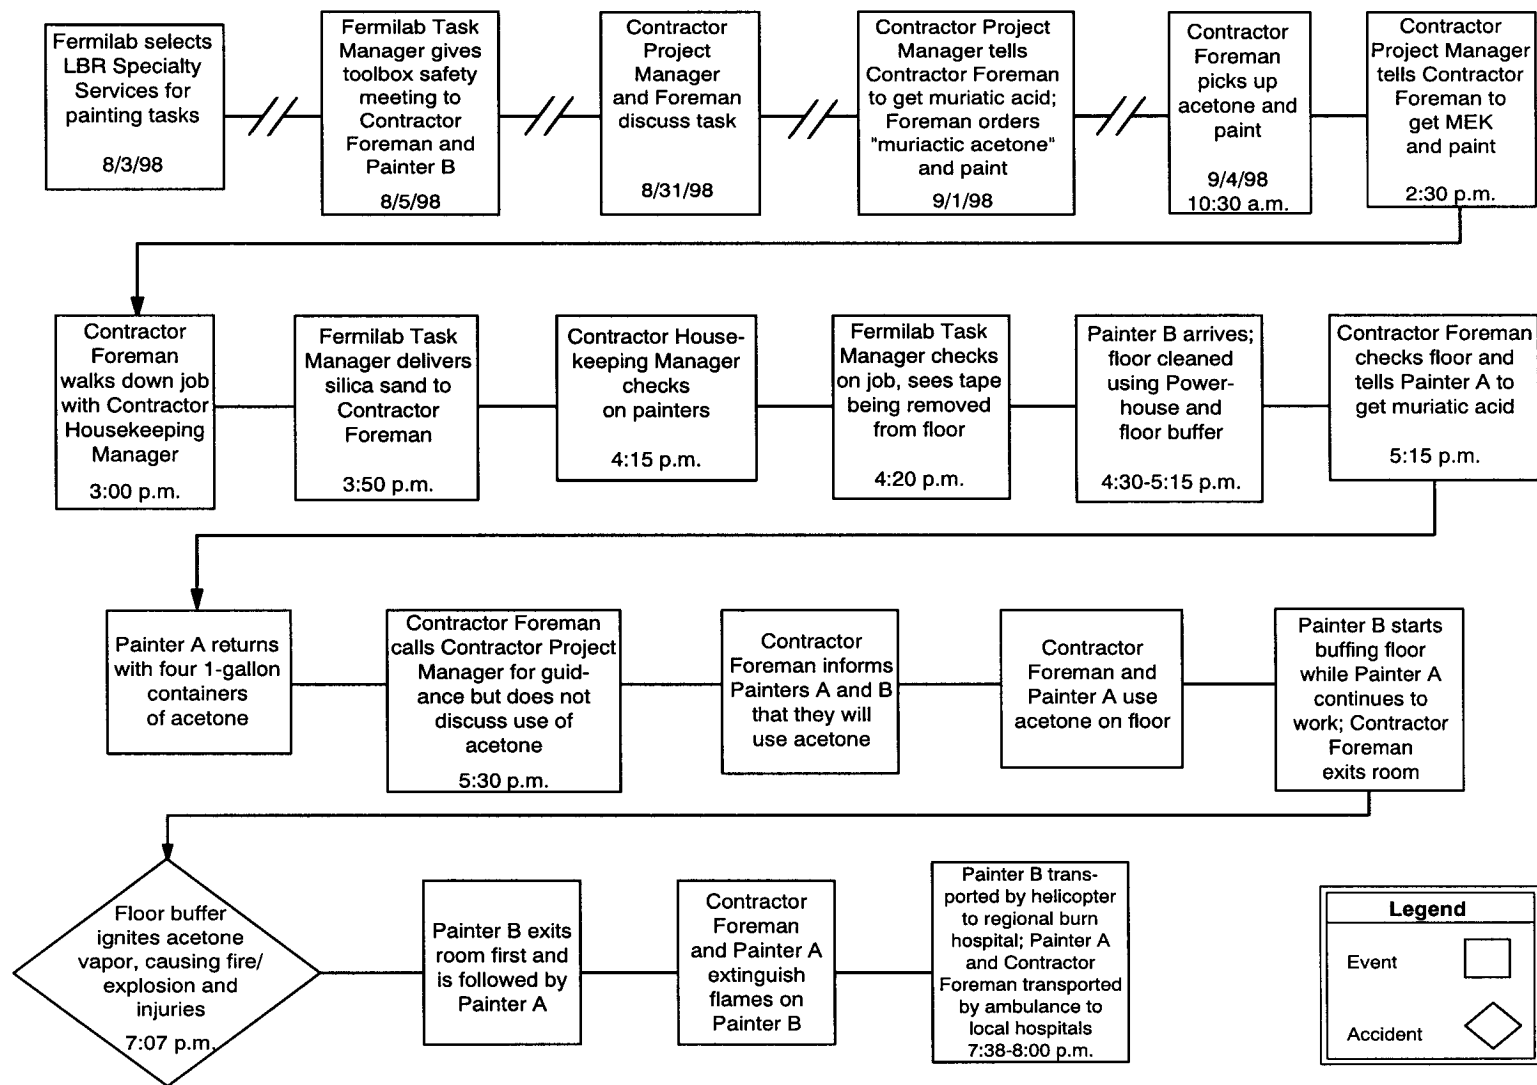
FIGURE 5 Summary of Significant Events and Accident Chronology (all times are approximate)

Figure 5 summarizes the chronology of events leading up to the fire and explosion.

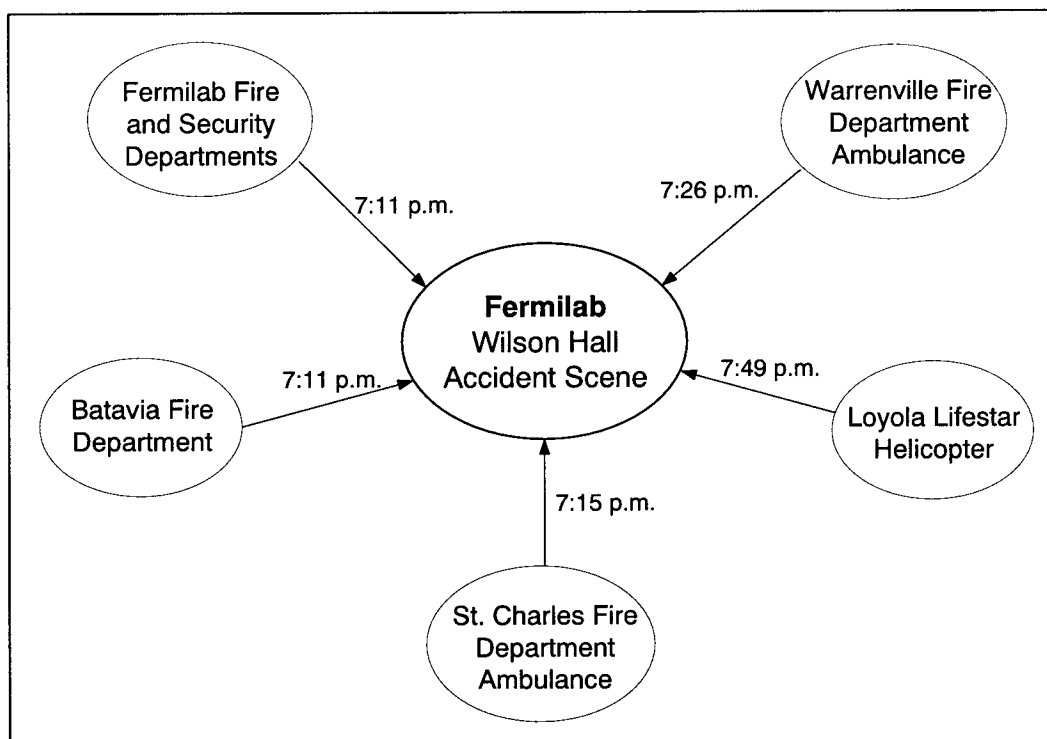
**FIGURE 6 Emergency Responders and Arrival Times**

The initial emergency response involved the Fermilab Fire and Security departments and four other mutual aid companies as shown in Figure 6. The Board concluded that the initial

The Board concluded that the initial response was timely and well coordinated.

response for fire-fighting activities, medical treatment of injured, and bringing the scene to a safe condition was timely and well coordinated. See Appendix B for a detailed sequence of events.

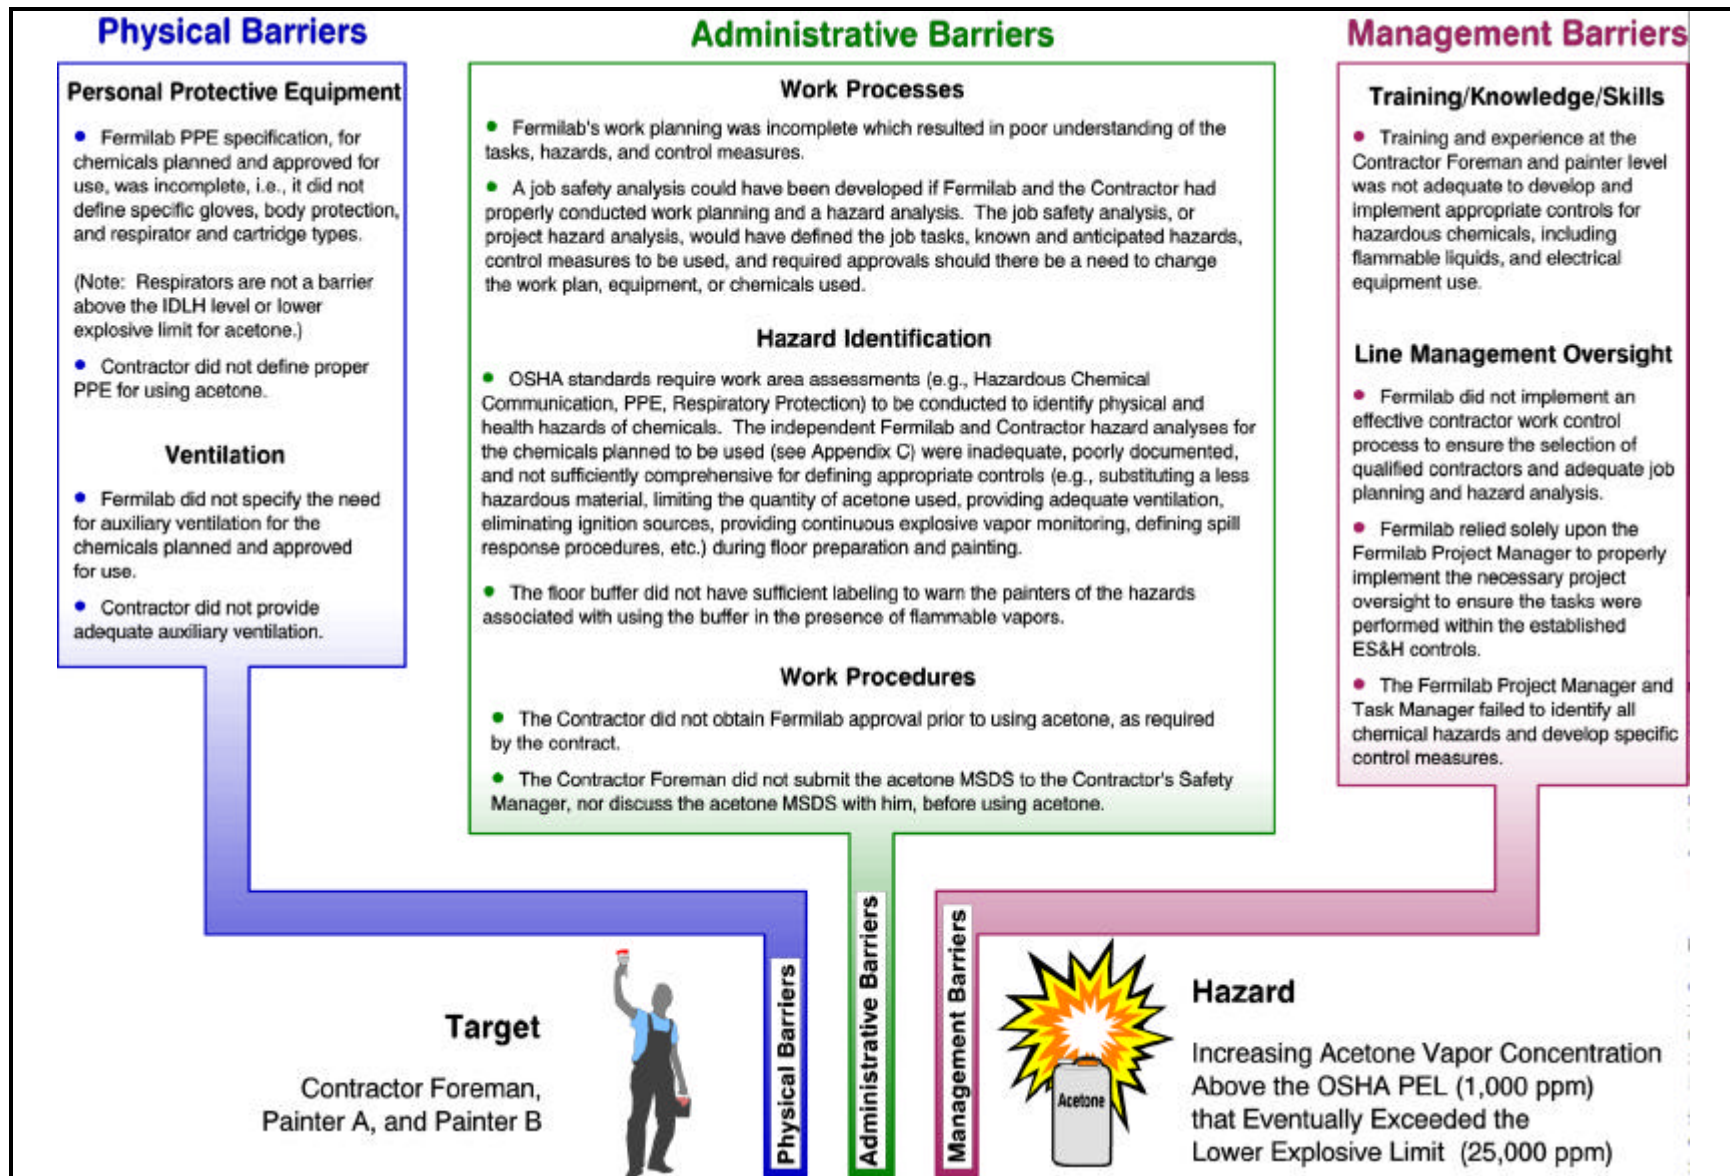
FIGURE 8 Barrier Analysis for the Accident

A barrier is defined as anything that is used to control, prevent, or impede process or physical energy flows to protect a person or object from hazards. The safety barriers between the target (Contractor Foreman and the two painters) and the hazard (high concentration of acetone vapors) were physical barriers, administrative barriers, and management barriers. Figure 8 describes why these barriers failed.
