**Office of Oversight  
Environment, Safety and Health**

*Type A Accident Investigation  
of the December 8, 1999*

**Multiple Injury Accident  
Resulting from the  
Sodium-Potassium Explosion  
in Building 9201-5  
at the Y-12 Plant**

February 2000

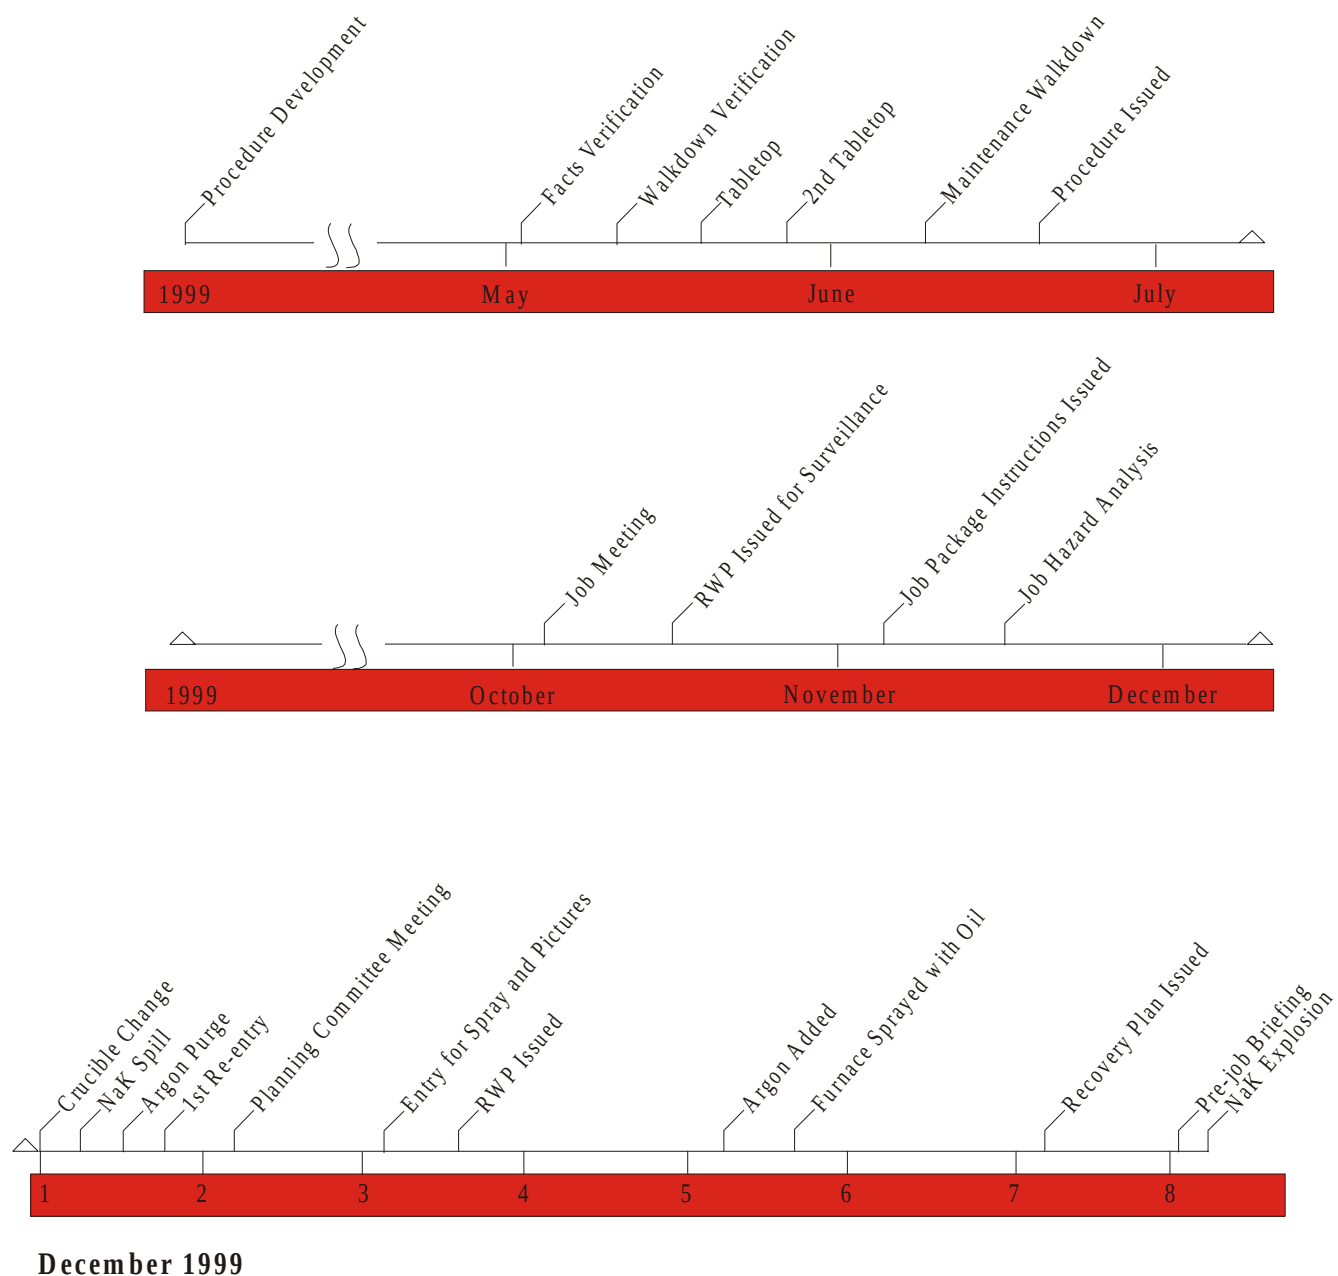
Figure 1. Activities Related to Development of the Crucible Changeout Procedure

Although the explosion and injuries occurred on December 8, the circumstances that led to the accident occurred on December 1, 1999, when NaK was inadvertently released during preparation for crucible changeout. This section describes the chronology of events leading up to the accident, the response to the accident, and the personnel injuries resulting from the accident. The event timeline is shown in Figure 1.

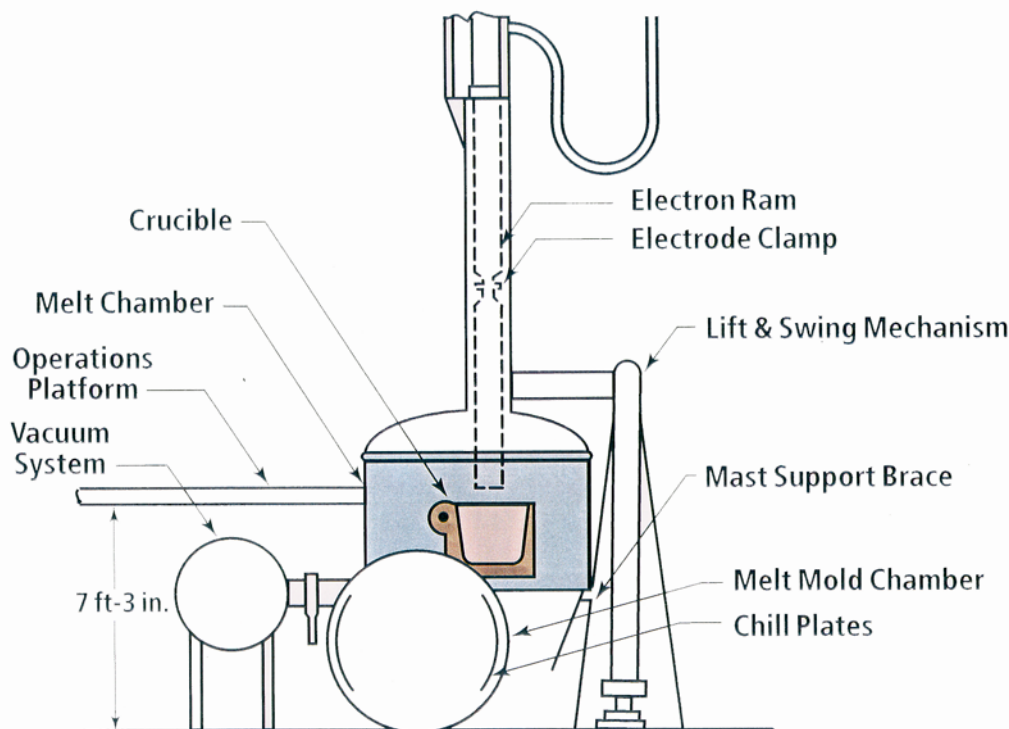
Figure 2. Skull Caster Furnace

In early 1999, Y-12 Plant management began planning to replace the steel crucible of the skull caster furnace (Figure 2). These crucibles experience heat stress during the arc melting process and need to be replaced (typically after about 70 melting cycles) to reduce the likelihood of a crucible failure during operations. The last crucible change occurred in 1993.

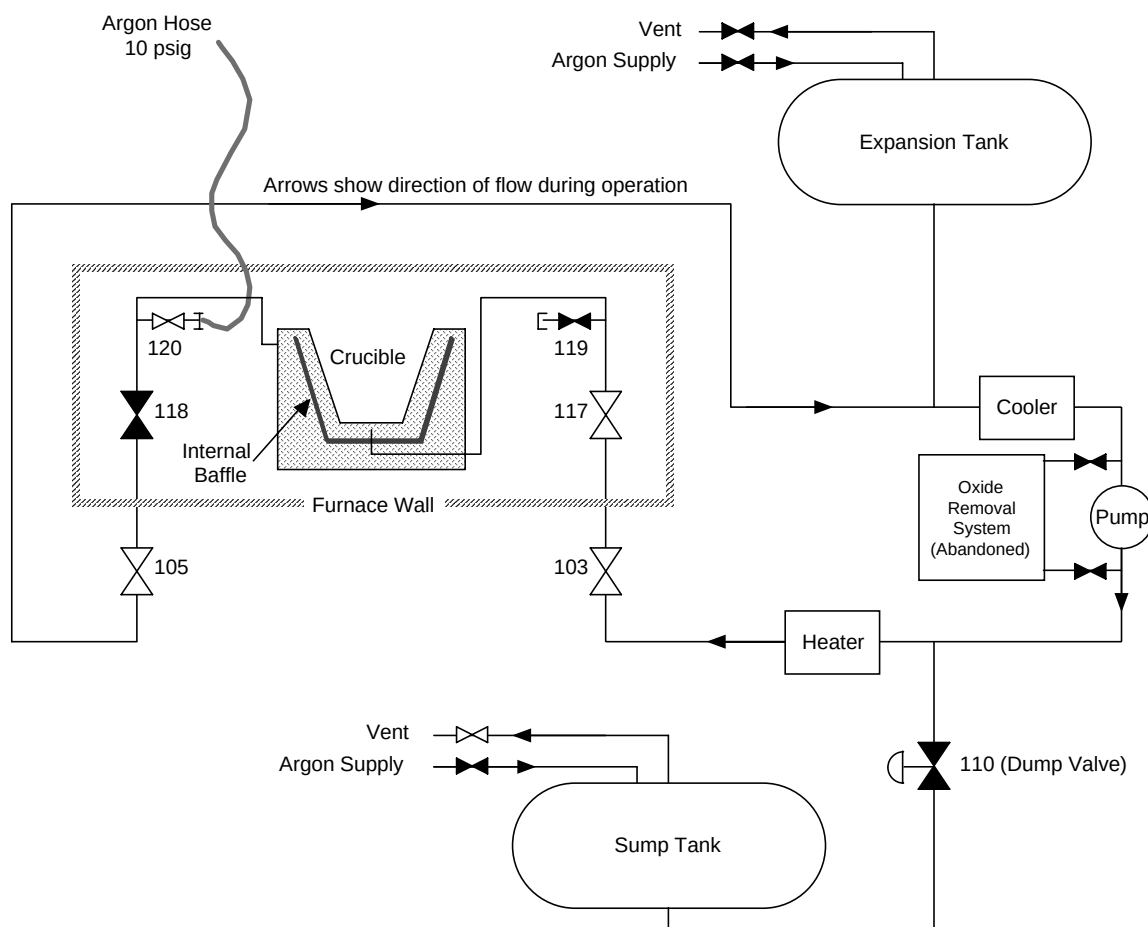
**Figure 3. Simplified NaK System Schematic**

Figure 3 (see page 10). The first portions of the procedure involved heating the NaK system to about 200 F to improve flow characteristics and then draining the expansion tank through the dump valve.

After the tank was drained, the dump valve was closed in accordance with the procedure. An engineer was marking up a copy of the procedure as it was being performed. Next, the crucible annulus was pressurized with argon to force NaK from the crucible annulus to the sump tank. The sump level was then measured and a four-inch discrepancy was noted, indicating to the operators that the crucible had not been fully drained. At this point, the supervisor, along with others present, decided to repeat the procedure steps involving heating the NaK. The supervisor then directed the pipefitter to close the argon isolation valve and remove the argon purge hose. The pipefitter removed the hose without closing the valve.

A combination of procedural errors (as discussed in Section 3.2) resulted in NaK spraying out the vent line. The spray of argon and NaK continued until the operators closed the NaK crucible isolation valves outside the furnace. Operators also closed the furnace lid and added argon to minimize the exposure of NaK to air. Oxides coated the walls and outside surfaces of the piping and furnace internals. Y-12 Plant personnel estimate that about three to ten gallons of NaK were spilled (although the estimates vary considerably).

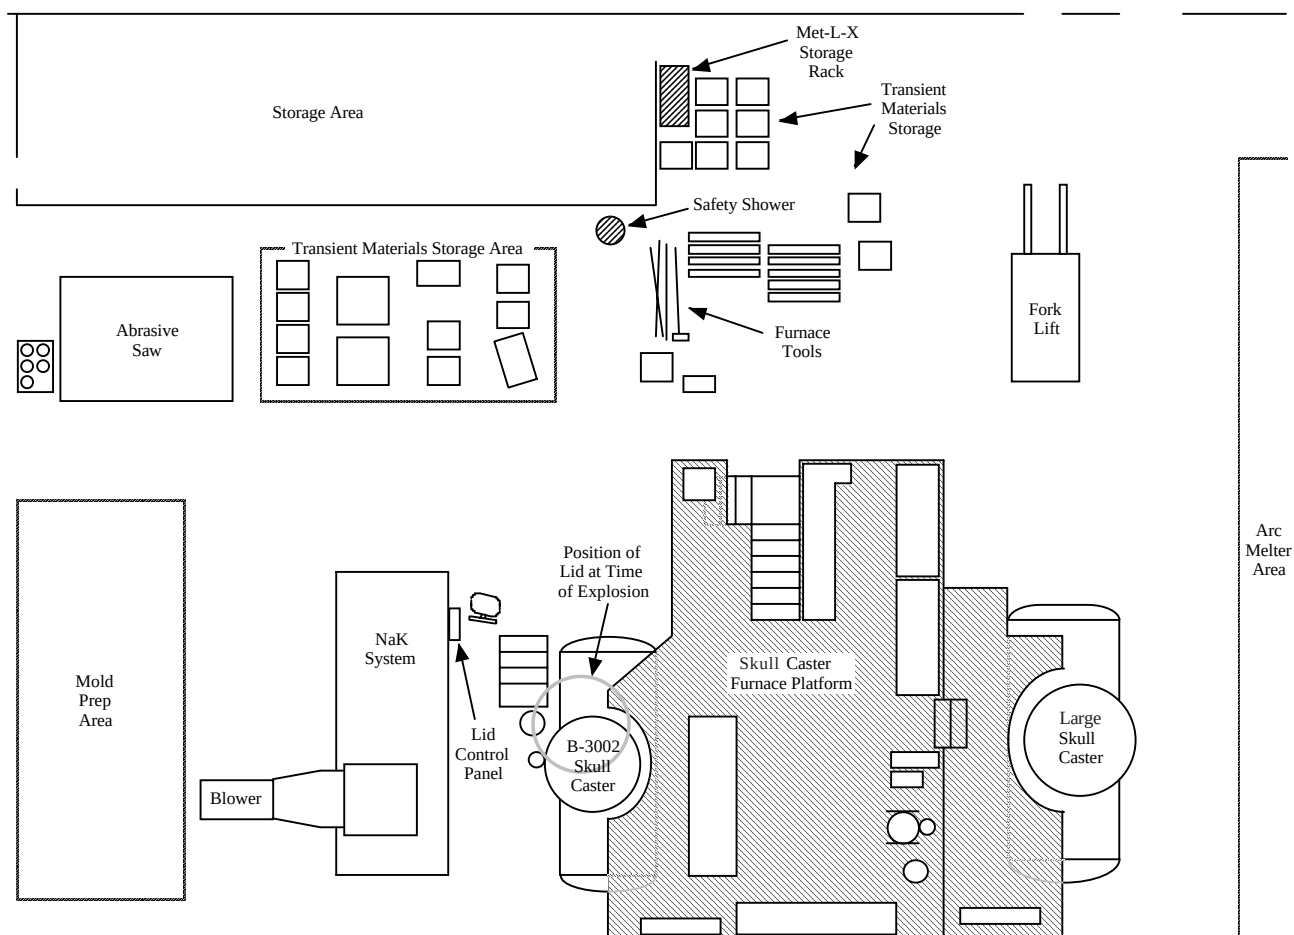
**Figure 4. Skull Caster Furnace Area, Showing Position of Safety Showers**

The layout of Building 9201-5 is shown in Figure 4. At the time of the explosion, the ten workers were positioned as marked on Figure 5.

The workers on the platform left as rapidly as possible. The operations manager (OM-1) helped the most severely injured worker (CO-1) off the platform and held him in an effort to smother his burning coveralls as they proceeded to the safety shower. Other workers discarded burning clothing as they left the area. The workers assisted the injured personnel and extinguished small fires. One worker (IH-1) exited the area and called 911, which connects to the Y-12 fire department dispatcher.

Although suffering from burns, three team members (OM-1, CO-3, and CO-4) returned to the furnace area to close the lid and extinguish small spot fires using dry chemical extinguishers. Another worker (FS-2) cleaned up water from the safety showers, which was accumulating on the floor (there are no berms or drains around the safety shower that is nearest the furnace). The water had spread in the direction of furnace and was reacting with NaK that had been dispersed onto the concrete floor by the explosion. Another DUO worker not involved in the recovery plan heard the noise and provided assistance when the accident occurred.

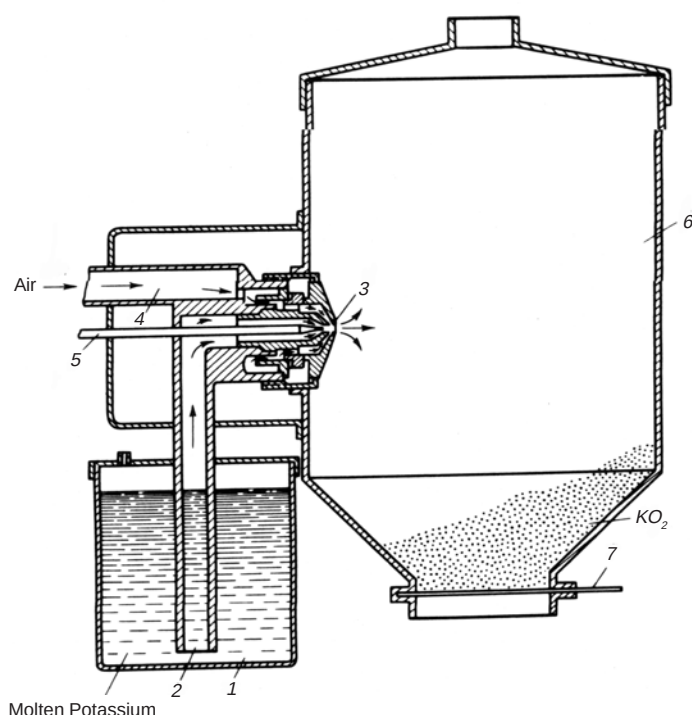
**Figure 6. Commercial Production of Potassium Superoxide**

The initial spill on December 1, 1999, involved a failure to close a valve, resulting in NaK spraying into the crucible while under pressure and at elevated temperatures. These conditions—forced exposure to air at elevated temperature—were favorable for the formation of potassium superoxide. Spraying NaK into the air in this manner is similar to the process used for commercial production of potassium superoxide, although commercial processes would use a higher temperature and a controlled fine spray (see Figure 6 on page 19).

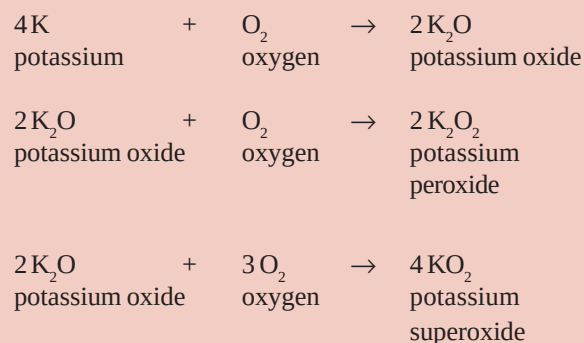
In a potassium fire, the dense white smoke formed is the potassium oxide ( $\text{K}_2\text{O}$ ). Because of the limited quantity of water vapor present in the air at the time of the spill, a relatively small amount of the NaK would react with water vapor to produce hydroxides. As shown in the box, the reactions of potassium and oxygen in the air can produce three different oxides, depending on the conditions.

If potassium oxide is subjected to an oxygen environment at an elevated temperature, the oxide will form potassium superoxide. At the time of the spill, the NaK had been heated to about 80 C. After the NaK spill, the material that sprayed into the furnace would be at a higher temperature because of the heat of the reaction. The residue noted after the spill was a combination of NaK, the oxides of potassium and sodium, potassium superoxide, and a small amount of sodium and potassium hydroxides.
