# **EPA CHEMICAL ACCIDENT INVESTIGATION REPORT**

**Pennzoil Product  
Company Refinery  
Rouseville, Pennsylvania**

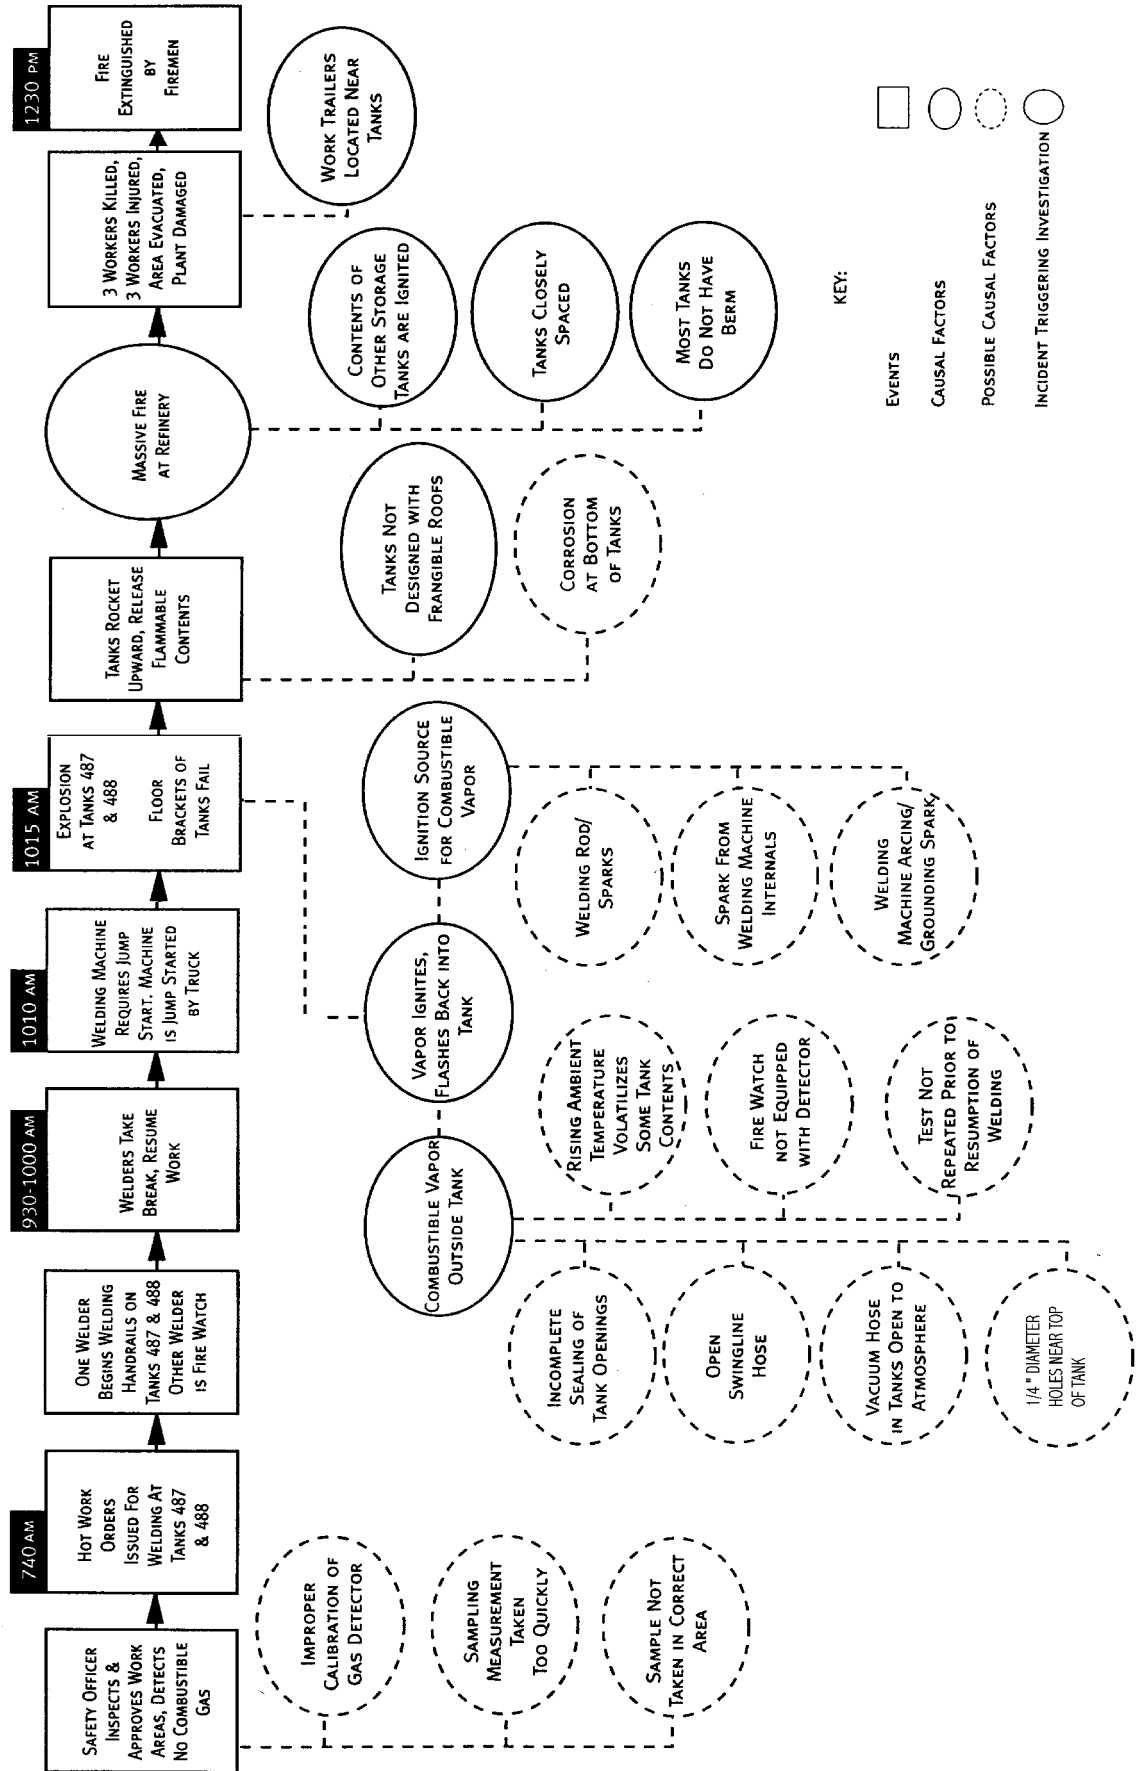
# EXHIBIT 6 EVENT AND CAUSAL FACTORS DIAGRAM OCTOBER 16, 1995 EXPLOSION OF TANKS 487 & 488 AT PENNZOIL REFINERY - ROUSEVILLE, PA

The CAIT used the information collected to develop an Event and Causal Factors Chart (described below). The Event and Causal Factors Chart combined with the factual information collected in addition to professional and engineering judgement were used to determine the causes of this accident.

- Following ignition of vapors, the storage tanks failed along their bottom seam and lifted off their base, releasing their contents.

- Once released, the burning liquid flowed without restriction to other areas nearby involving trailers, storage tanks and other equipment in the fire; and
- Tool and work break trailers were spotted in the vicinity of storage tanks 487 and 488.
