Report on the investigation of  
an explosion on board  
***fv Fleur de Lys***  
which then foundered  
18 miles south-east of Portland Bill  
on 16 April 2000

Marine Accident Investigation Branch  
First Floor, Carlton House  
Carlton Place  
Southampton  
United Kingdom  
SO15 2DZ  
**Report No 36/2001**  
**October 2001**

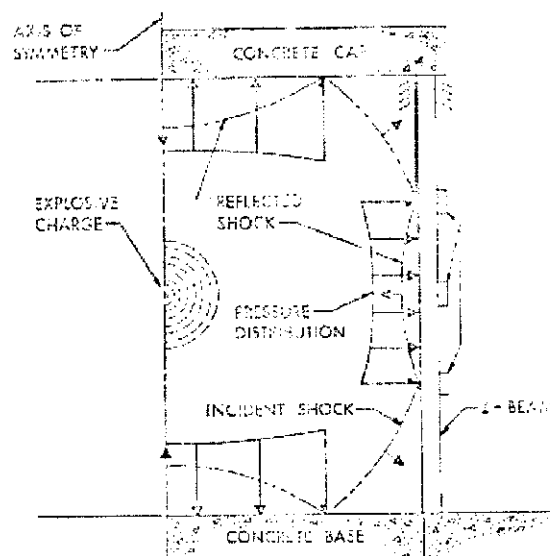
The blast wave from the explosion reflects in a very complex way within the engine room space. An illustration from Ref.2 is reproduced on the right and shows an example of the way the blast from a conventional explosive reflects inside a symmetrical containing room. In the present instance with the explosion epicentre in one corner and a finite source size the reflection patterns would be more complex.

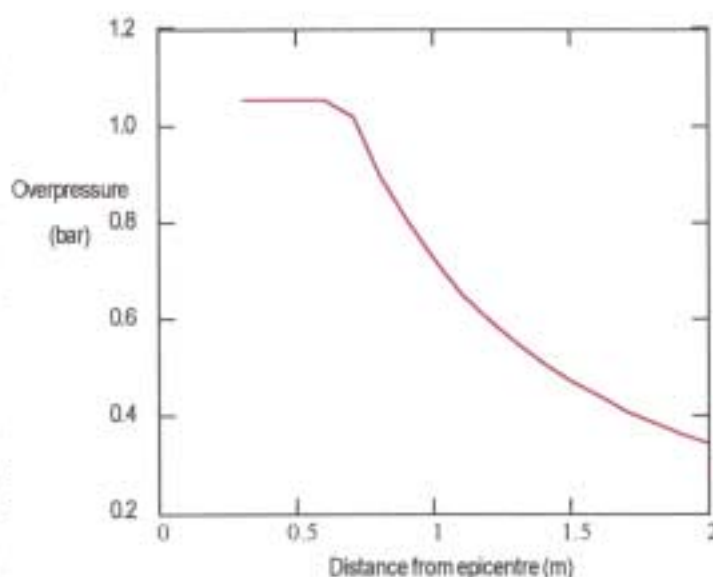
The appropriate graphical result relating blast impulse as a function of distance from

the explosion epicentre for this explosive energy is shown below. The maximum value close to the water cylinder perimeter is 0.06 bar s.

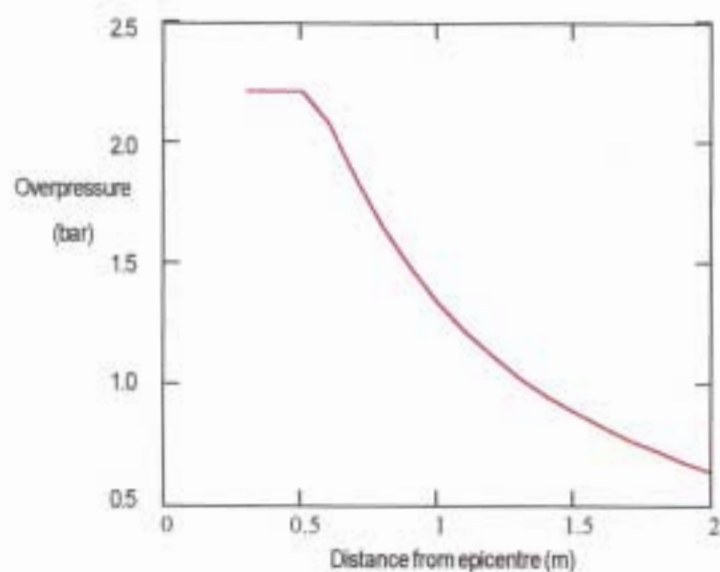
The appropriate graphical result relating blast impulse as a function of distance from the explosion epicentre for this explosive energy is shown below. The maximum value close to the water cylinder perimeter is 0.13 bar s.

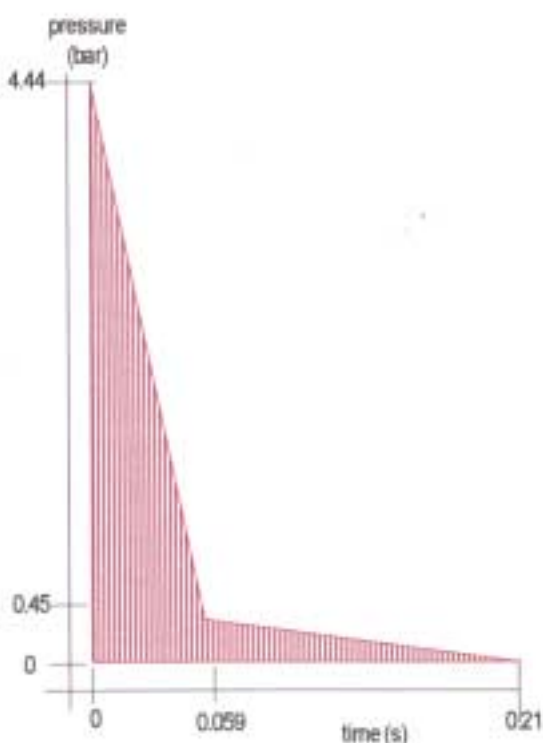
The PI chart for beams has been reproduced from the figure in Ref.2 and is shown below. The Y-axis represents the resistance to peak overpressure and the X-axis represents the resistance to impulse. The X and Y values for the peak overpressure of 4.44 bar and the impulse of 0.155 bar s and for the hull plank defined earlier are 0.705 and 141 respectively and these figures fall outside the chart as shown in the figure on the next page.
