Report of the investigation  
of a carbon monoxide poisoning on  
**fr *Mariama K* (FR242)**  
in Douarnenez, France  
on 10 June 2000  
One fatality

Marine Accident Investigation Branch  
First Floor, Carlton House  
Carlton Place  
Southampton  
SO15 2DZ

**Report No 12/2001**

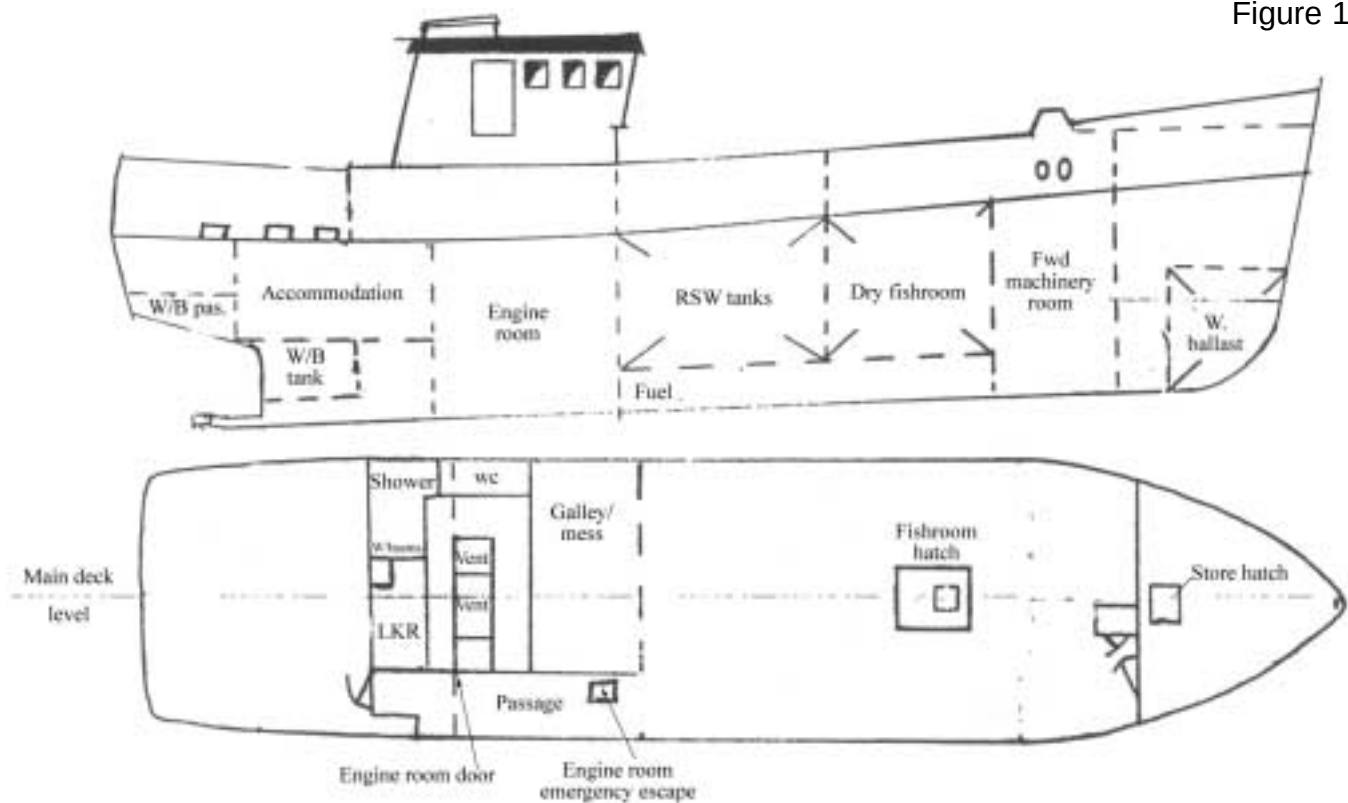
Figure 1

Below working deck level the hull is divided into five main compartments. From forward to aft, these are: forward store, forward machinery space, fishroom/refrigerated sea water (RSW) space; engine room; cabin (see Figure 1).

*Mariama K* - General Arrangement
