## **Live Oak/Milstar Complex and Carpet Service Center**

**LaGrange, Georgia**

This is Report 086 of the Major Fires Investigation Project conducted by Varley-Campbell & Associates, Inc. under contract EMW-94-C-4423 to the United States Fire Administration, Federal Emergency Management Agency.

Tuesday, January 31, 1995

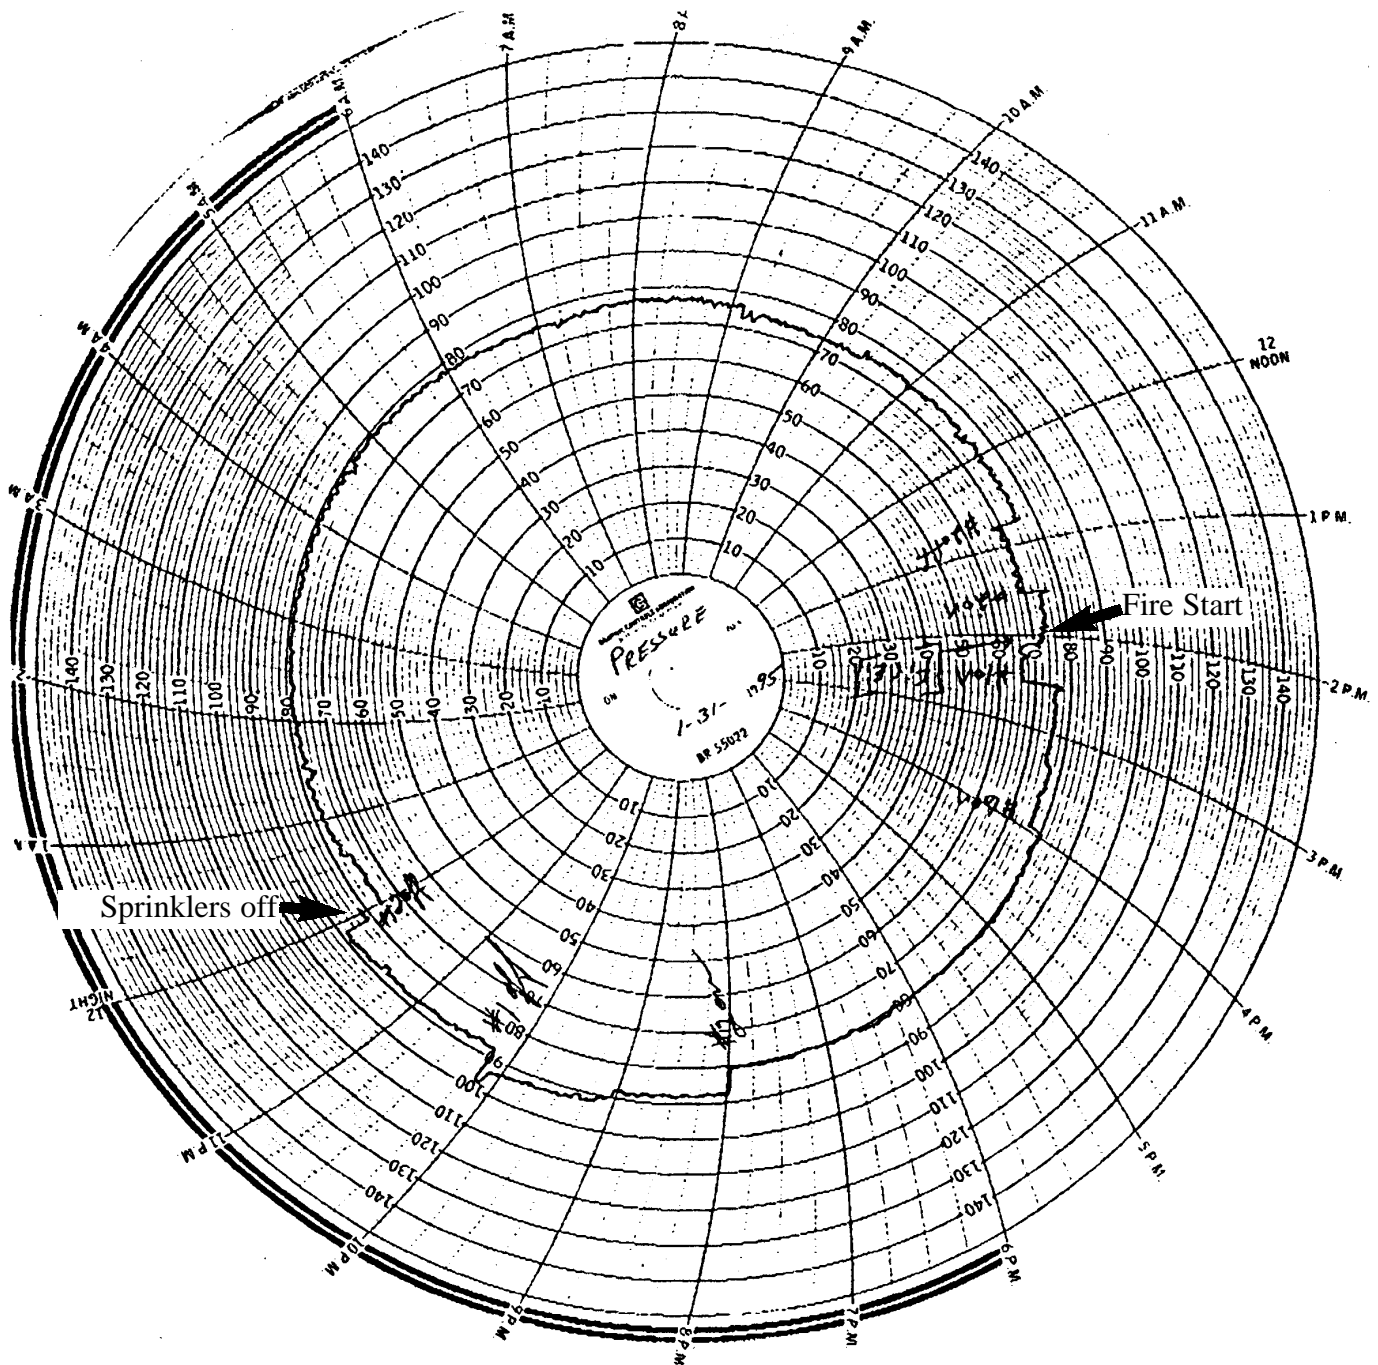
# LaGrange Water Department Delivery Pressure Chart

Records indicate that during the afternoon and evening of January 31, 1995 four of the five pumps were placed into service and that nearly 10 million gallons of water was delivered that day. This figure was significantly above the normal daily consumption for the time of year. The delivery pressure chart recording at the treatment plant documents the pressure drop at the start of the fire and a spike when the city water connections to the Milliken plant were closed. During the period between these events, the treatment plant delivery pressure remained within the normal operating pressure range of 72 to 96 psi. This indicates that the water mains in the area of the fire were delivering water at their maximum rate.
