**Tanker Truck Fire**

**Date of Incident: August 14, 2001**

**Type of Incident: Fatal**

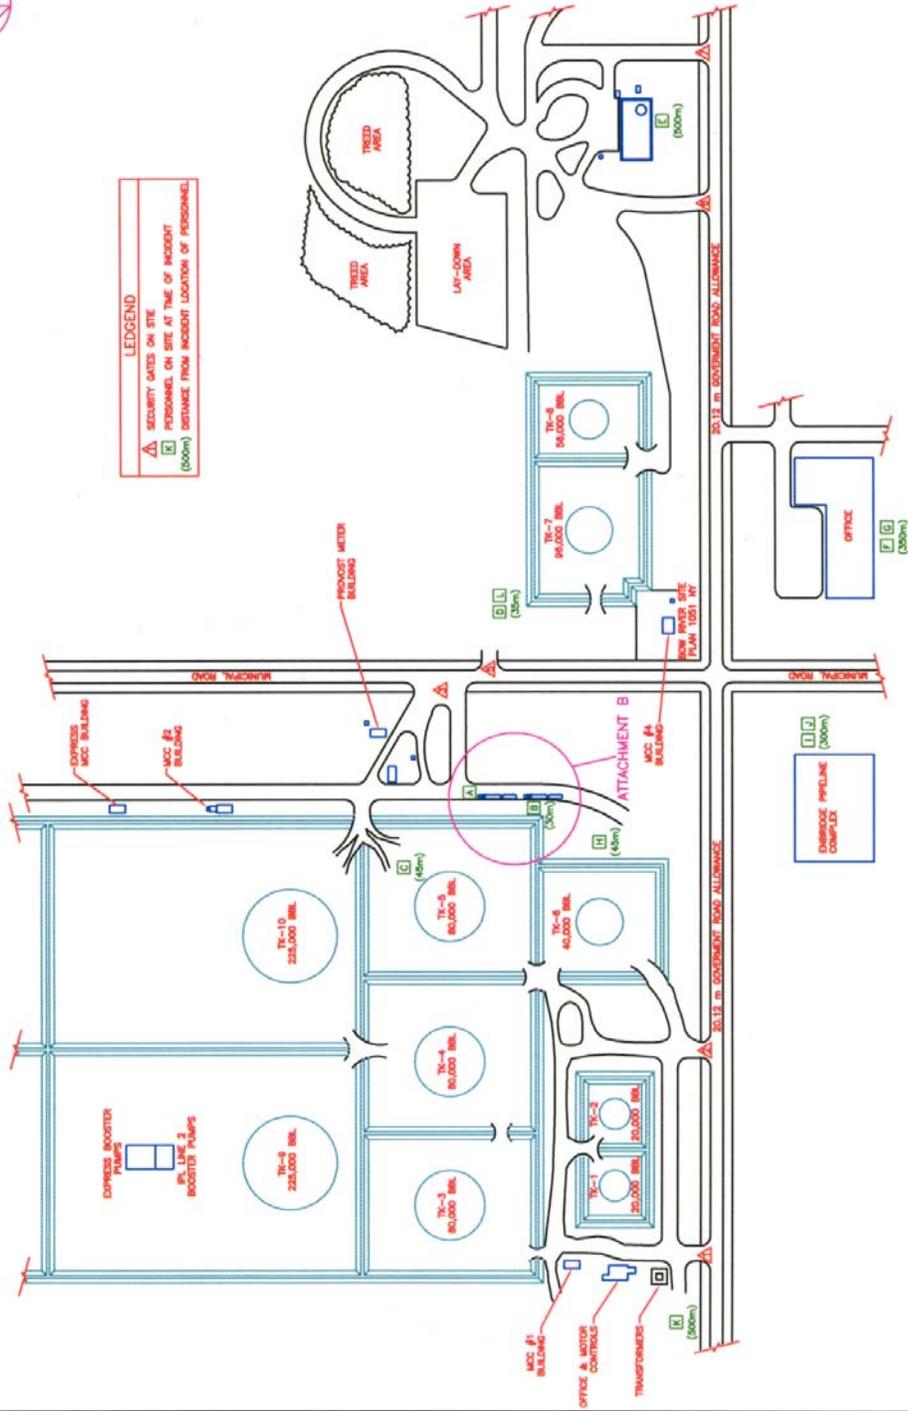
FILE NO: F123456      ATTACHMENT: A      NAME: GIBSON PETROLEUM      SCALE: NTS      DATE: 01-09-27

- NOTES:
- VALVE #1 WAS OPEN AT THE TIME OF INCIDENT AND GIBSON PERSONNEL CLOSED VALVE
  - VALVE #2 WAS OPEN AT THE TIME OF INCIDENT AND FIRE CREW CLOSED VALVE
  - VALVE #3 WAS FOUND ON SITE IN THE OPEN POSITION
  - VALVE #8 WAS OPEN AT THE TIME OF INCIDENT AND FIRE CREW CLOSED VALVE
