# **EPA CHEMICAL ACCIDENT INVESTIGATION REPORT**

**Accra Pac Group, Inc.  
North Plant  
Elkhart, Indiana**

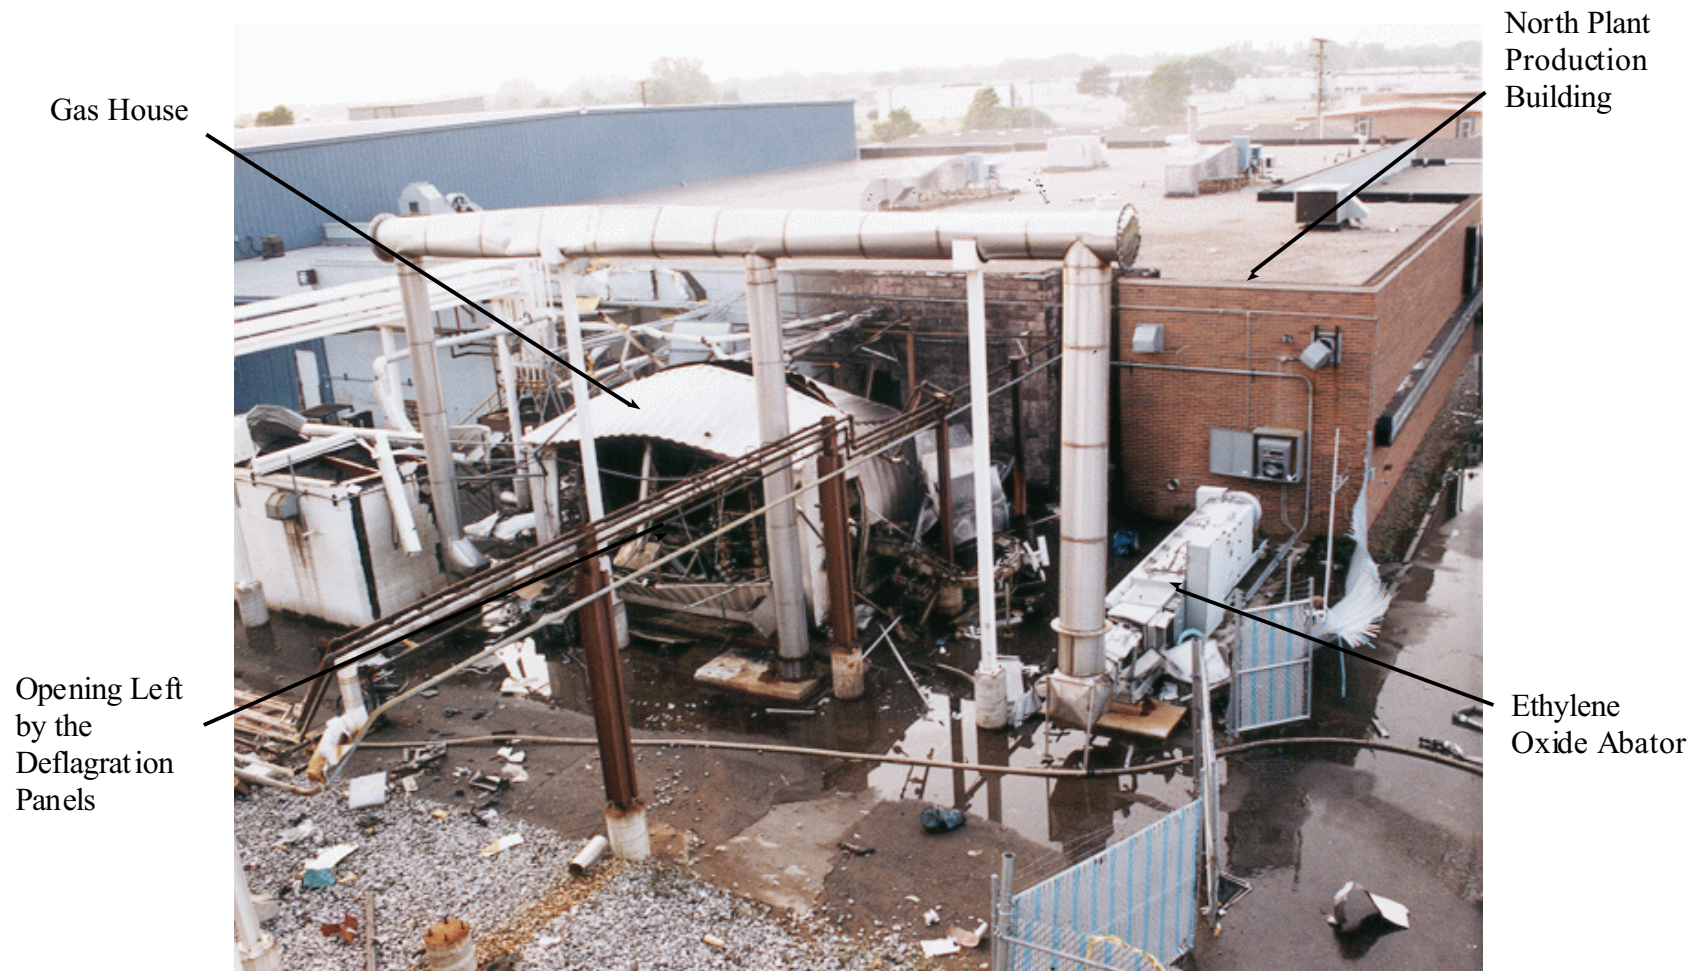
An Accra Pac employee working in the Production Building across from the Gas House was killed as a result of the explosion. When the Gas House doors were blown off, the door facing the Production Building impacted the Production Building door and caused that door and its frame to be dislodged and blown into the Production Building where it struck and killed the employee.

**A-1: The Gas House and the Production Building after the explosion and fire.**

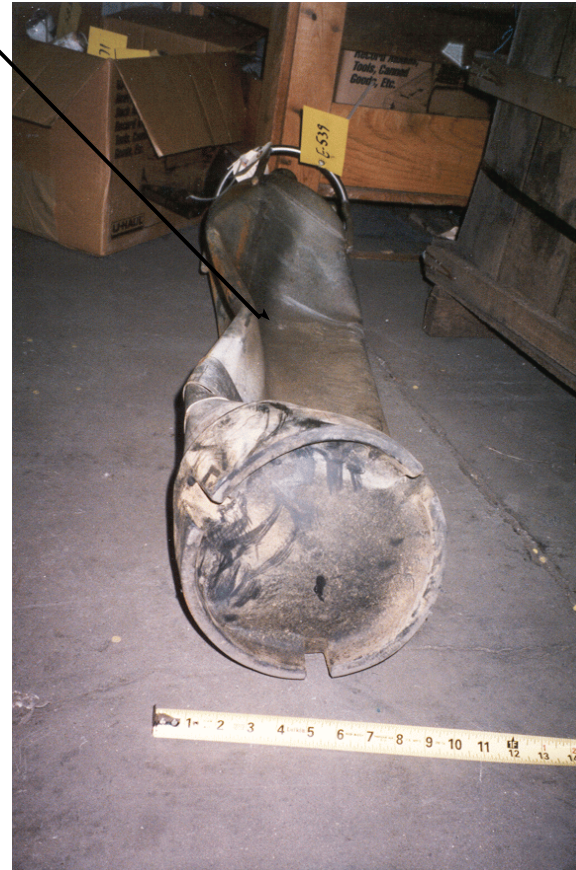
Ethylene Oxide Reclamation Tank

- Polyethylene tubing was used to carry excess ethylene oxide from the under-the-cup filler to the reclamation tank. The polyethylene tubing is much more susceptible to failure than metal tubes. There is no non-return check valve on the connection of this tubing to the reclamation tank. If this polyethylene tubing failed or became disconnected, ethylene oxide would rapidly escape from the reclamation tank.

- The ethylene oxide reclamation tank in the Gas House was found to have been crushed by the force of the explosion. (See Appendix A-3) The tank collapsed from three sides leaving almost no void volume. Had the reclamation tank been substantially full of liquid, which is not compressible, the reclamation tank would not have become crushed in the explosion. The reclamation tank showed no signs of puncture or rupture. Thus, any release of ethylene oxide would have had to have occurred in the connectors, valves, or tubing associated with the reclamation tank.

**A-3: Side and bottom view of the ethylene oxide reclamation tank after the explosion and fire.**

- **Relocate the reclamation tank to a location outside the Gas House to reduce the amount of hazardous material inside the occupied building.** In the event of a tank leak, this would reduce the likelihood of injury to the occupant of the Gas House. Also, **develop a way to monitor the quantity of material in the reclamation tank.** This capability is necessary to avoid overfilling which can lead to an accidental release. Finally, **install a non-return check valve on the reclamation tank.** This would minimize any release should the feed line or any connectors leading to the reclamation tank fail.
